**Annex A**

**Photographic bundle**

## **Site Diary Entry**

| <b>Name of site</b> | <b>Name of Operator/Licence holder</b> | <b>WML Number</b> |

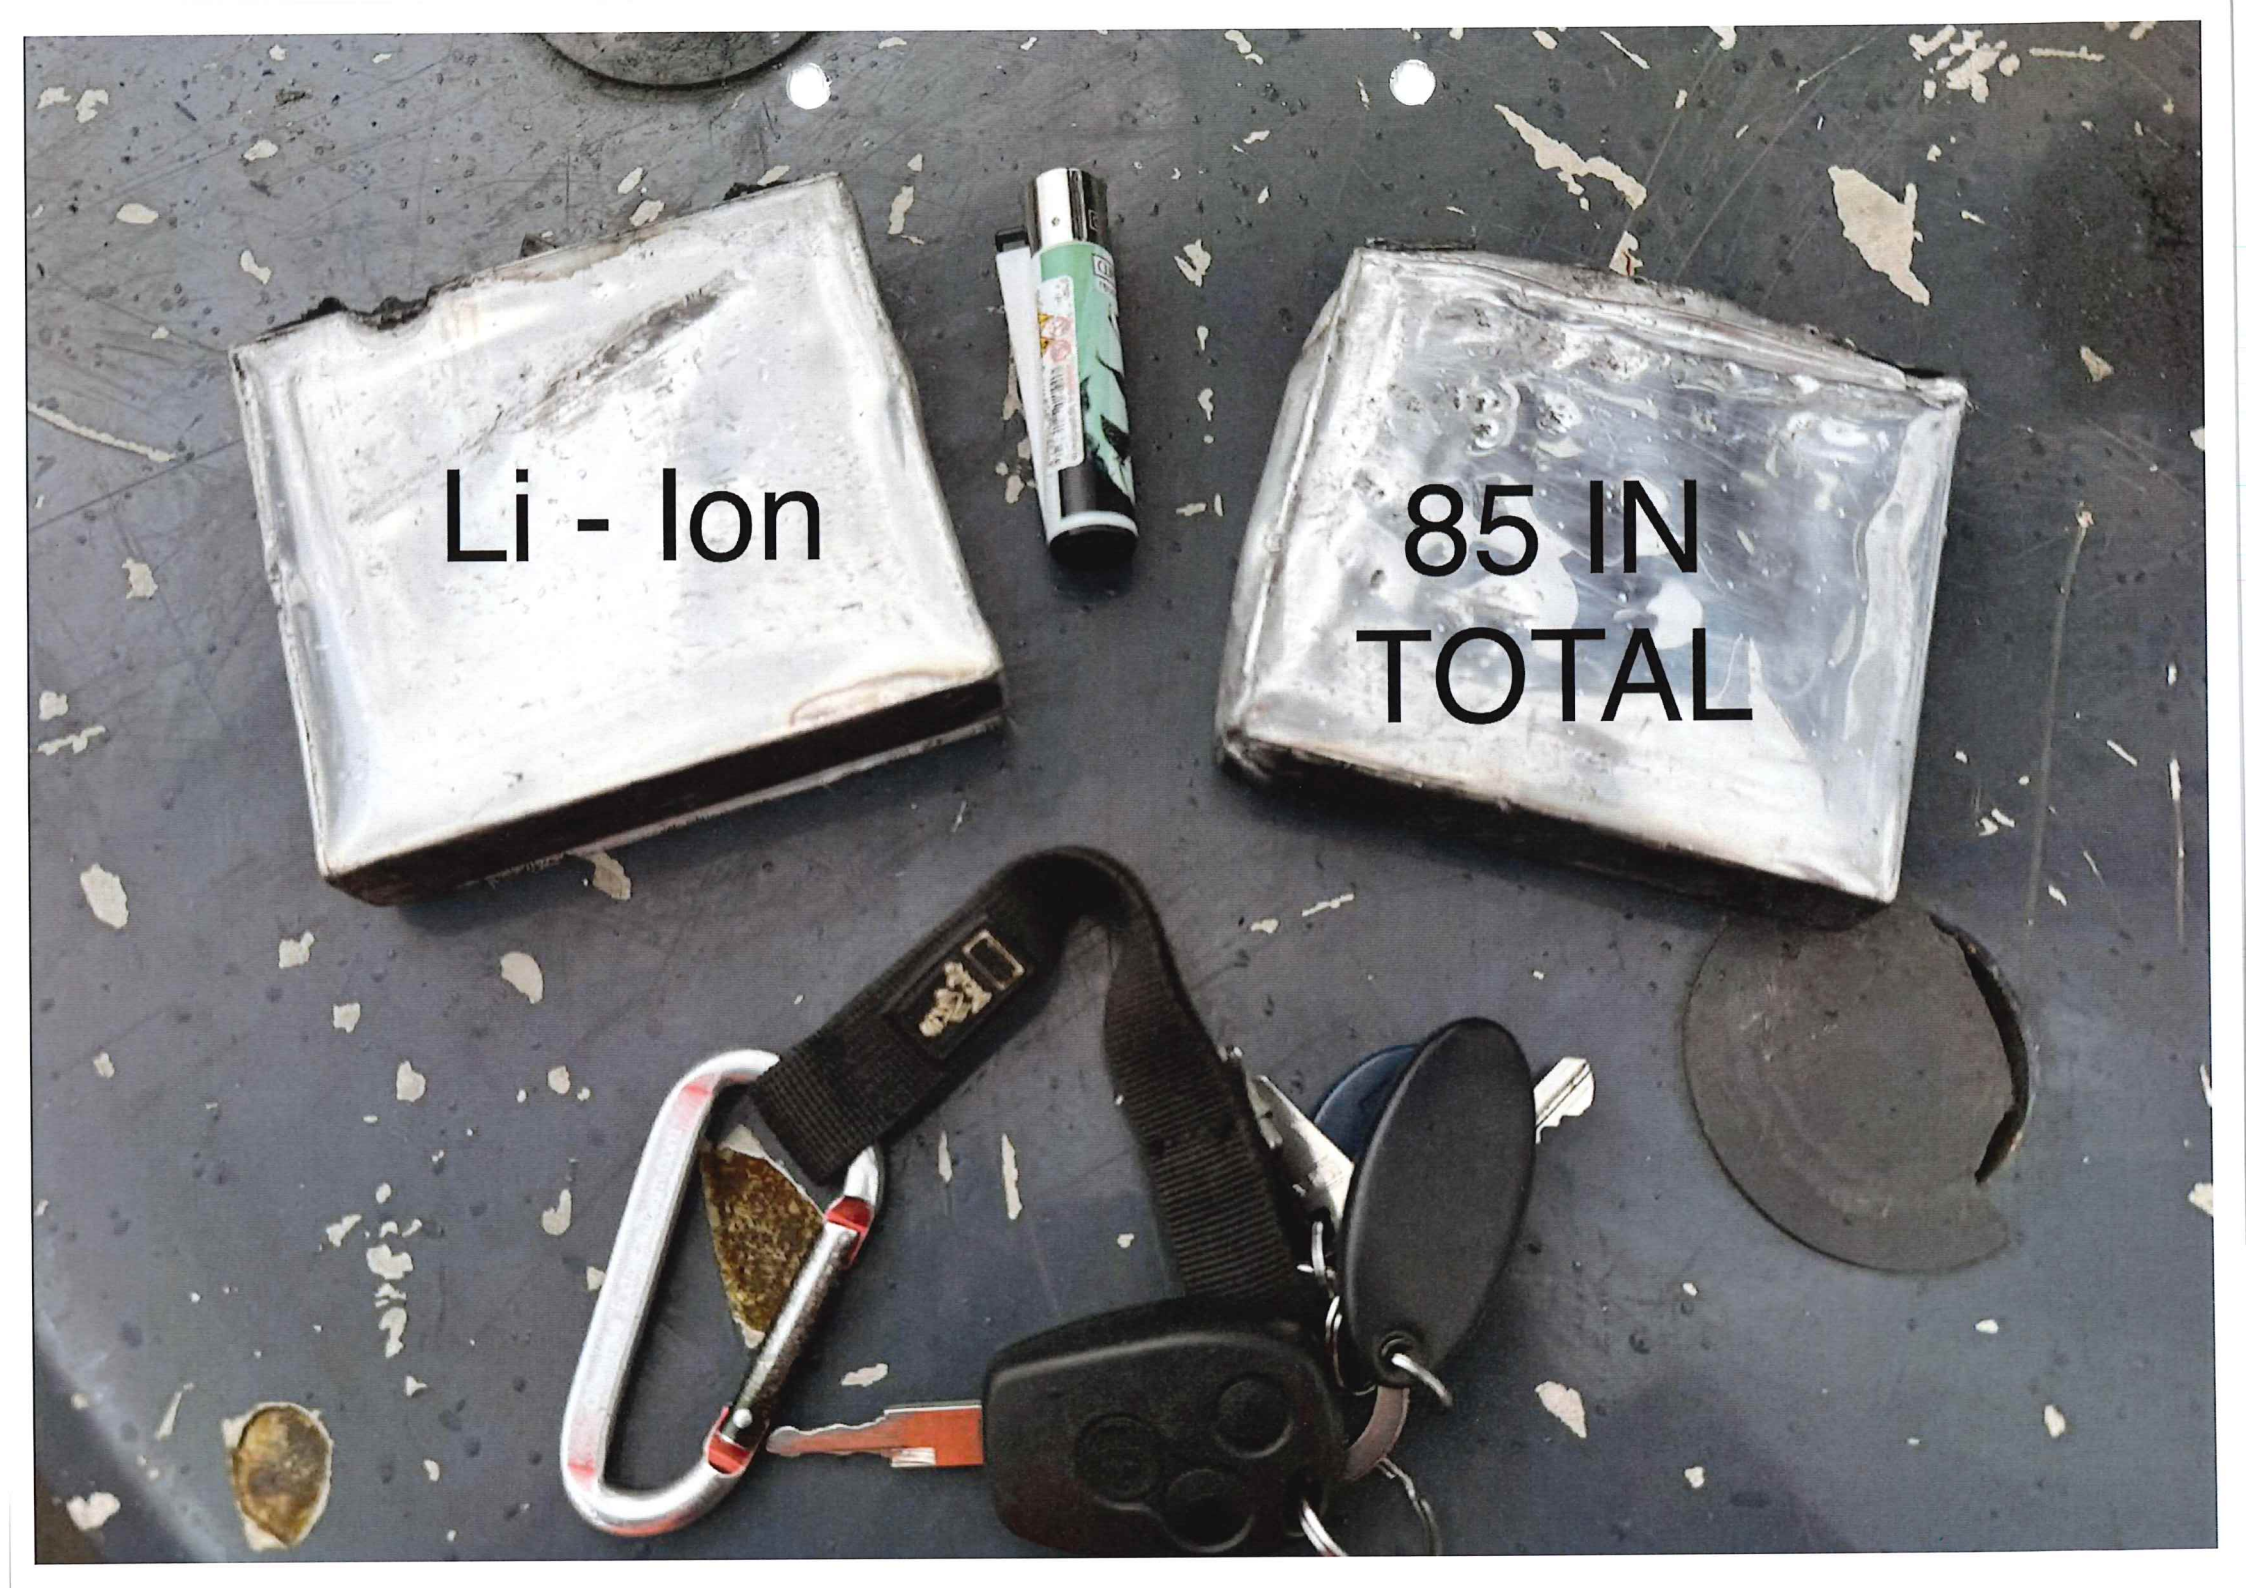
Li - Ion

85 IN  
TOTAL
