NORTHERN IRELAND ENVIRONMENT AGENCY

Investigation Summary Sheet

Investigating Officer: Person 1 **Grade:**WQI **Incident Ref:**WR3/24/0504

Nature of contamination:Cow slurry

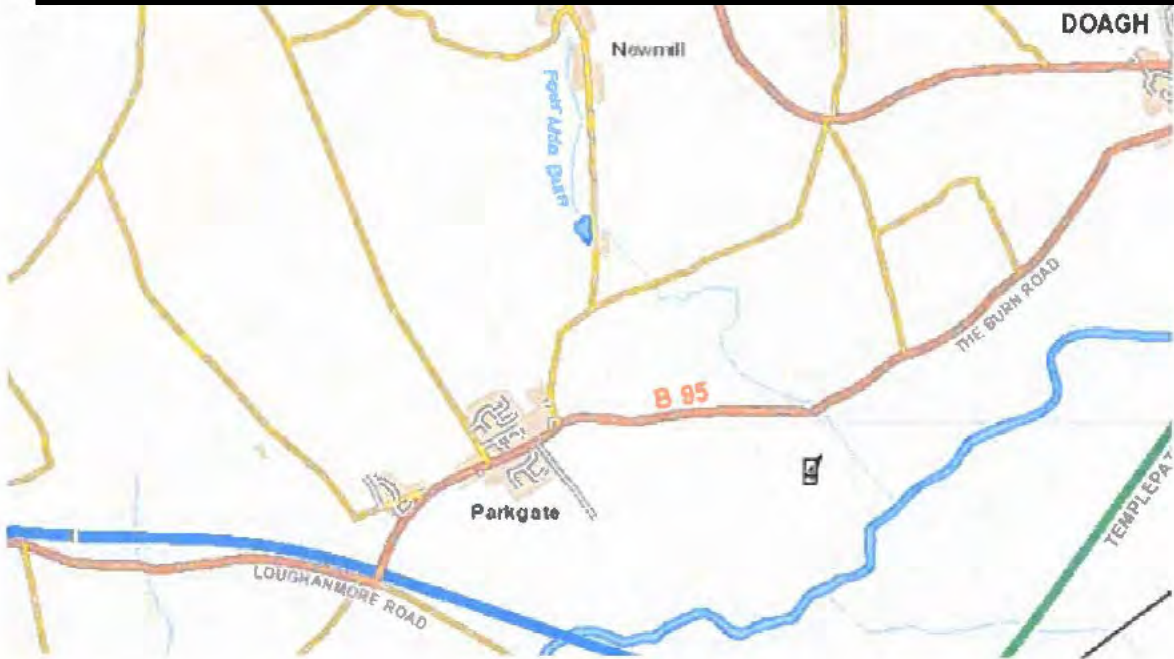
Exhibit [redacted] 2

Sketch map of the Ballyclover Burn and Four Mile Burn.

Sketch map of the Ballyclover Burn to Ballyvoy Bridge where it becomes the Four Mile Burn

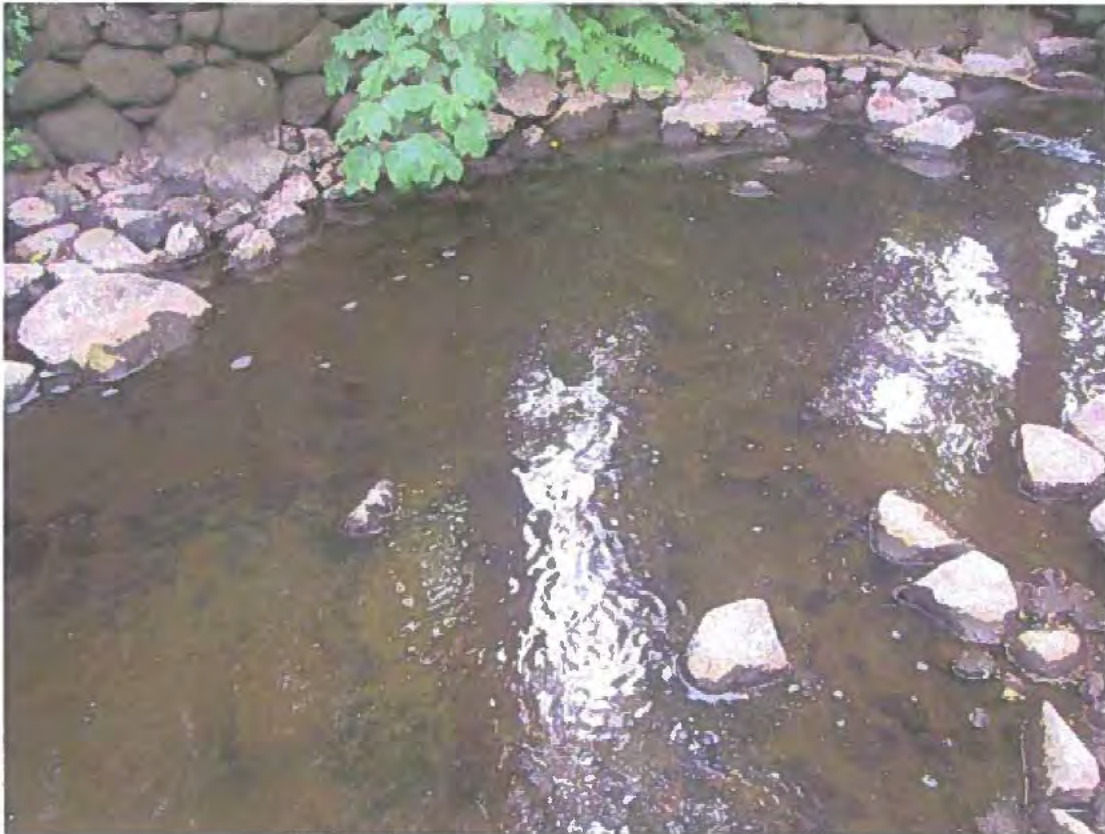
Exhibit **Person 1**/4

4. Mr **Person 2** and I then proceeded to Burn Road, Doagh and inspected the Four Mile Burn. I observed the water was visually clear with no detectable pour. I did not observe any dead fish. I photographed the Four Mile Burn and I produce Exhibit **Person 1/4**.

Four Mile Burn visually clean and no dead fish observed

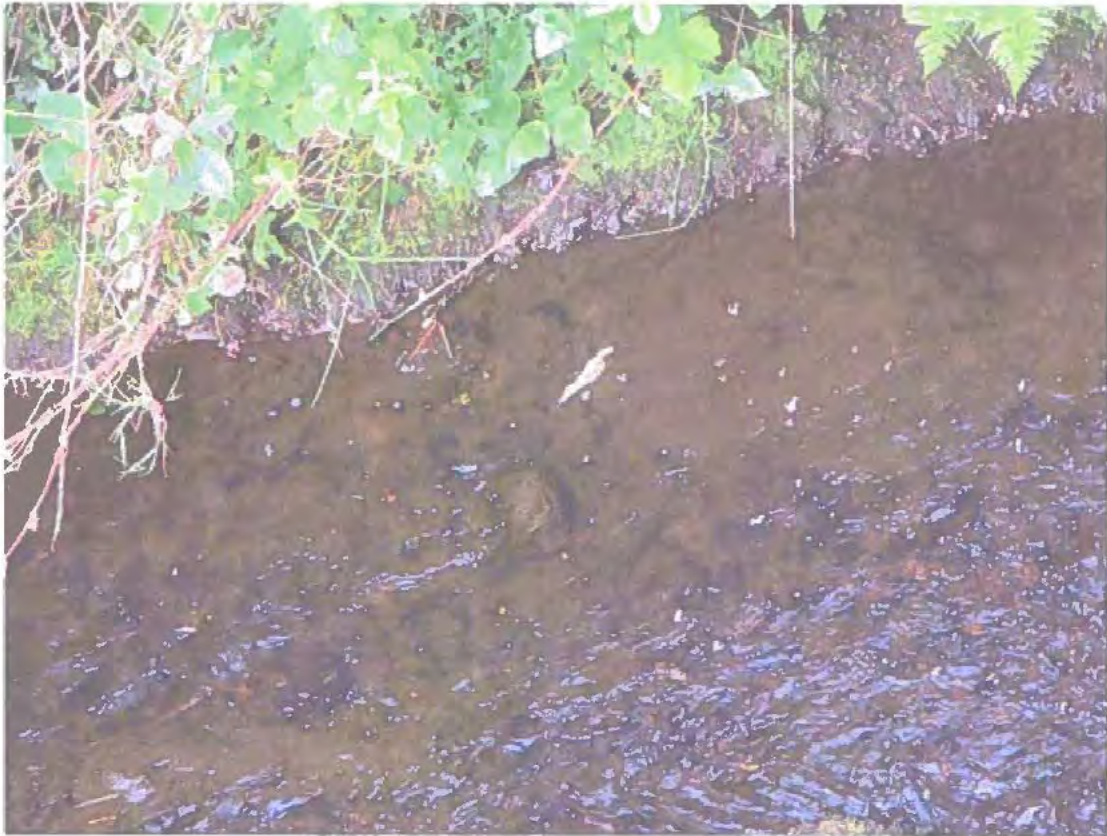
Exhibit Person 1/5

Dead fish in Four Mile Burn (immediately downstream of Ballyvoy Bridge)

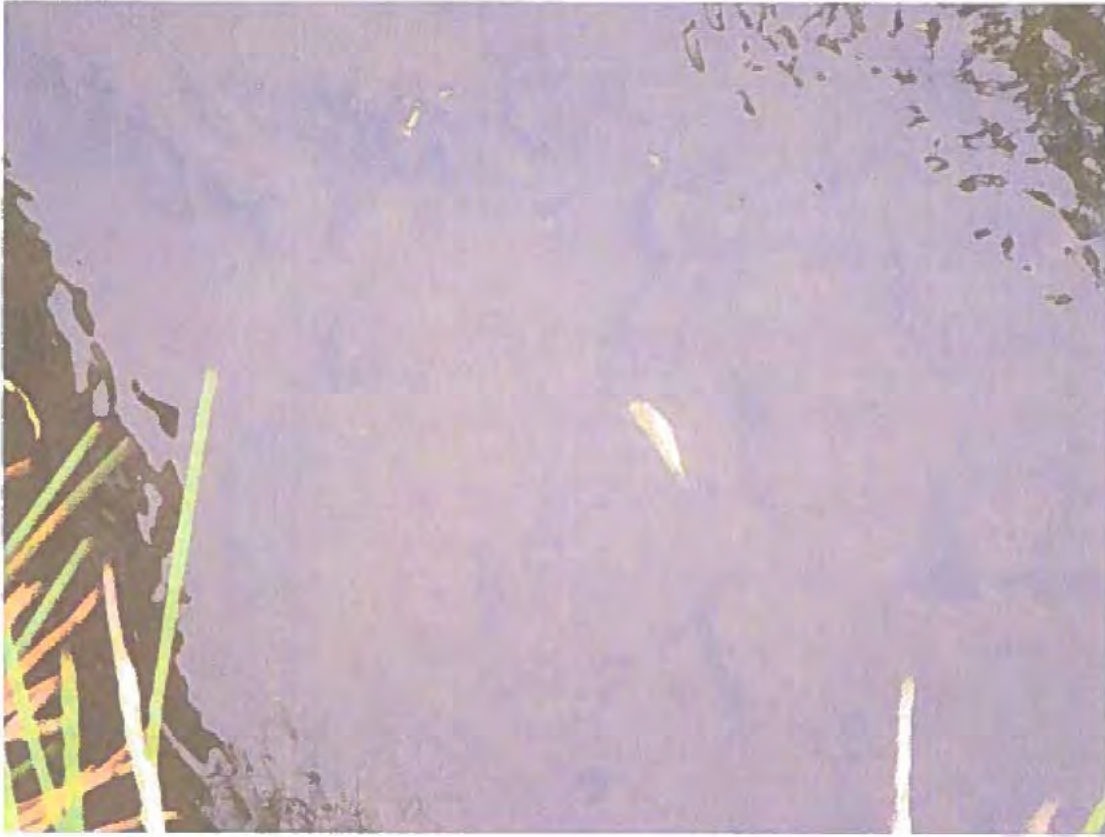
Exhibit **Person 1**/6

Dead fish in Ballyclover Burn (immediately upstream of Ballyvoy Bridge)

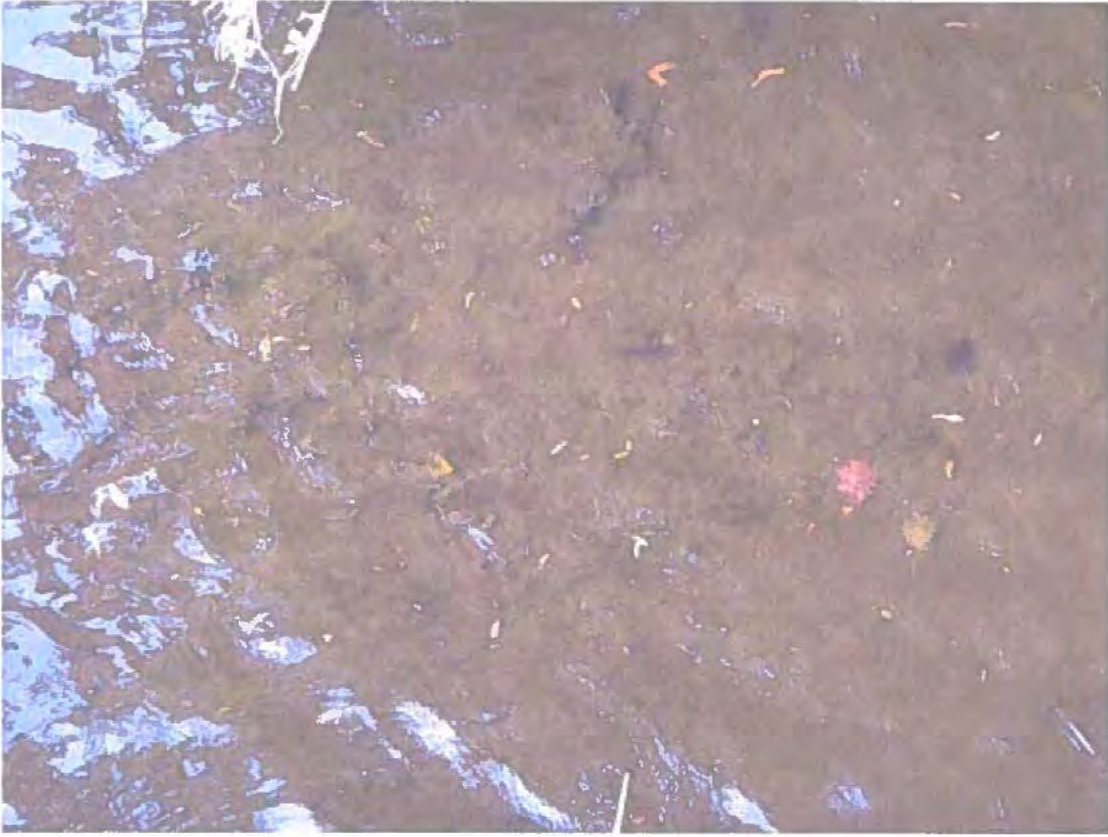
Exhibit Person 1/7

5. Mr **Person 2** and I then proceeded to Ballyvoy Bridge. I produce Exhibit **Person 1/2**, a sketch map of the Ballyclover Burn to Ballyvoy Bridge where it becomes the Four Mile Burn downstream of the bridge. Upon arrival, I photographed dead fish on the downstream side of the bridge (Four Mile Burn) and on the upstream side (Ballyclover Burn). I produce these photographs as Exhibits **Person 1/5** and **Person 1/6** respectively. I proceeded downstream and counted approximately 30 dead fish along a c. 25m stream of the river. In addition to the dead fish, I observed a number of dead macroinvertebrates on the bed of the river. This I photographed and I produce Exhibit **Person 1/7**.

Dead macroinvertebrates in Four Mile Burn (immediately downstream of Ballyvoy Bridge)

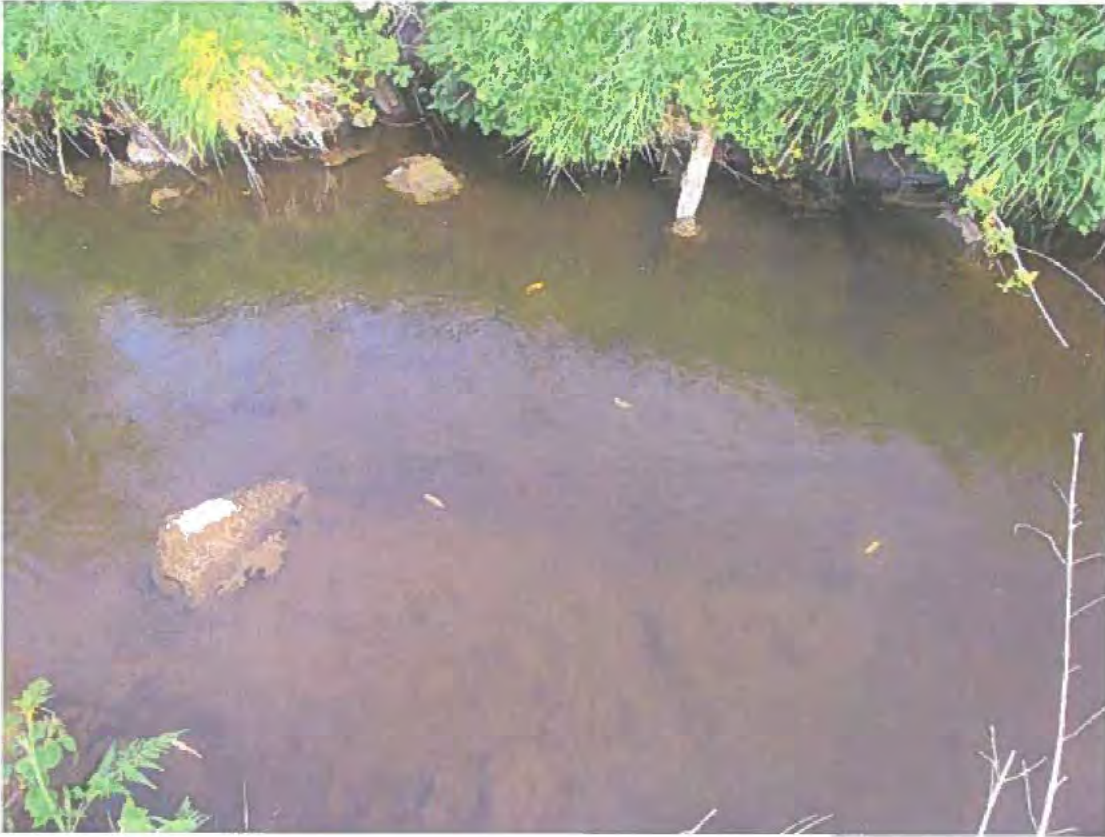
Exhibit Person 1/8

7. Having rejoined **Person 2** and having adhered to NIEA Agricultural Regulations bio-security and health and safety guidelines, we proceeded down a farm laneway leading to **Person 1** Ballymena Road and again inspected the Ballyclover Burn. I counted more than thirty dead fish along a c. 50m stretch of the river. I photographed some of these dead fish and I produce Exhibit **Person 1/8**.

Dead fish in Ballyclover Burn

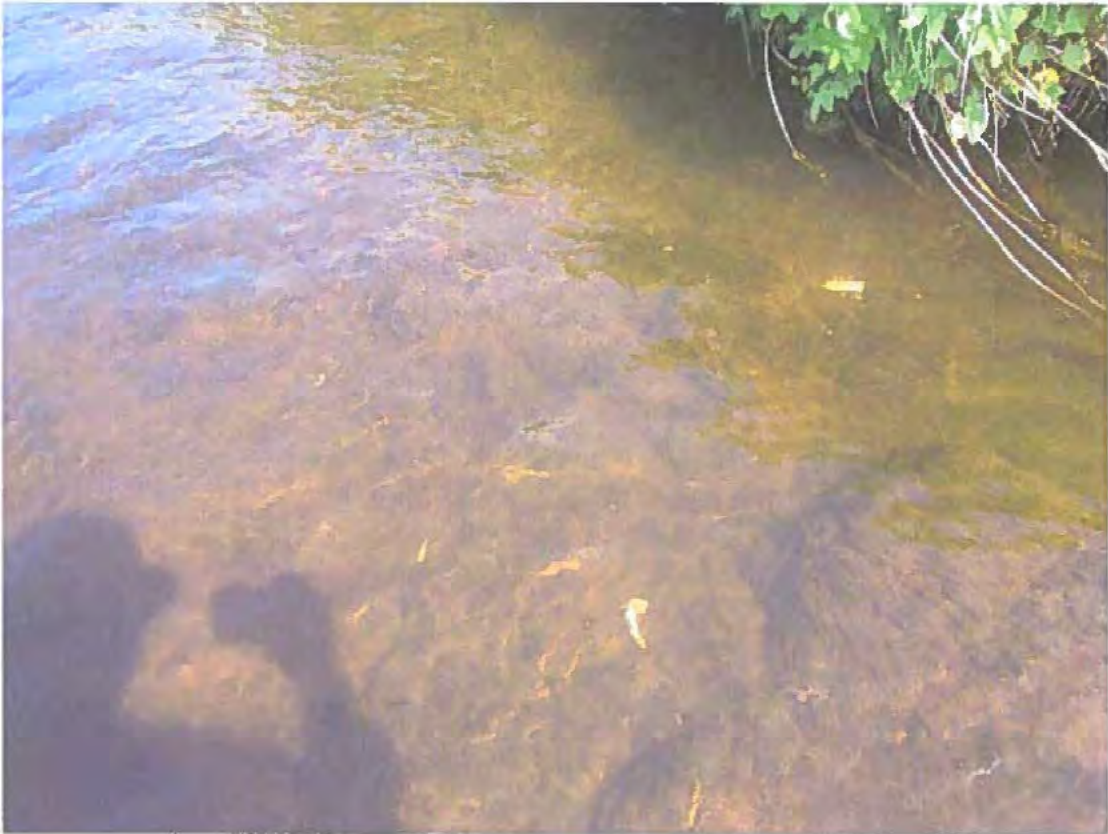
Exhibit Person 1/9

8. **Person 2** and I then proceeded upstream along the Ballyclover Burn, following the dead fish in the waterway. I took two photographs of dead fish and I produce Exhibits **Person 1/9** and **Person 1/10**. The locations where these photographs were taken is depicted on Exhibit **Person 1/2**.

Dead fish in Ballyclover Burn

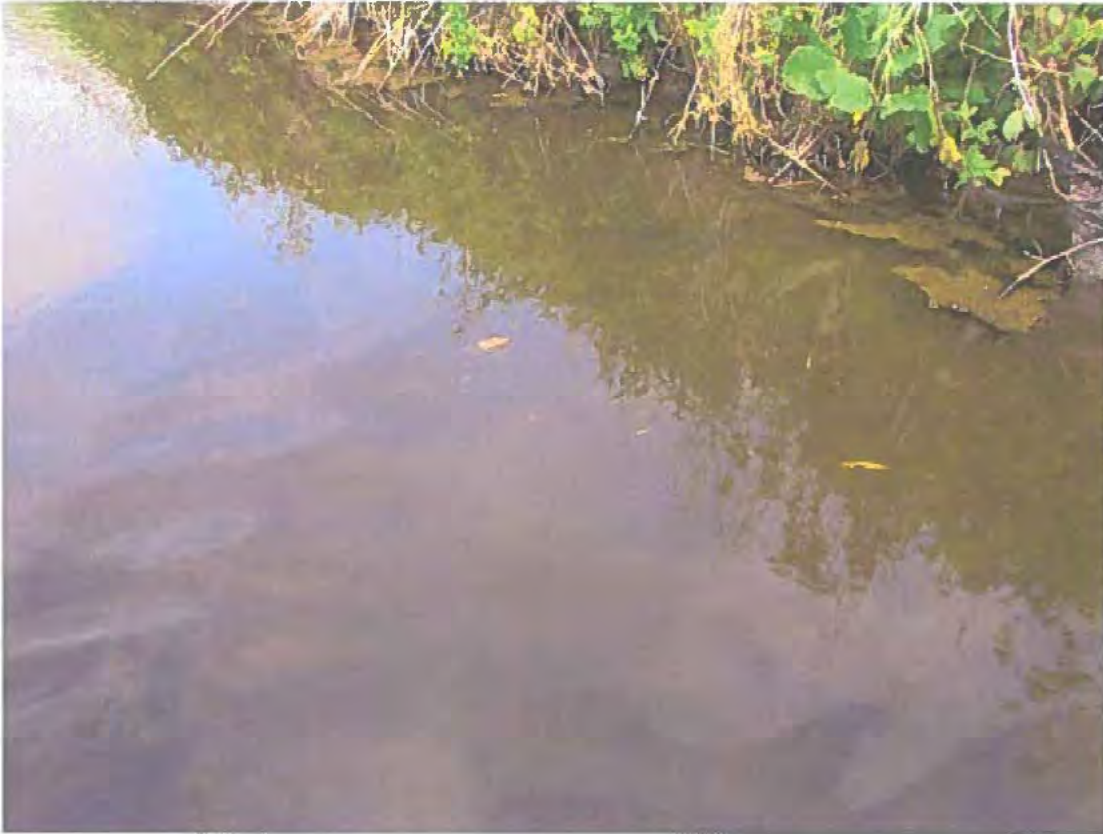
Dead fish in Ballyclover Burn

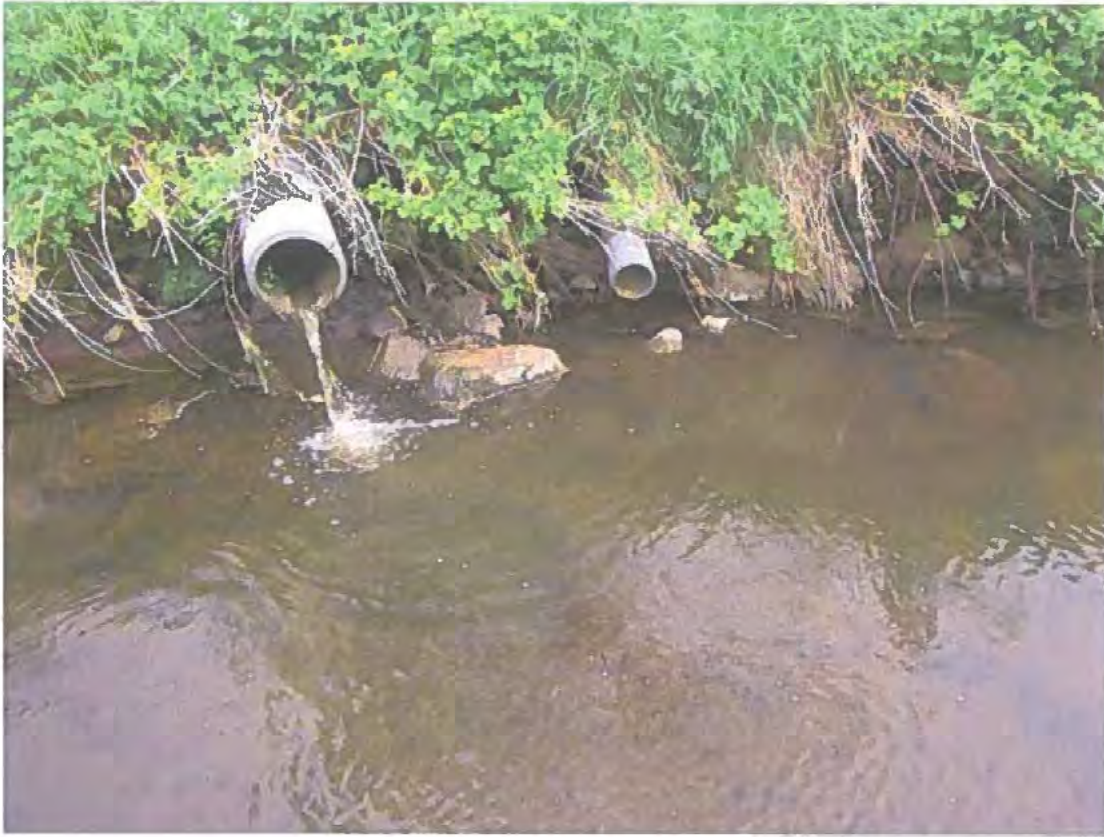
The Inspectors proceeded upstream along the Ballyclover Burn following the trail of dead fish. At 12:10hrs the Inspectors observed a pipe actively discharging a light greenish coloured liquid with the appearance and odour of dilute slurry to the Ballyclover Burn; a light green coloured plume was visible in the waterway for approximately 2-3 metres. Dead fish were visible up to this discharge pipe and live fish were observed upstream from the discharge pipe.

9. At 1210 hours, I observed a pipe actively discharging to the Ballyclover Burn from the left-hand bank. This I photographed and I produce Exhibit **Person 1/11**. I observed a light green coloured plume in the Ballyclover Burn for approximately 2-3m. I could detect an agricultural odour from the discharge which I believed to be weak dilute

Pipe actively discharging weak dilute slurry to the Ballyclover Burn at [REDACTED]
Statutory sample WR3/24/0504 was collected from this location.

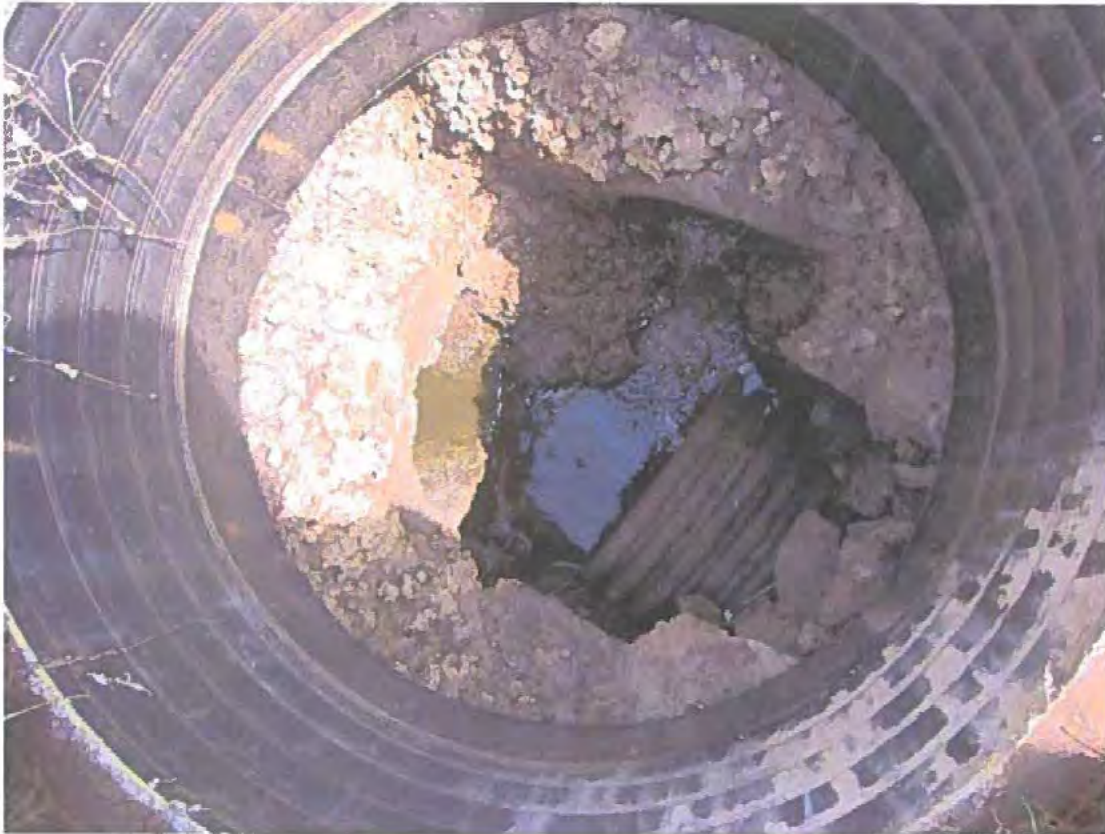
12. **[Name Redacted]**, **Person 2** and I then entered Field **Person 2** at the bottom of which was the pipe from which statutory sample WR3/24/0504 had been collected. Approximately 30m from the gate I observed a large circular inspection chamber cover, which **[Name Redacted]** stated was the same drain which would discharge at the bottom of the field. I retrieved a crow bar from the van and opened the inspection chamber. I observed two concrete inlet pipes and one plastic outlet pipe. This I photographed and I produce Exhibit **Person 1/12**. I observed the water in the top inlet

Flow of green coloured agricultural effluent through inspection chamber in Field [Redacted] at [Address Redacted]. Statutory sample WR3/24/0504B was collected from this location.

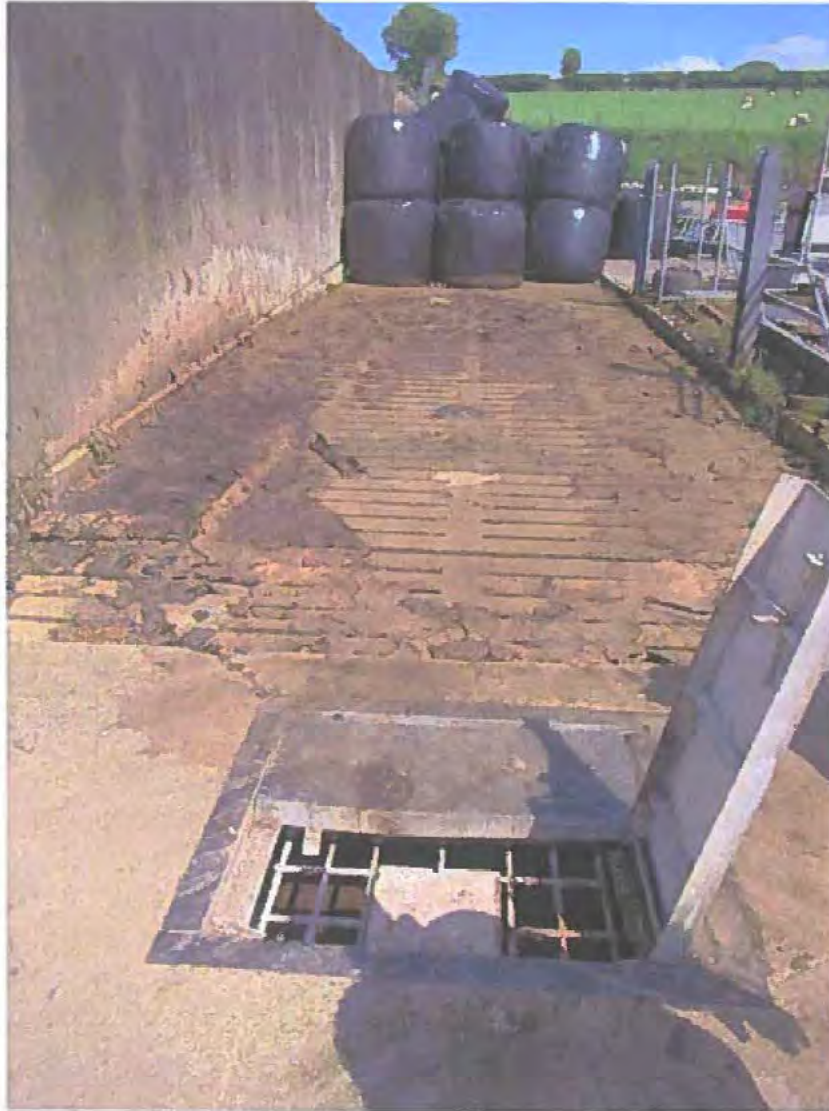
Dried slurry on the slats of the below ground slurry store.

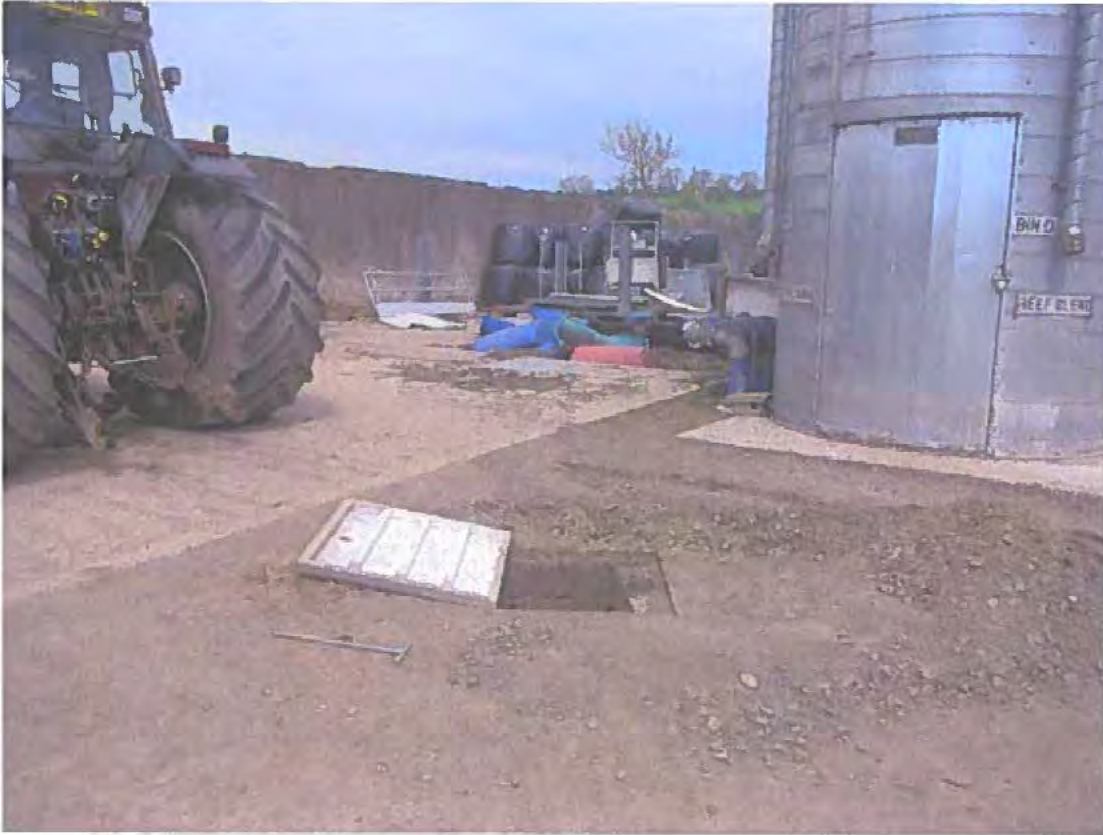
15. I locked the bottles of statutory sample WR3/24/0504B along with WR3/24/0504 in the NIEA van and **Person 2** and I proceeded with **[Name Redacted]** back to the uncovered inspection chamber adjacent to the meal bin. This I photographed and I produce Exhibit **Person 1**/14. On closer inspection I observed a dark coloured liquid at the outlet pipe from the chamber (left hand pipe), however, I observed no liquid flowing through the chamber. I photographed the inside of the inspection chamber and I produce Exhibit **Person 1**/15. **[Name Redacted]** stated **[Name Redacted]** would remove the six loads of slurry which he had transferred to the below ground store the previous day and immediately spread this slurry to fields.

Inspection chamber adjacent to slurry tank.

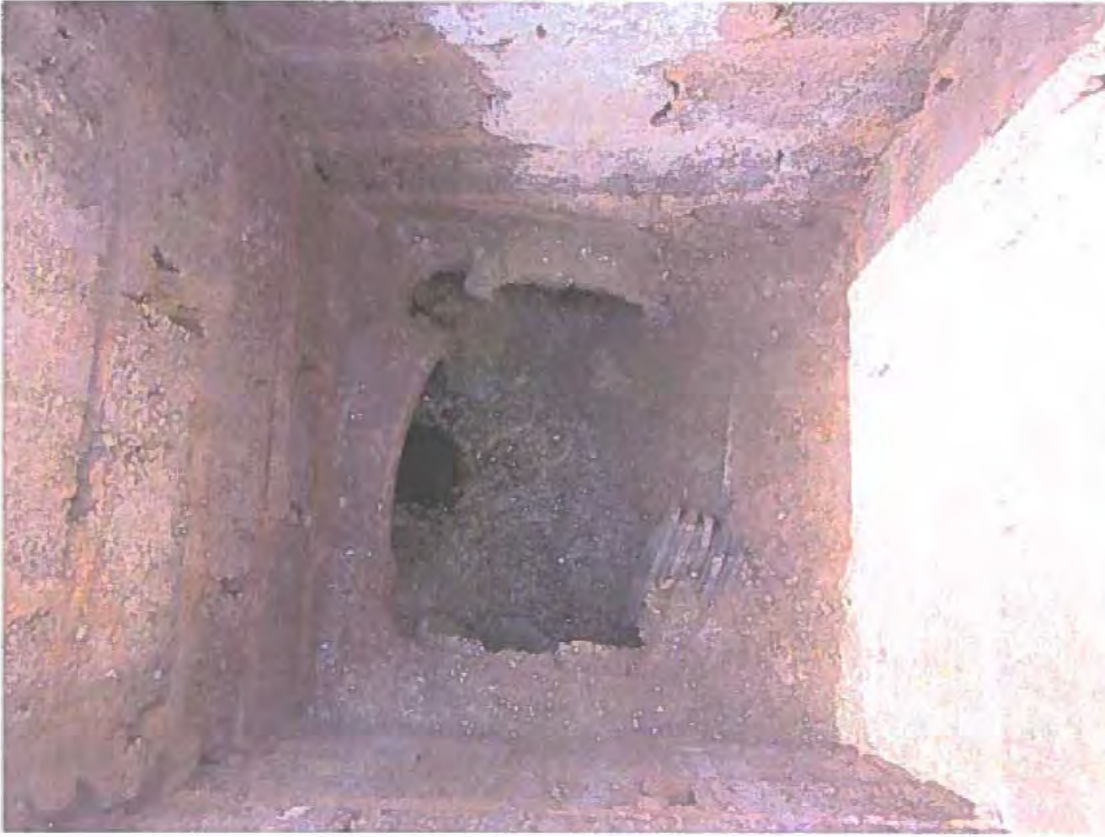
Exhibit Person 1 15

Inspection chamber adjacent to slurry tank.

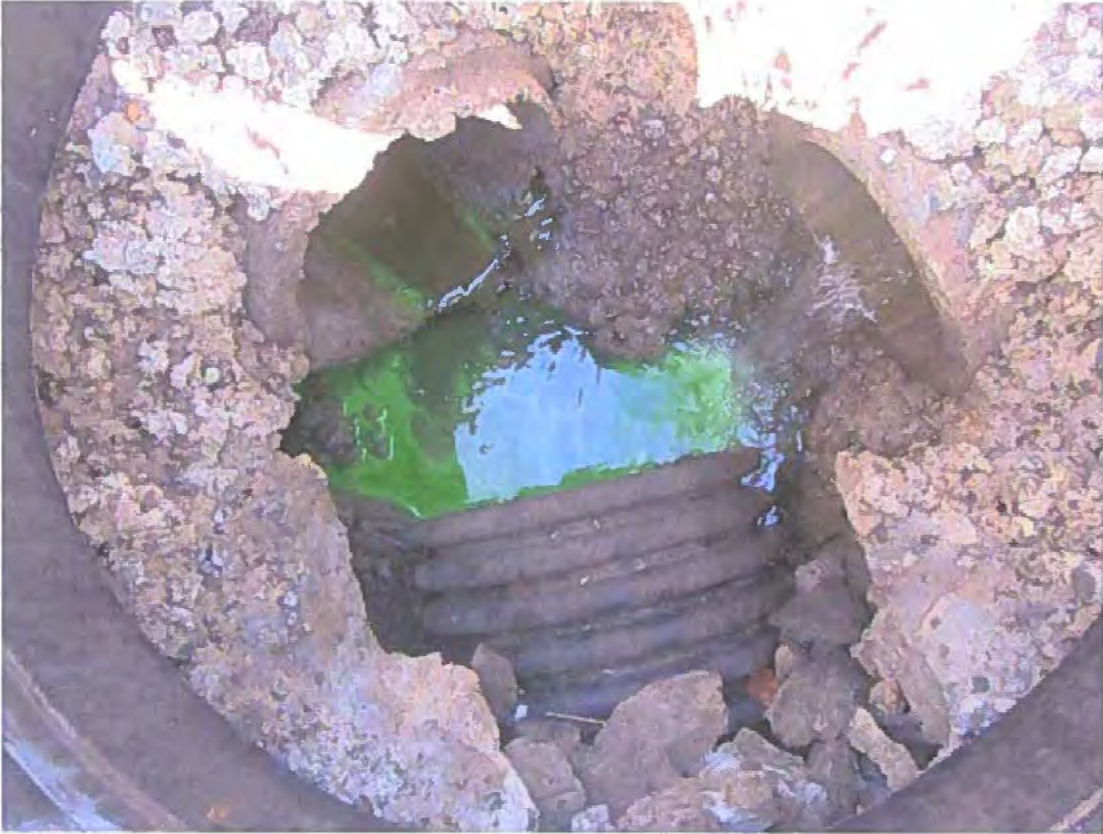
Exhibit Person 1/16

Inspectors added green drain tracing dye to the flow of liquid in the inspection chamber in the field at 15:28 (/16), at 15:30 dye was observed in the Ballyclover Burn (/17).

Drain tracing dye in inspection chamber in [REDACTED]

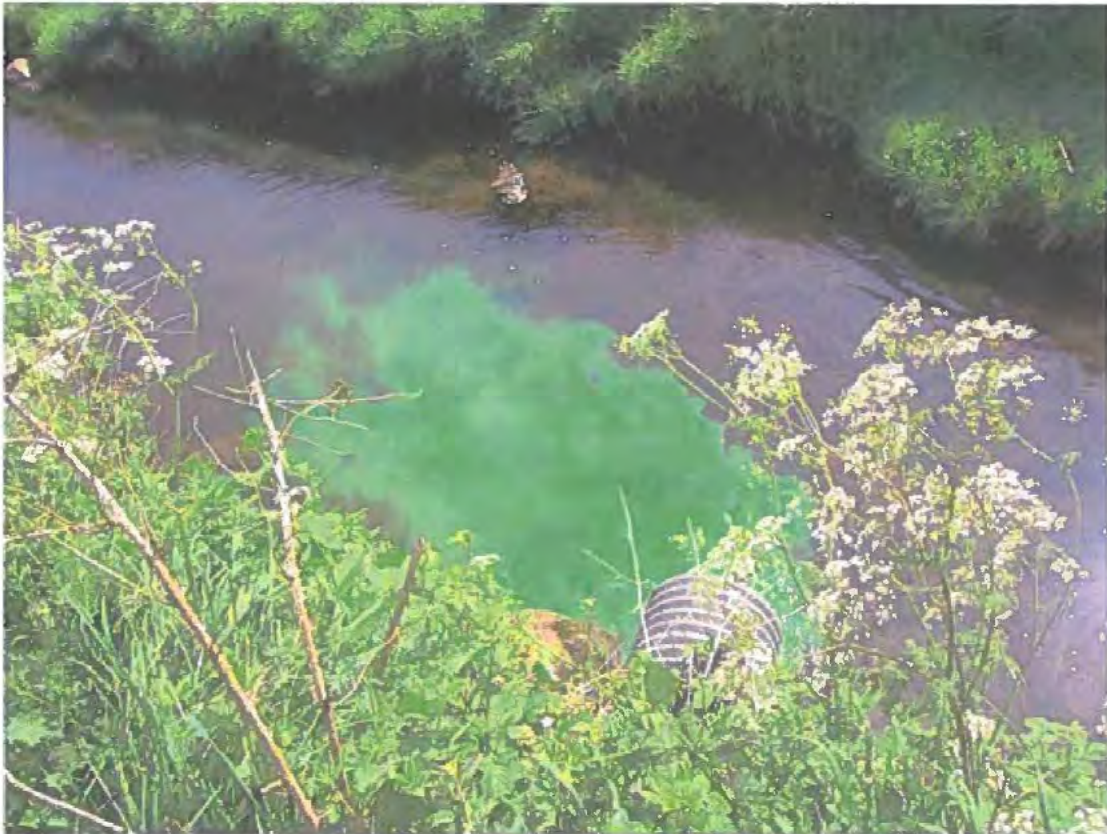
Exhibit Person 1/17

18. On returning to the yard, **[Name Redacted]** returned to the tractor and slurry tanker. At 1528 hours, witnessed by **Person 2** I introduced green drain tracing dye to the flow of liquid actively in the inspection chamber in Field **[Name Redacted]**. This I photographed and I produce Exhibit **Person 1/16**. **Person 2** and I proceeded to the Ballyclover Burn. At 1530 hours, I observed green dye actively discharging to the Ballyclover Burn. This I photographed and I produce Exhibit **Person 1/17**.

Drain tracing dye actively discharging to the Ballyclover Burn at [REDACTED]

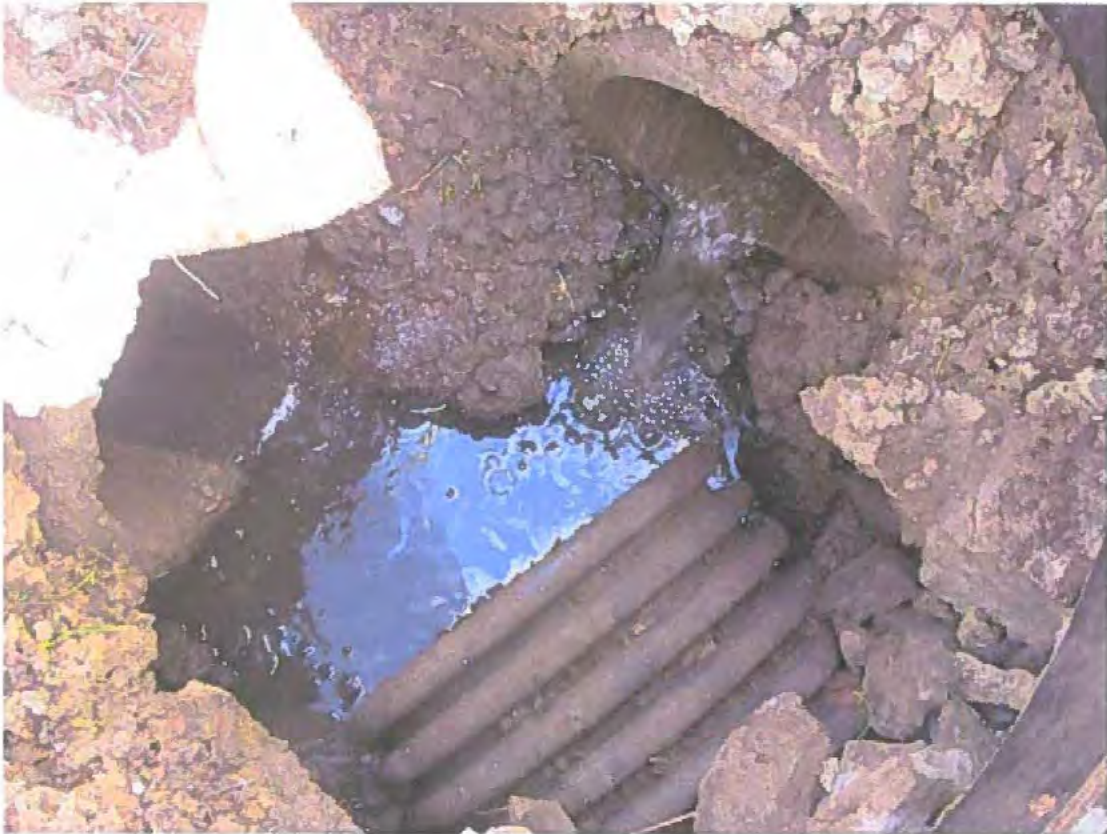
Exhibit Person 1/19

Inspection chamber in Field [REDACTED]

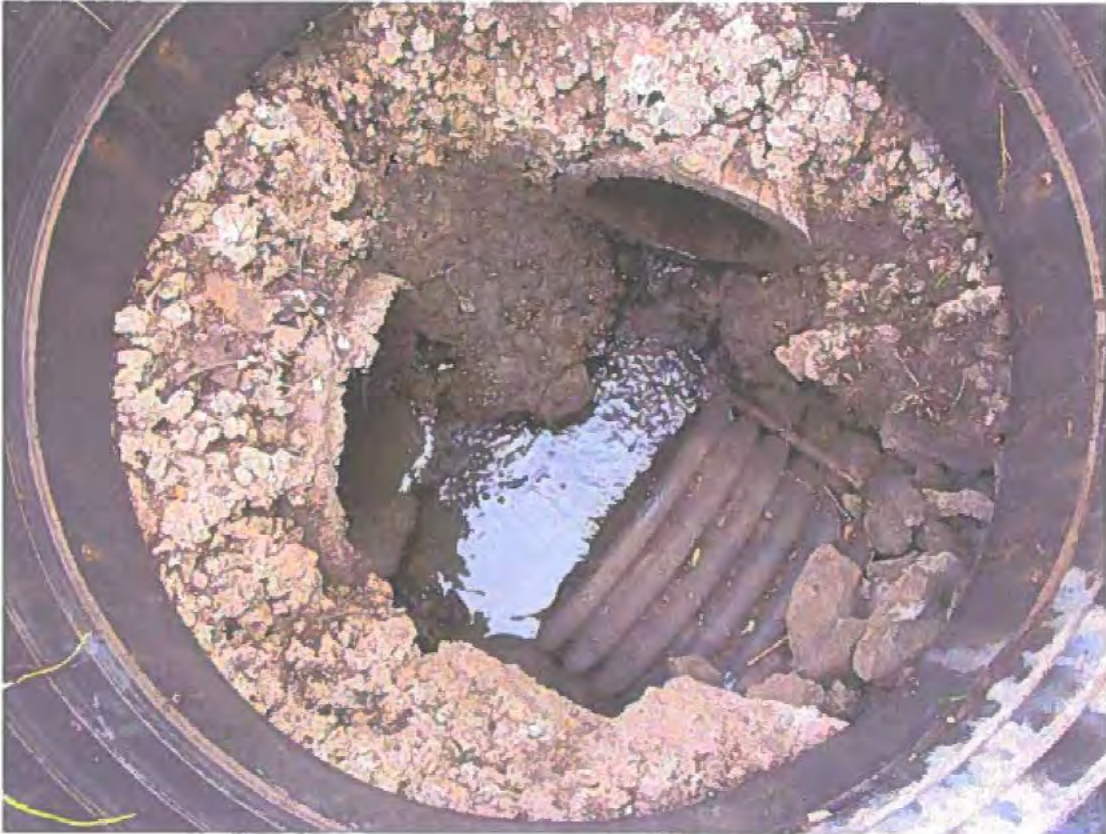
Exhibit Person 1/20

guidelines. We met with **[Name Redacted]** in the yard, proceeded to Field **[redacted]** and opened the inspection chamber. I observed flow through the inspection chamber was visually clean. This I photographed and I produce Exhibit **Person 1/20**. **[Name Redacted]**, **Person 2** **[redacted]** and I proceeded to the below ground slurry store and inspected same. I observed the level of the slurry was very near the bottom of the store. This I photographed and I produce Exhibit **Person 1/21**. **[Name Redacted]** opened the inspection chamber adjacent to the meal bin and I observed any liquids therein were visually clean. This I photographed and I produce Exhibit **Person 1/22**. **[Name Redacted]** again outlined the further remedial which **[redacted]** had planned. Having agreed to a further revisit on 27 June 2024, **Person 2** and I departed the farm at 1548 hours.

Inspection chamber in Field [REDACTED]

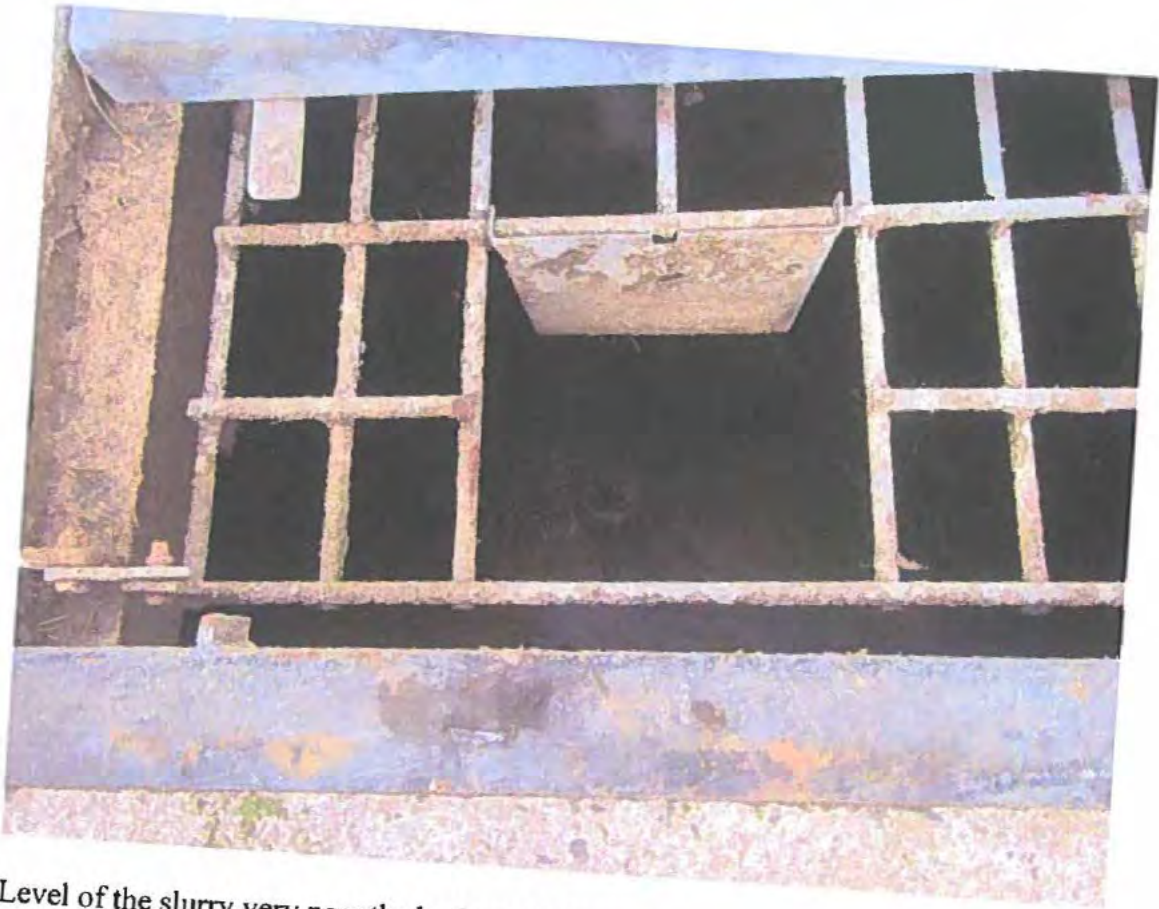
Exhibit Person 1/21

Level of the slurry very near the bottom of the store.

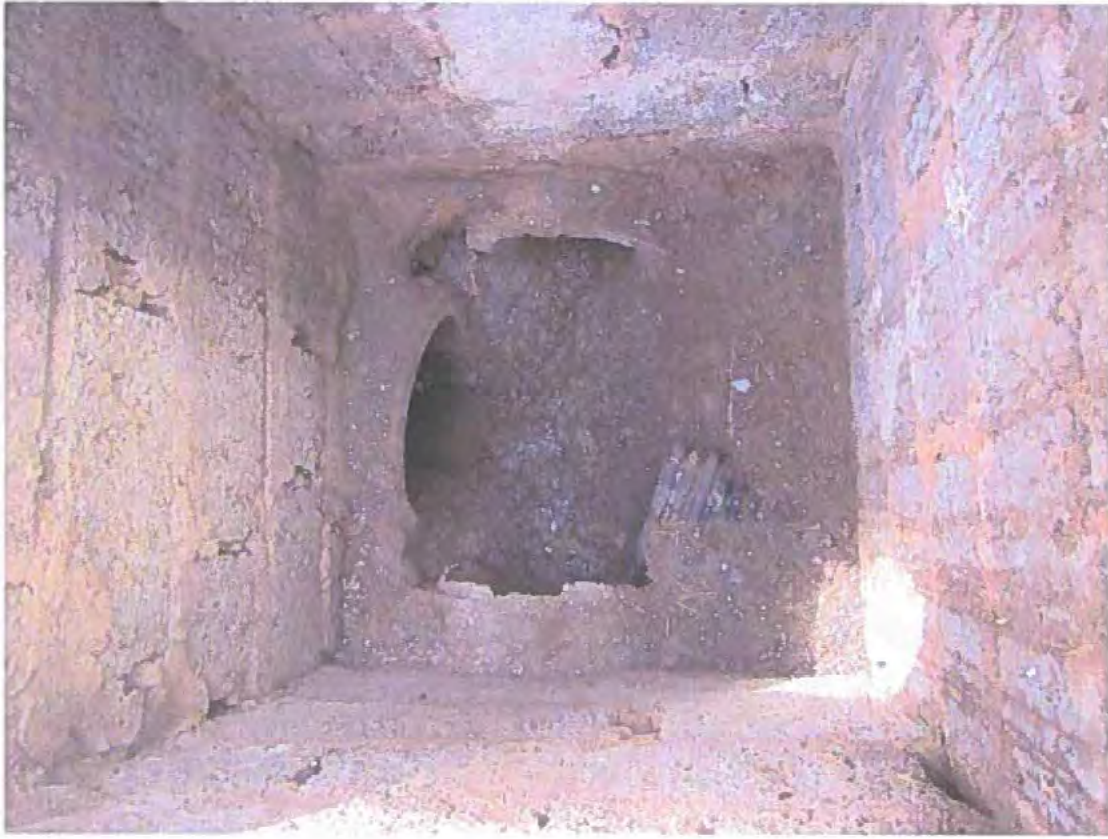
Exhibit Person 1/22

Liquids in bottom of inspection chamber adjacent to meal bin visually clean.
