NORTHERN IRELAND ENVIRONMENT AGENCY

Investigation Summary Sheet

Investigating Officer: Person 1 **Grade:**WQI **Incident Ref:**WR3/24/0504

Nature of contamination:Cow slurry

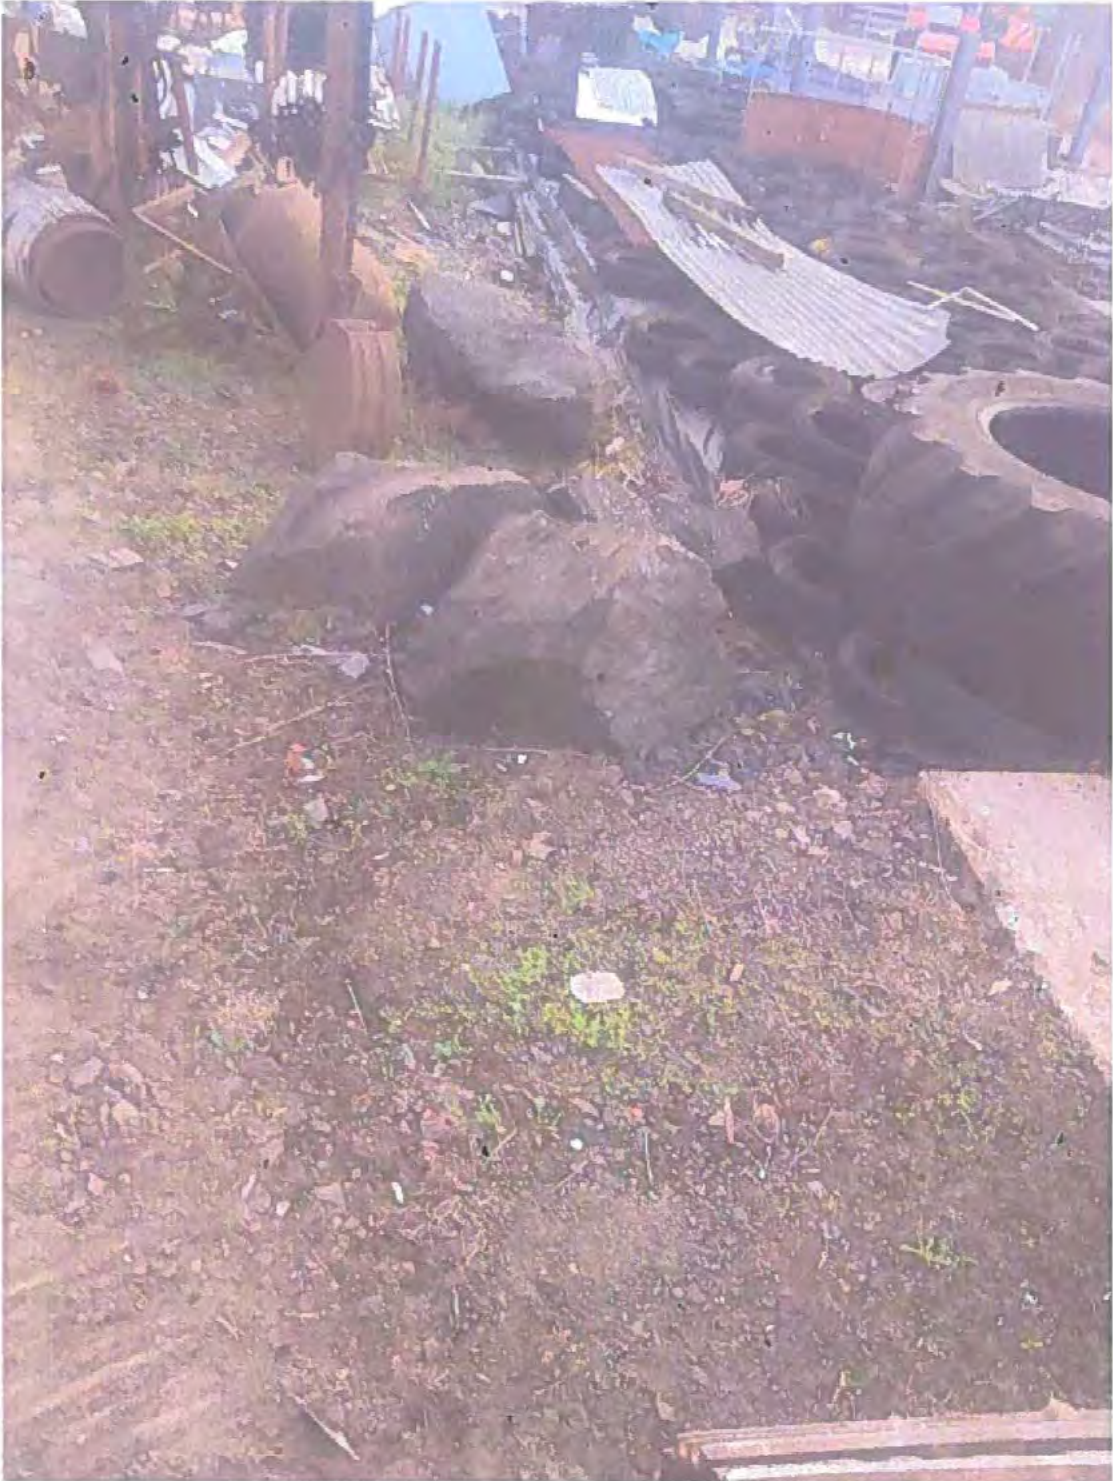
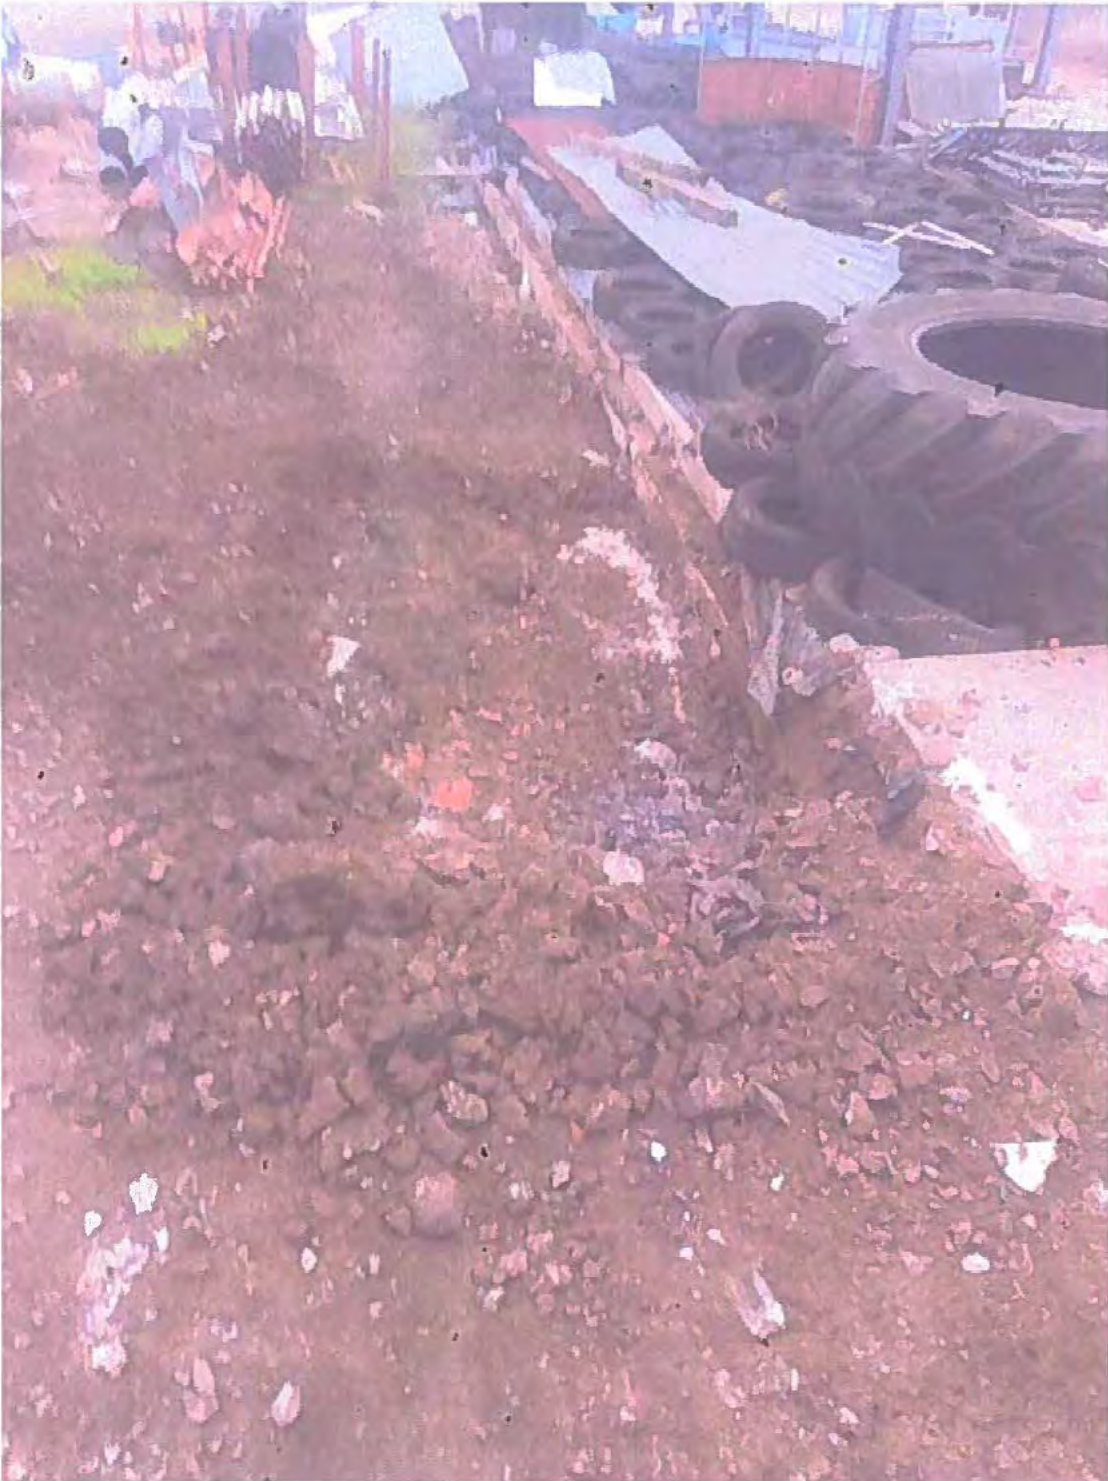
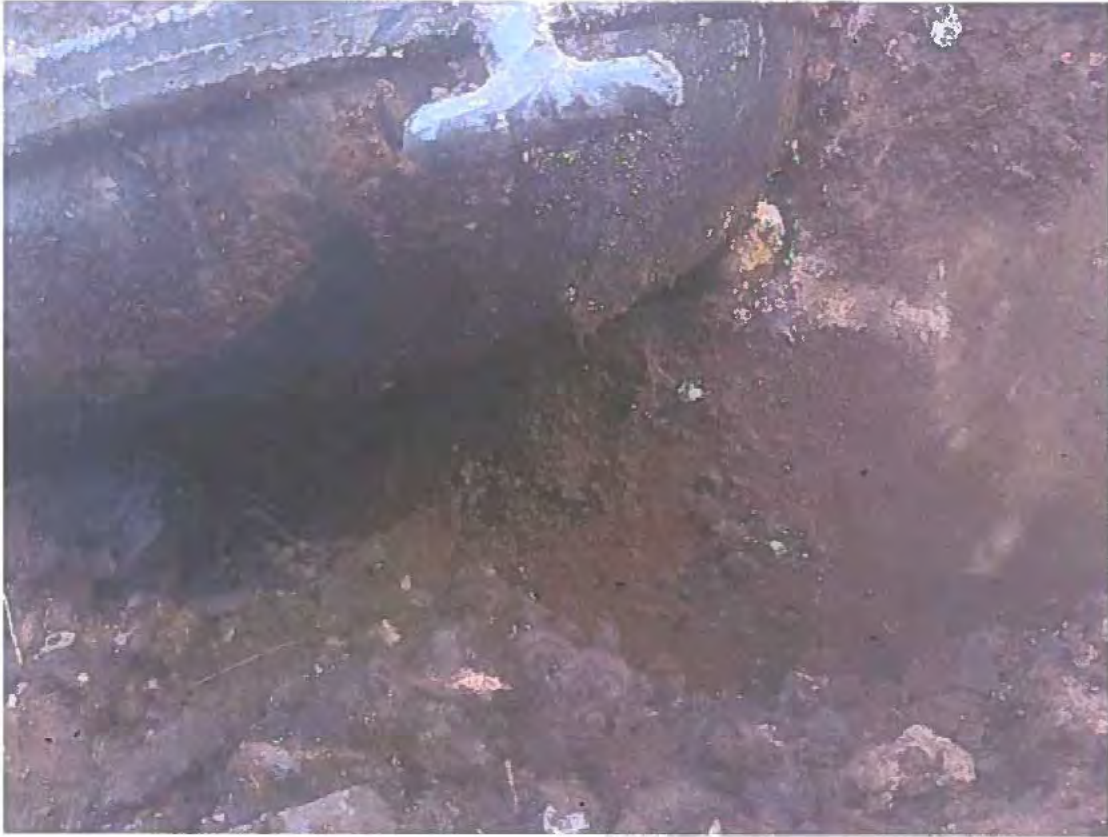
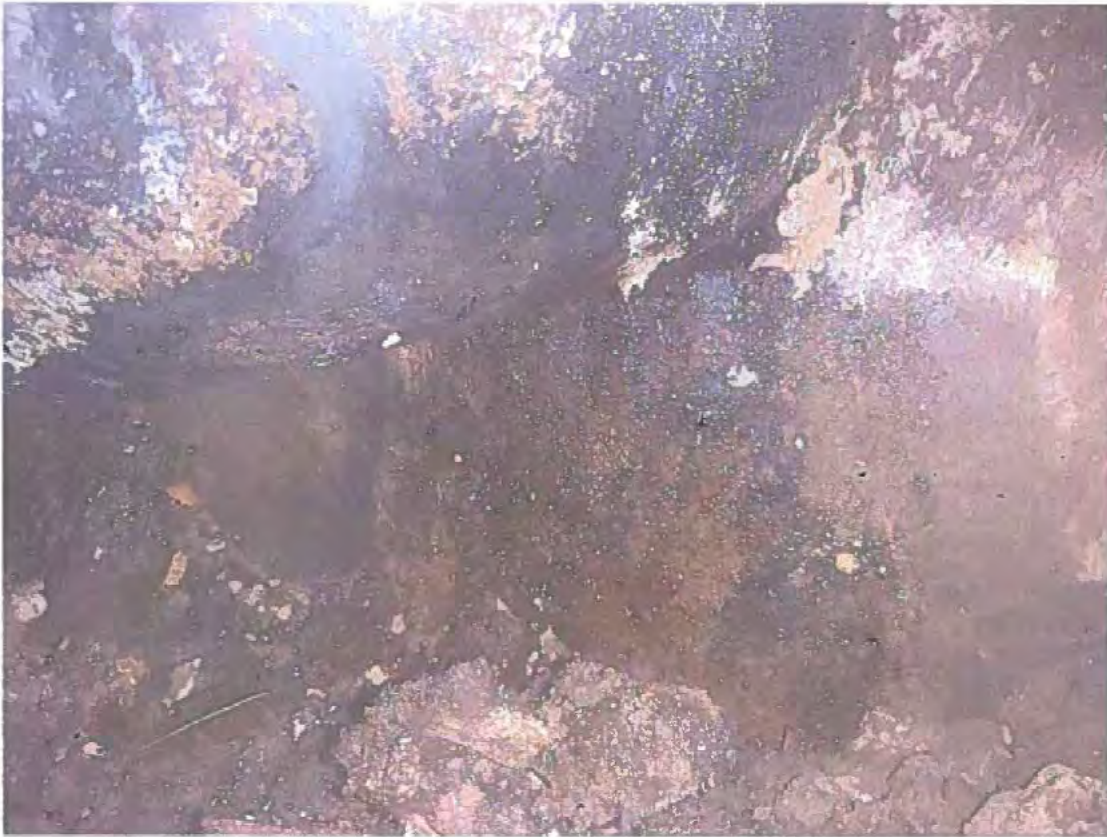
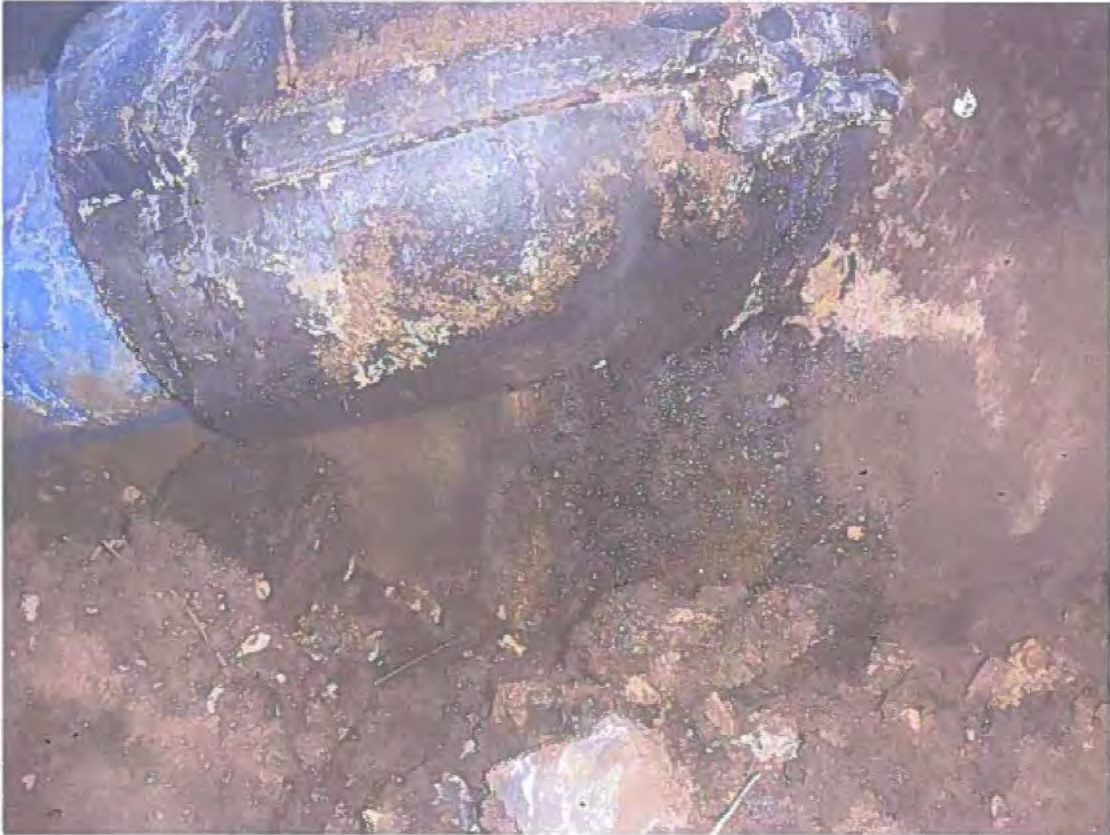
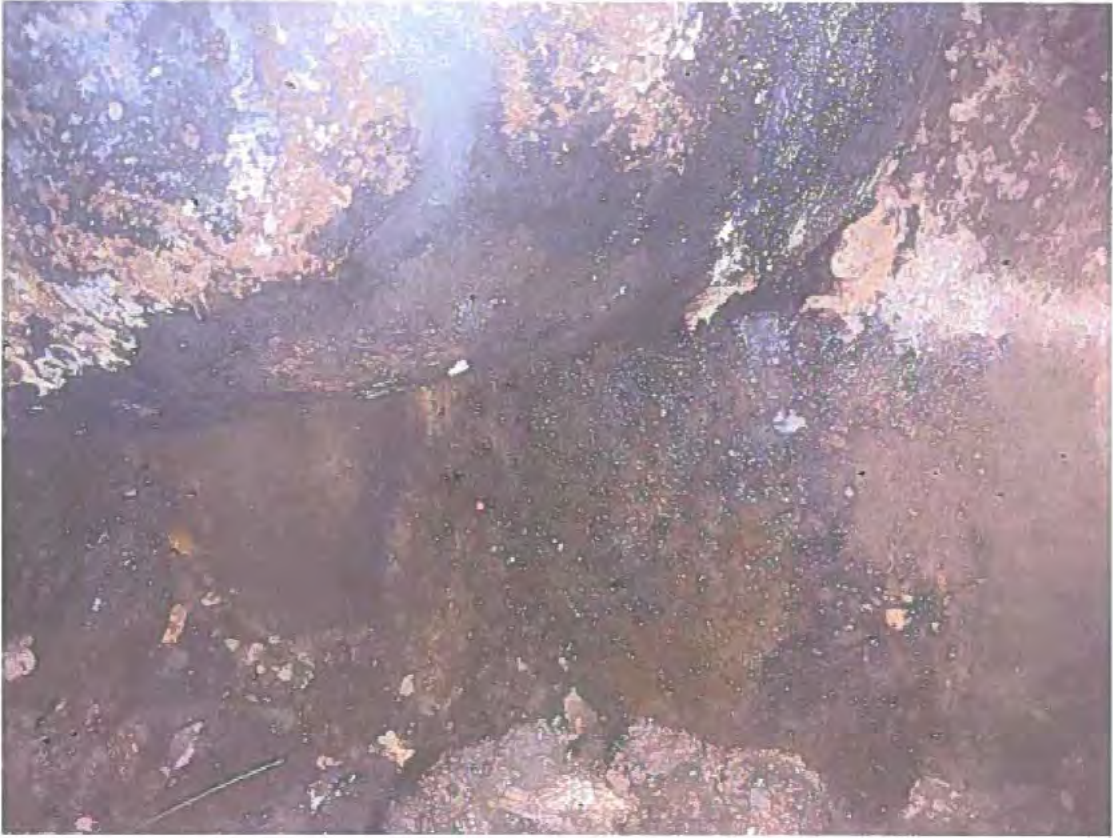
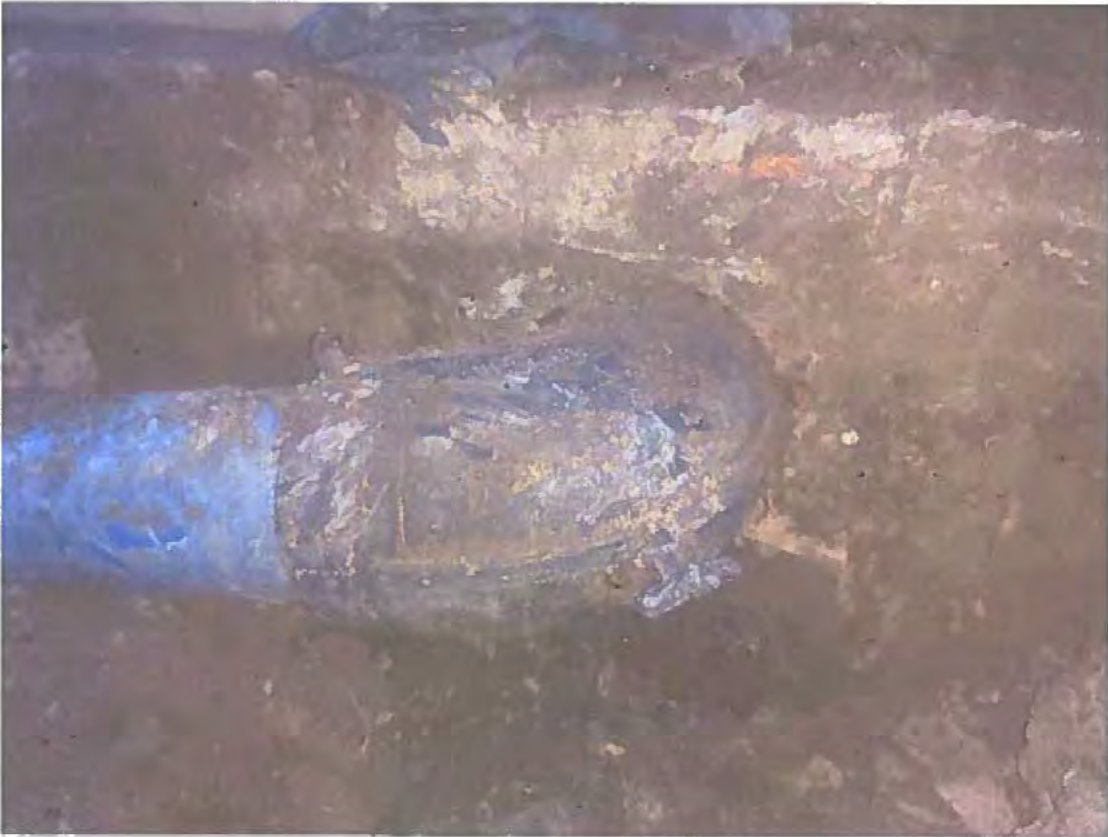
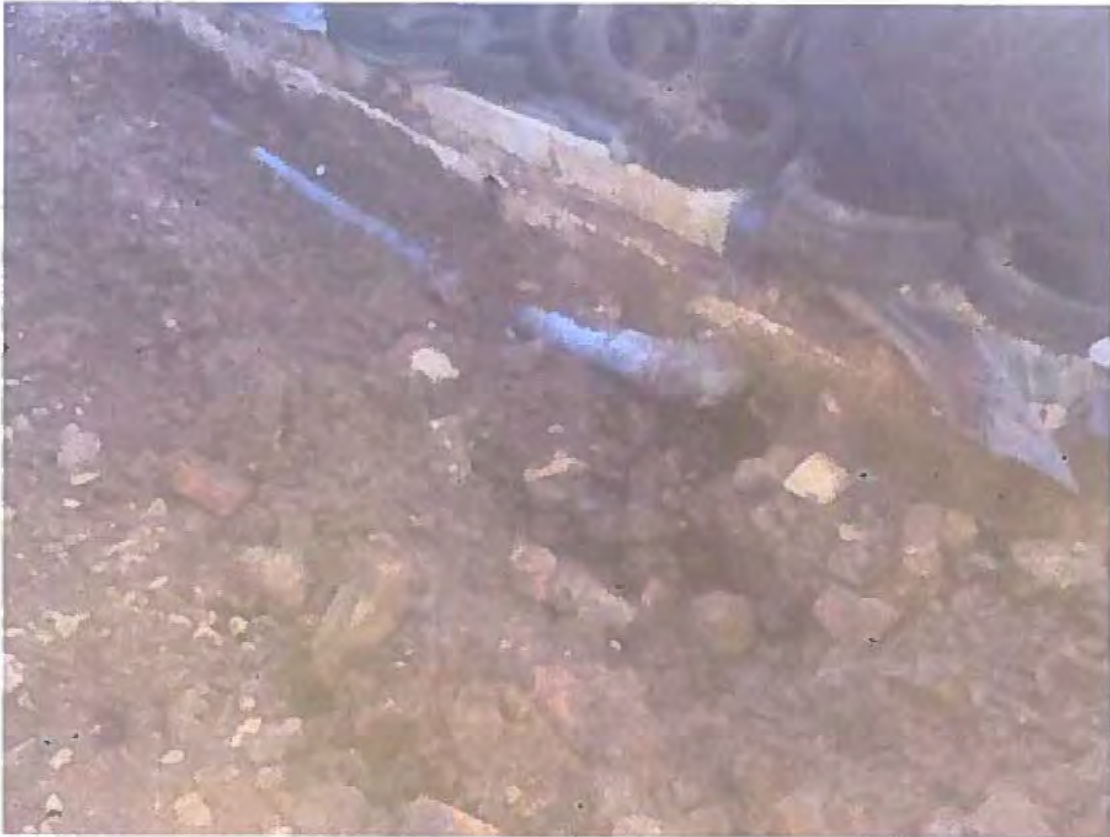
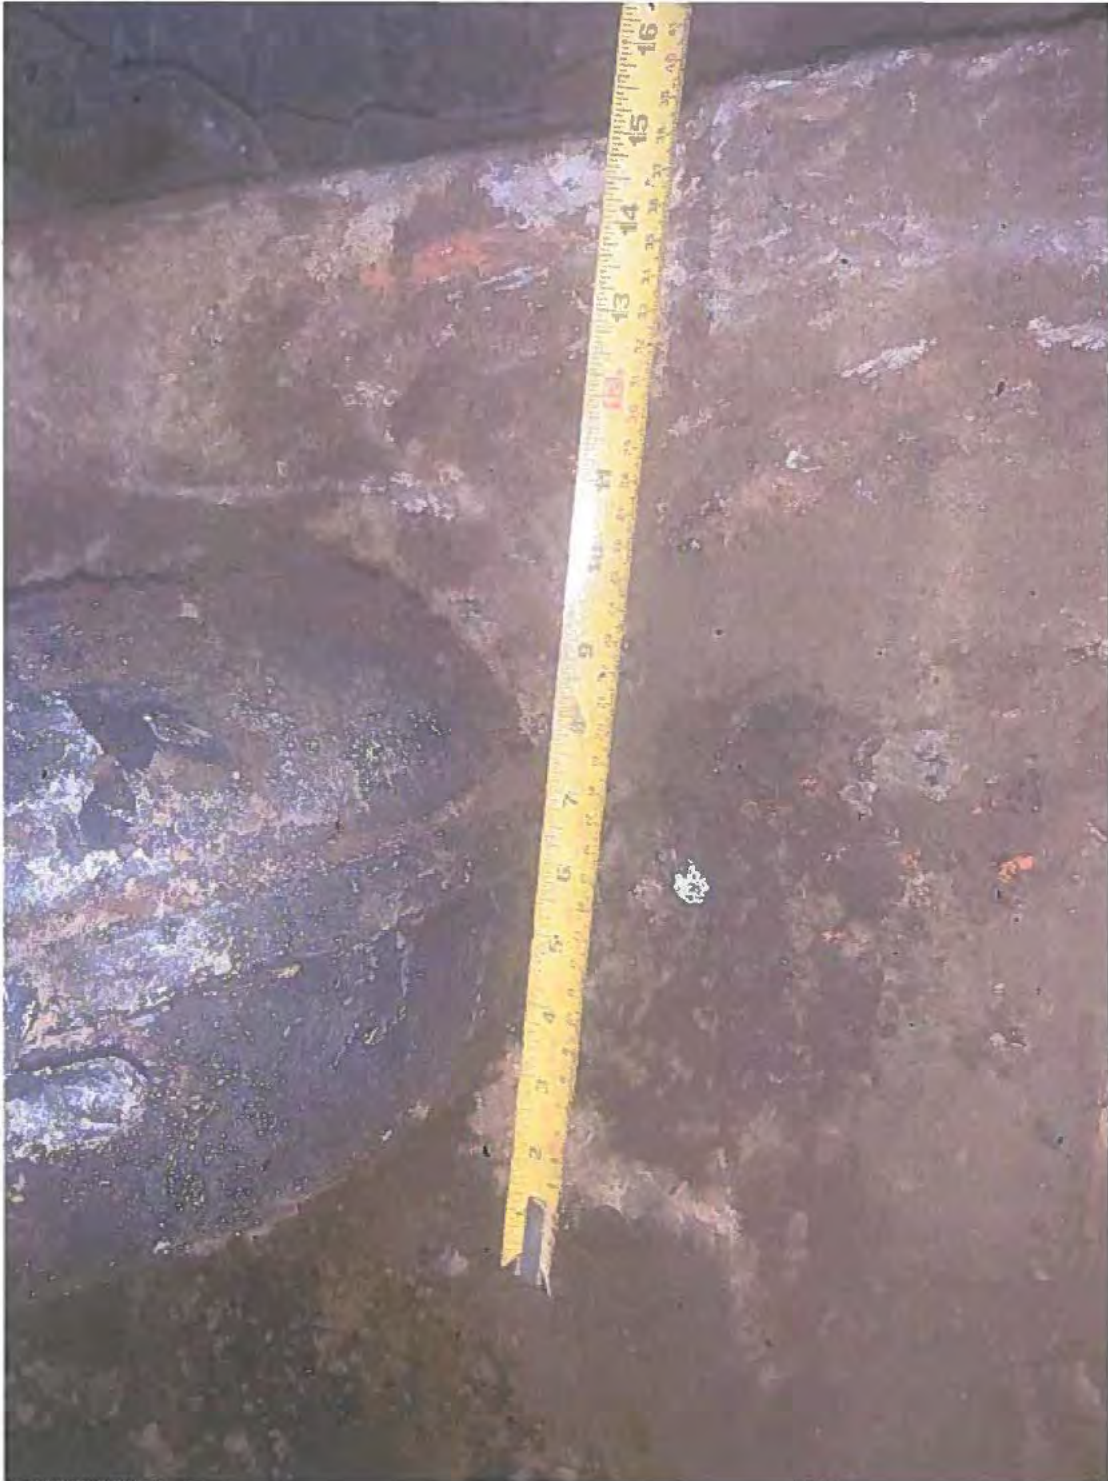
Exhibit Person 1/24a

I excavated the area at the back of the tank where the pumping main enters the tank through the concrete wall and unfortunately our suspicions are correct and there has been an underground leak at this point.

The bond between the pipe and wall has broken down and there is evidence of liquid escape, this is evident below the pipe starting about 15 inches from the top of the tank. I have included photos taken before, during and after the excavation. More excavation will be required before a repair is made but I have stopped until you and Person 2 can inspect the fault as the dampness on the wall is still present and any further work will remove evidence.

After inspection it is my intention to remove the failed joint and have repaired to required standard, I have taken professional advice on this and a product called 'HyperSeal' is to be used per manufacturers instructions.

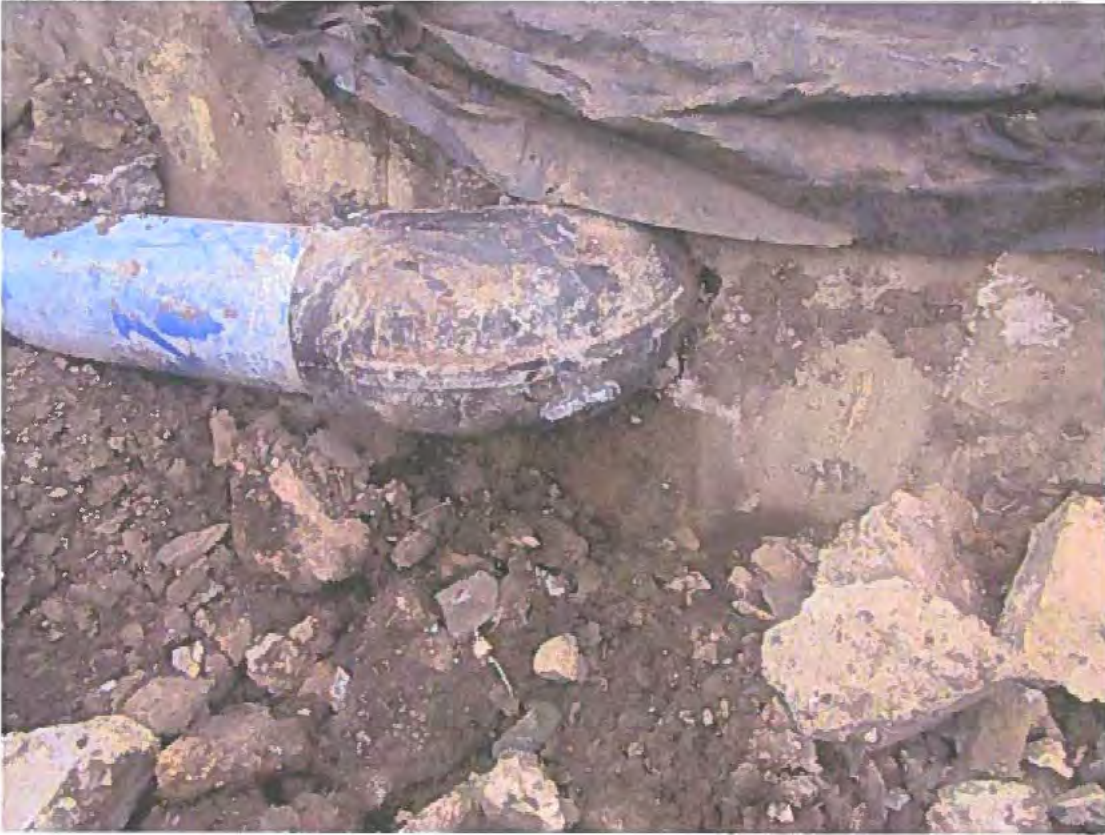
Exhibit Person 1/26

29. At 1510 hours, **Person 2** and I arrived at **[Address Redacted]** and adhered to NIEA Agricultural Regulations bio-security and health and safety guidelines. We met with **[Name Redacted]** in the yard and proceeded to the below ground slurry store. I observed excavation works had been undertaken to the rear right-hand side of the store. **[Name Redacted]** explained that the excavation work had been to expose the blue plastic slurry mixing pipe (which I observed lying parallel to the slurry store) and the black plastic "return nozzle" (which I observed towards the rear of the slurry store). **[Name Redacted]** stated this return nozzle had been encased in concrete, necessitating the use of rock hammer to expose it. On closer inspection of the return nozzle, I observed dark staining on the outer wall of the slurry store. This I photographed and I produce Exhibit **Person 1/26**. I also inspected several unused high level inlet pipes (which were bunged) and observed no staining on the outer wall of the slurry store. This I photographed and I produce Exhibit **Person 1/27**.

Recently exposed return nozzle with dark staining on the outer wall of the slurry store.

[Name Redacted] remained in contact with the Inspectors, keeping them updated on progress of all works he was undertaking, including sending photographs. [Name Redacted] concluded, in a statement under caution, that the slurry had discharged due to a crack in the slurry mixing system. This crack has been sealed and repaired.

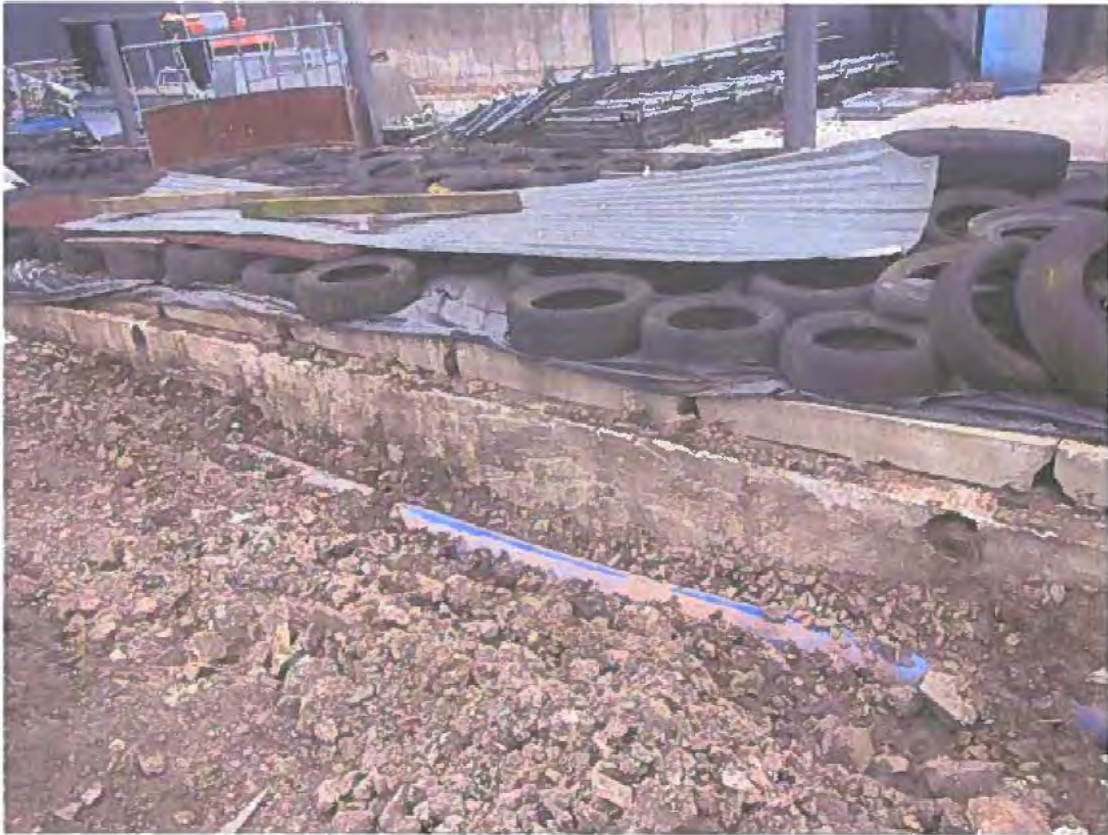
No staining on the other slurry store walls at the unused high level inlet pipes.

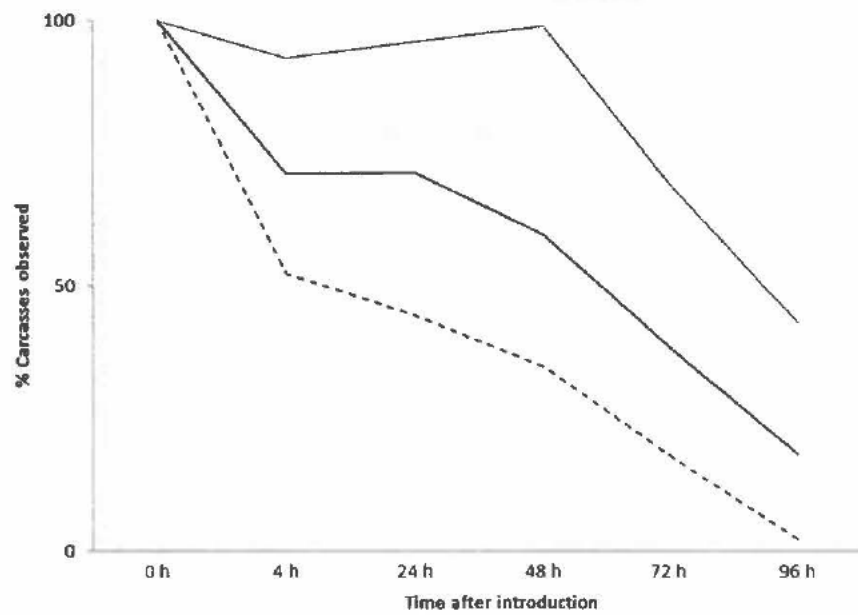
TABLE 2 The mean percentage of brown trout carcasses by fork length size class observed at increasing time lapse following introduction into Altnahinch Stream

FIGURE 2 The mean percentage of brown trout carcasses observed at increasing time lapse after introduction to Altnahinch stream; where the dashed line shows trout <8 cm L_p, the black line shows 11-14 cm L_p trout and the grey line shows larger trout >17 cm L_p

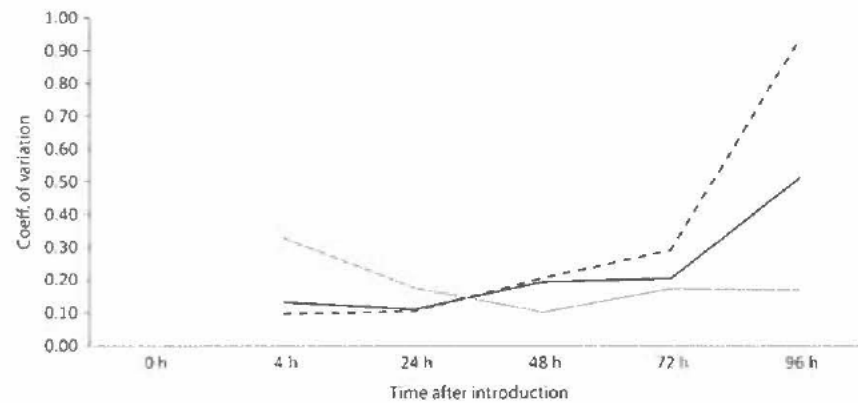
FIGURE 3 The coefficient of variation associated with carcass counts of dead brown trout in Altnahinch stream; where the dashed line shows trout <8 cm L_p, the black line shows 11-14 cm L_p trout and the grey line shows larger trout >17 cm L_p
