Ballyholme – Bathing Water Profile

Ballyholme beach, North Down, Northern Ireland

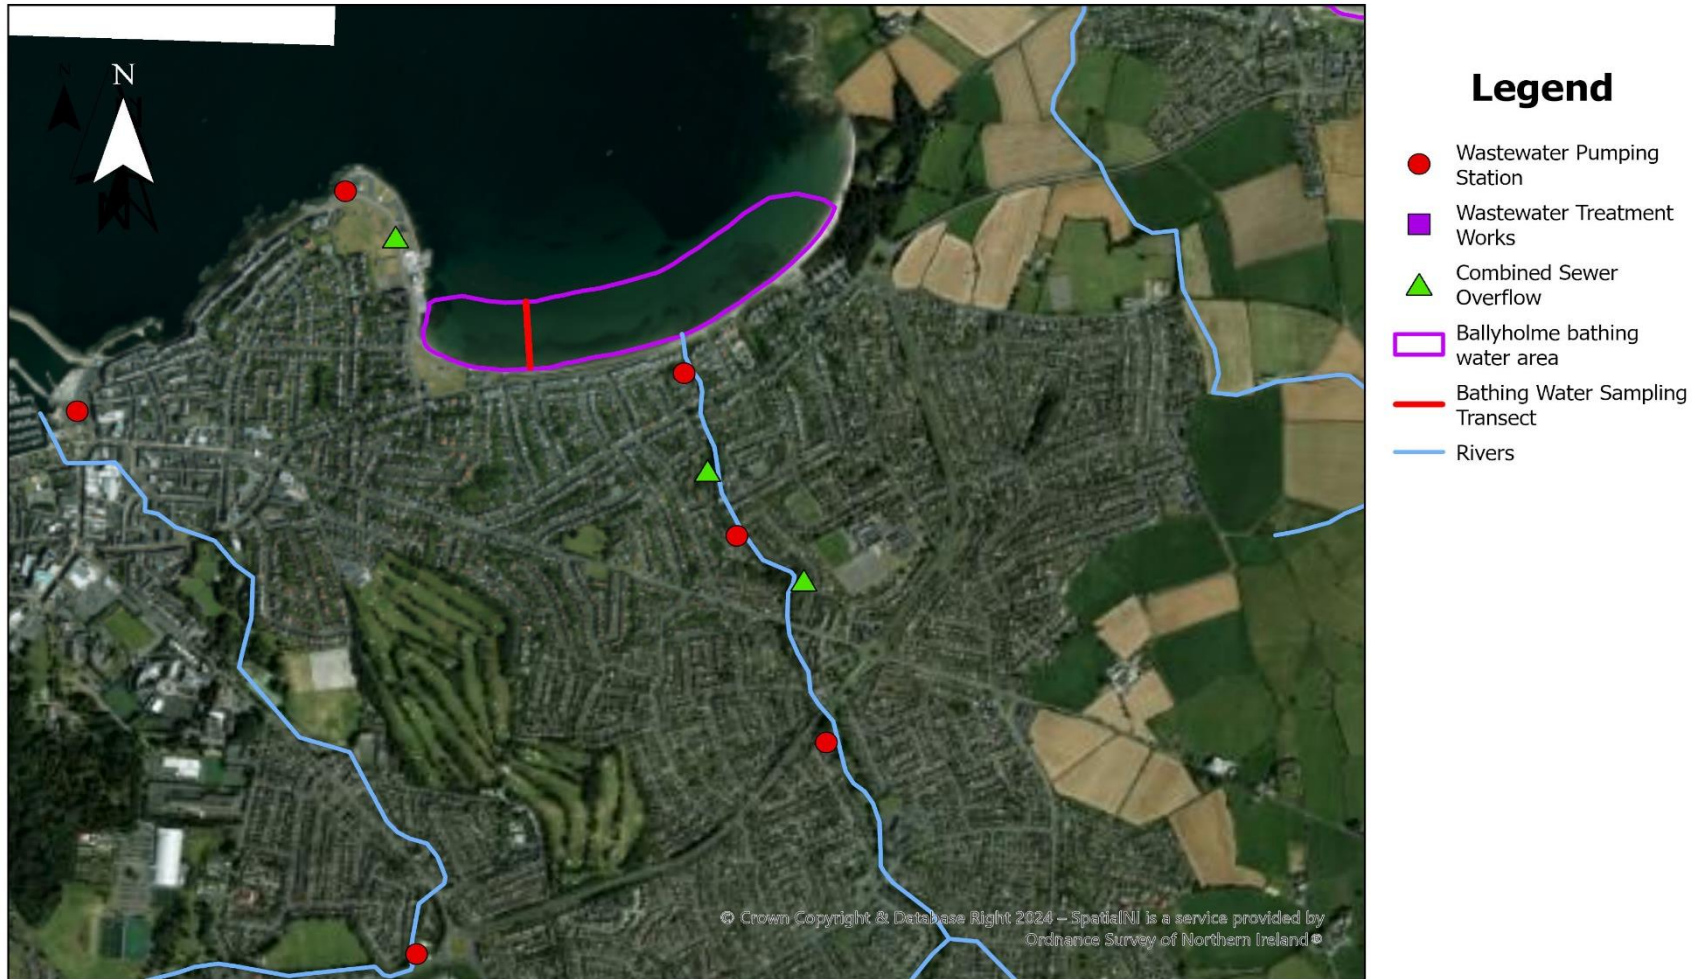
Map 1. Ballyholme Bathing Water

The collection and treatment of wastewater has the potential to cause pollution as all combined collection systems are designed to overflow in periods of extreme wet weather or following failure of the system. This prevents overflows into residential properties. Within the Ballyholme area there are combined sewer overflows (CSO) emergency overflows and wastewater pumping stations with associated emergency overflows, highlighted on Map 1.

There are no treated wastewater outfalls and wastewater treatment works located in the immediate vicinity of Ballyholme bathing water (Map 1). Wastewater from the wider Bangor area is pumped to a major wastewater treatment facility between Bangor and Donaghadee. It provides secondary treatment with UV disinfection during the bathing season. The treated effluent is discharged some 600m offshore, to the northeast of Brigg's Rocks. This is approximately 4.5km northeast of Ballyholme bathing water.
