## Cloughey – Bathing Water Profile

Cloughey beach, County Down, Northern Ireland

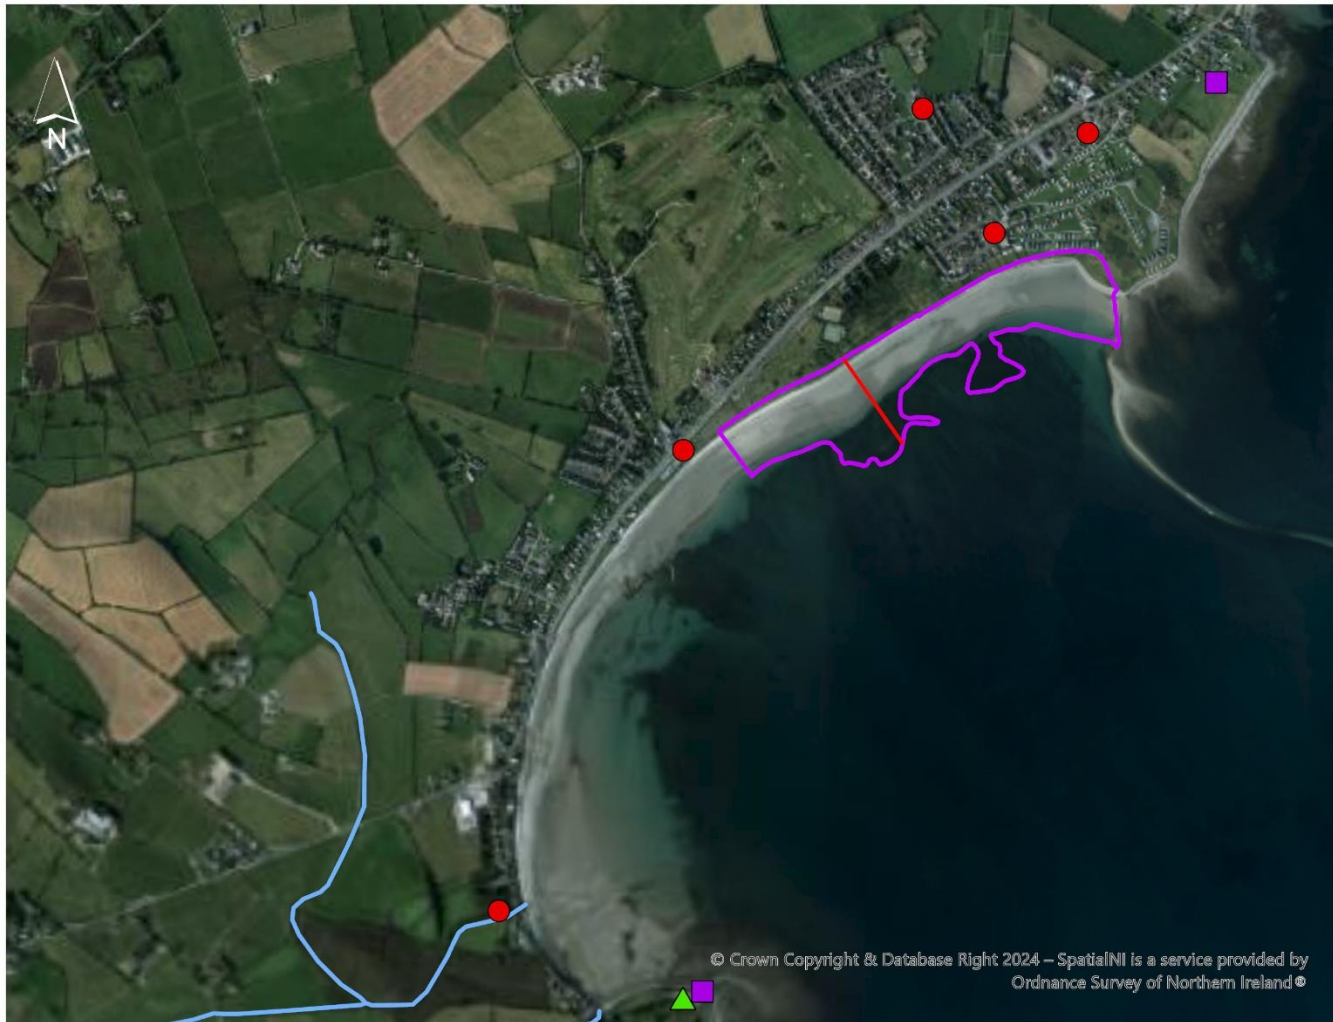
Map 1 Cloughy Bathing Water

The collection and treatment of wastewater has the potential to cause pollution as all combined collection systems are designed to overflow in periods of extreme wet weather or following failure of the system. This prevents overflows into residential properties. Within the Cloughey area there are several wastewater pumping stations and associated emergency overflows, highlighted on Map 1.

There is a wastewater treatment works approximately 1.5km to the south of Cloughey bathing water. The wastewater from the Cloughey area is pumped to this works for treatment, including UV disinfection as the final process.
