Groomsport – Bathing Water Profile

Groomsport beach, County Down, Northern Ireland

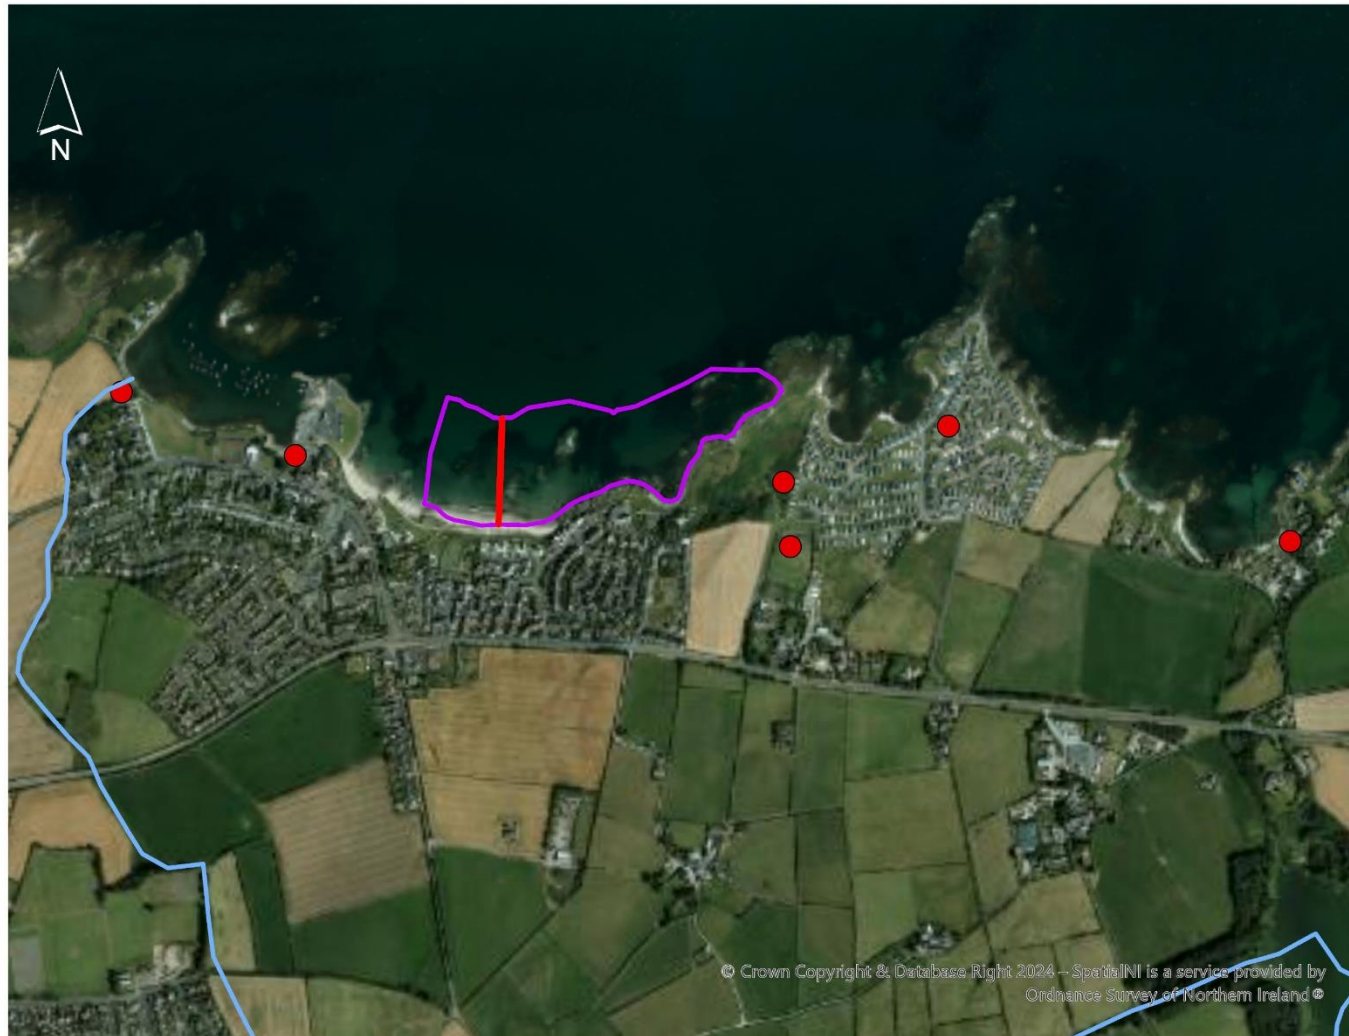
Map 1 Groomsport Bathing Water

The collection and treatment of wastewater has the potential to cause pollution as all combined collection systems are designed to overflow in periods of extreme wet weather or following failure of the system. This prevents overflows into residential properties. Within the Groomsport area there are wastewater pumping stations with associated emergency overflows, highlighted on Map 1.
