## Portrush Whiterocks – Bathing Water Profile

Whiterocks beach, County Antrim, Northern Ireland

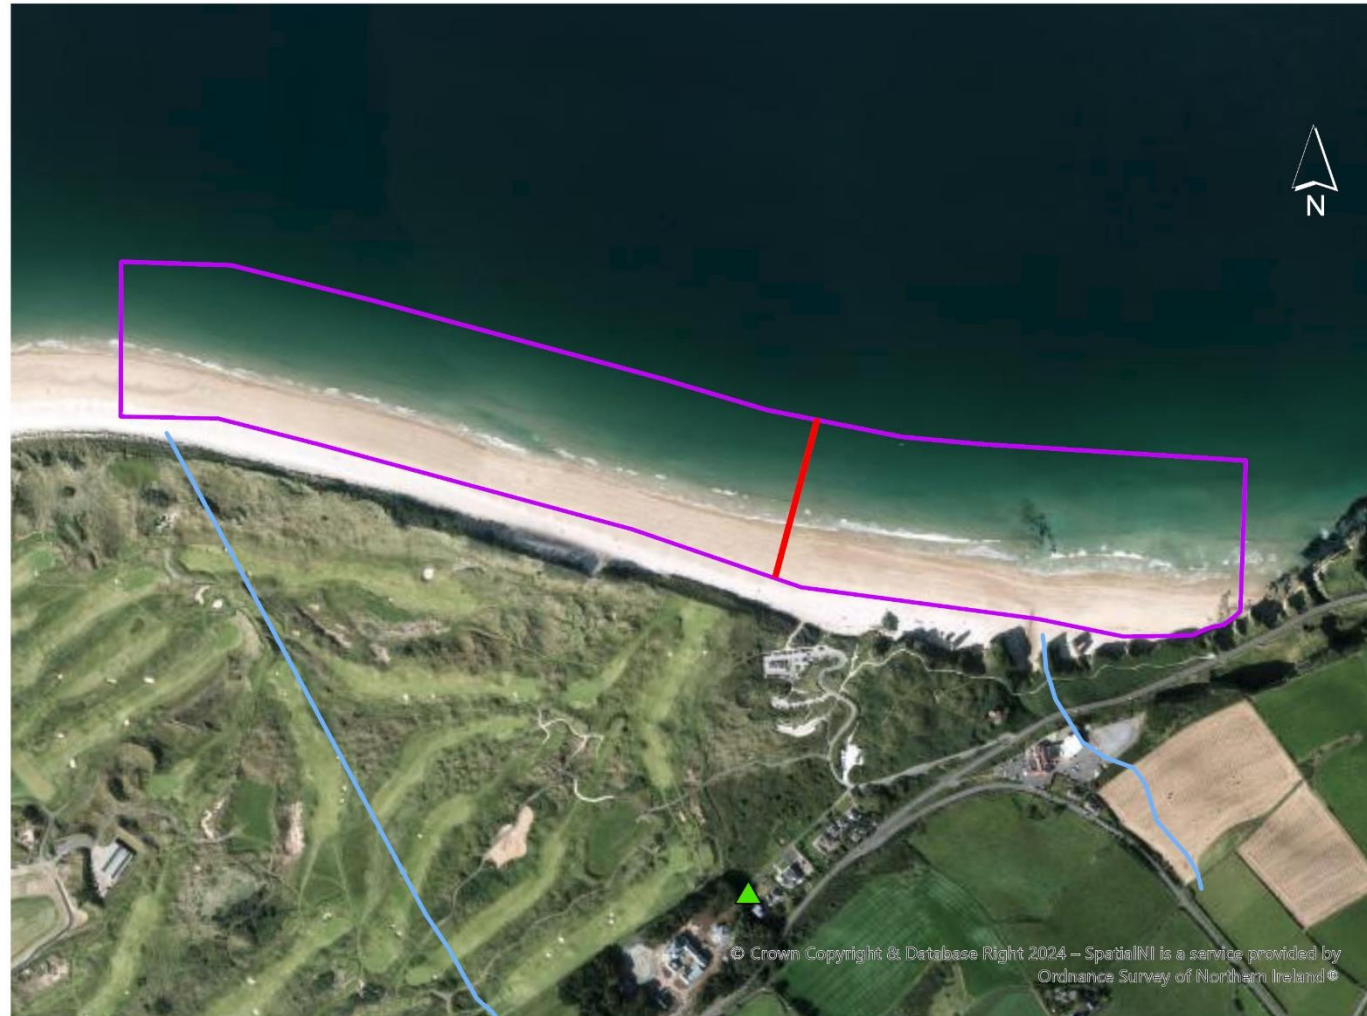
Map 1 Portrush Whiterocks Bathing Water

The collection and treatment of wastewater has the potential to cause pollution as all combined collection systems are designed to overflow in periods of extreme wet weather or following failure of the system. This prevents overflows into residential properties. Within the Portrush Whiterocks area there are combined sewer overflows (CSO), highlighted on Map 1.
