## Waterfoot – Bathing Water Profile

Waterfoot beach, County Antrim, Northern Ireland

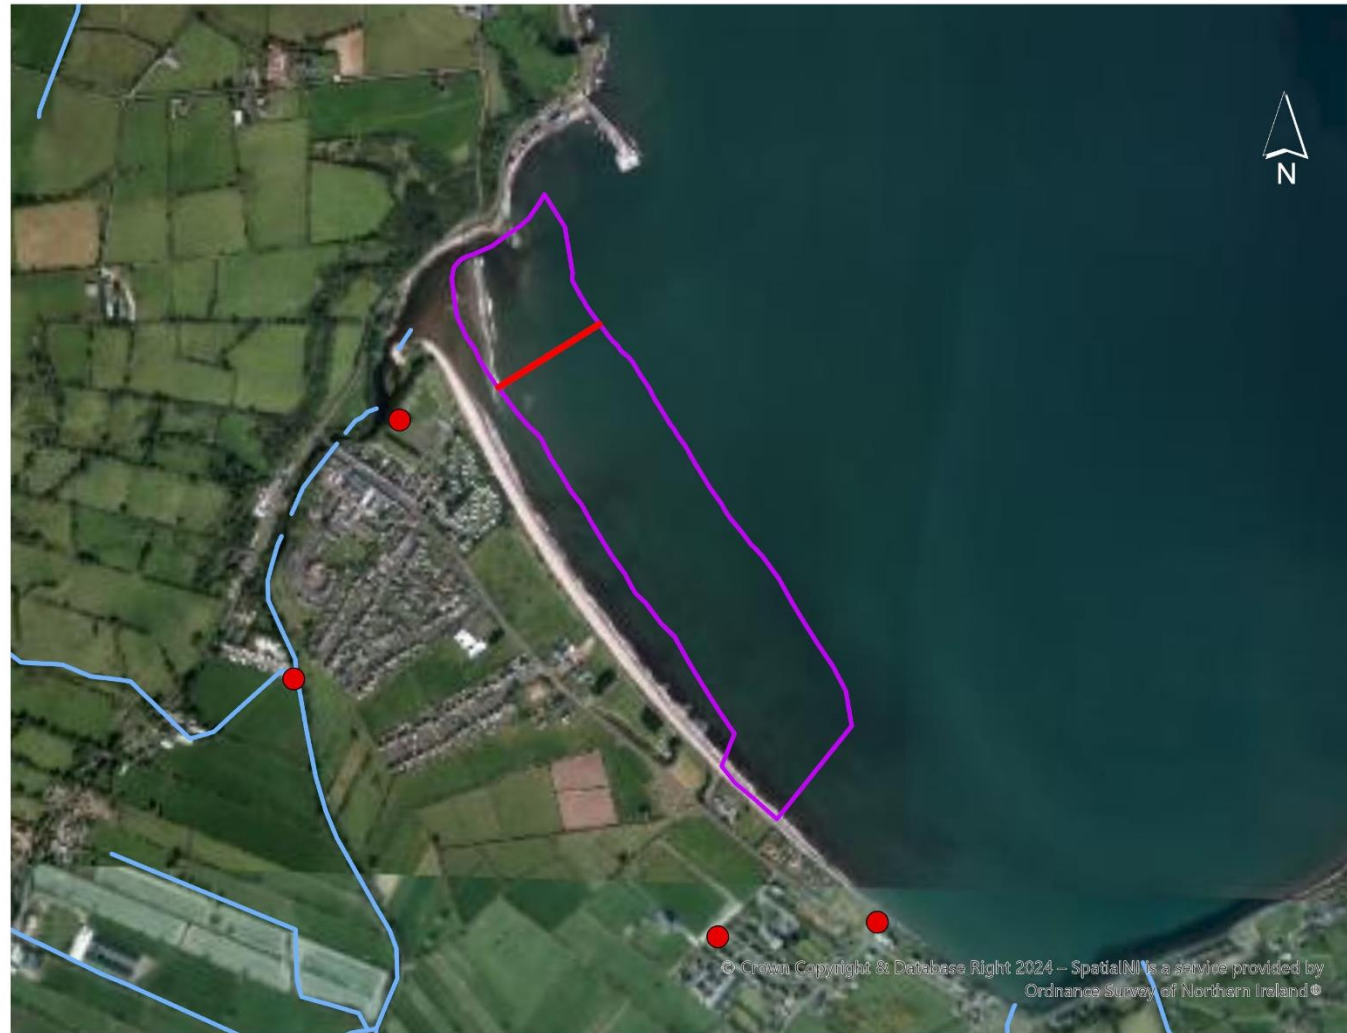
Map 1 Waterfoot Bathing Water

The collection and treatment of wastewater has the potential to cause pollution as all combined collection systems are designed to overflow in periods of extreme wet weather or following failure of the system. This prevents overflows into residential properties. Within the Waterfoot area there are wastewater pumping stations with associated emergency overflows, highlighted on Map 1.
