# **Cushendun Coastal Scoping Report and Monitoring Coastal Change to Inform Future Management**

**KPAL Report No: 110225**

**28 February 2025**

**Kenneth Pye Associates Ltd**

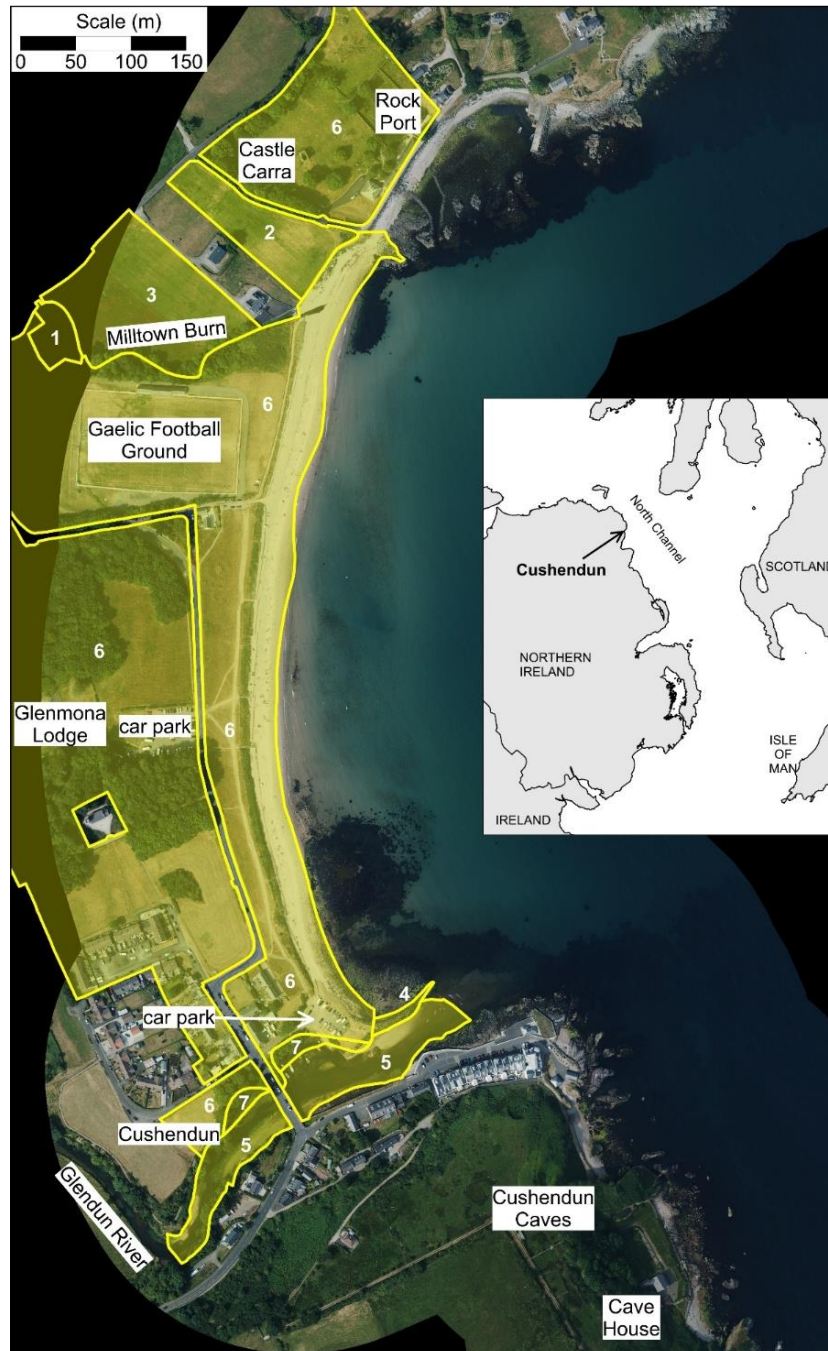
**Figure 1.** Location of land owned or leased by the National Trust at Cushendun. Individual land / property compartments and their dates of acquisition are shown in Table 1 (base aerial photography flown 2022 by Bluesky, supplied by DAERA)

This study was commissioned by the National Trust (NT) with funding provided by the Department of Agriculture, Environment and Rural Affairs (DAERA) Strategic Strand Environment Fund. The NT owns significant areas of land at Cushendun, County Antrim, Northern Ireland (Figure 1 & Table 1). The overall purpose of the study was to provide better information to inform the future management of the Trust's assets in the area which include several historic buildings, a café, shop, pub, two car parks, a rock breakwater adjacent to the mouth of the River Dun and a small harbour on its northern side.

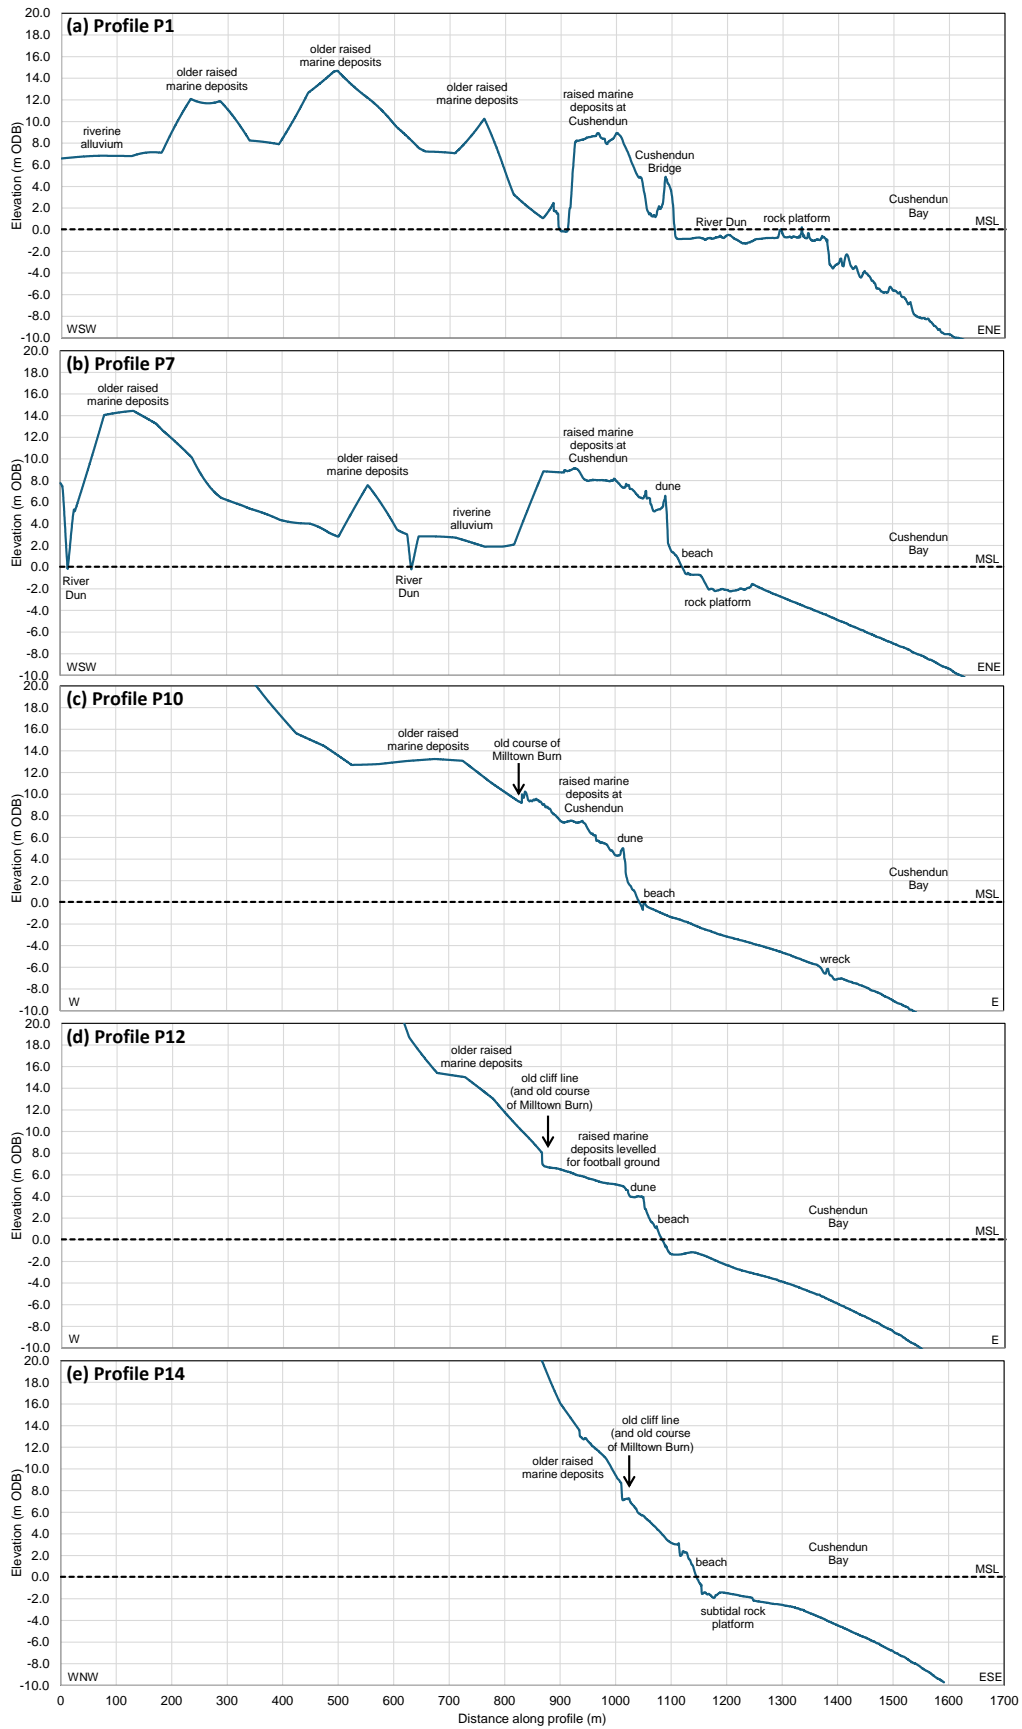
Figure 7. Topographic sections extracted from the combined topographic and bathymetric DEM

Figure 7 continued

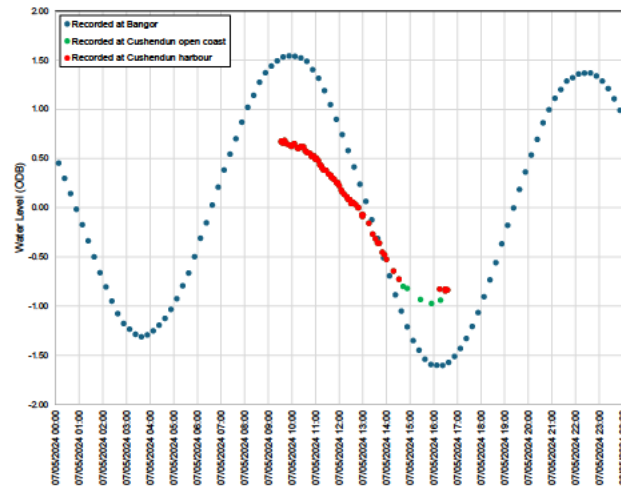
**Figure 9.** Comparison of tidal levels recorded at the Class A gauge at Bangor on 7<sup>th</sup> May 2024, and the levels recorded at Cushendun by RTK-GNSS on the same day. For low waters, the graph discriminates between values recorded on the open coast (beach) and beside the slipway in Cushendun harbour

Figure 9 and Table 3 show a comparison between tidal levels recorded at the Bangor Class A tide gauge and measured at the same time points by RTK-GNSS at Cushendun on 7<sup>th</sup> May 2024, a day with fair weather, standard pressure and low wind speeds i.e. no surge). The high and low waters occurred 10 minutes earlier at Cushendun than at Bangor. High Tide was observed to be about 87 cm lower at Cushendun than at Bangor. Low water on the open coast beach was found to be 98 cm lower but inside the harbour the low water level was found to be only 83 cm lower due to effect of river flow.

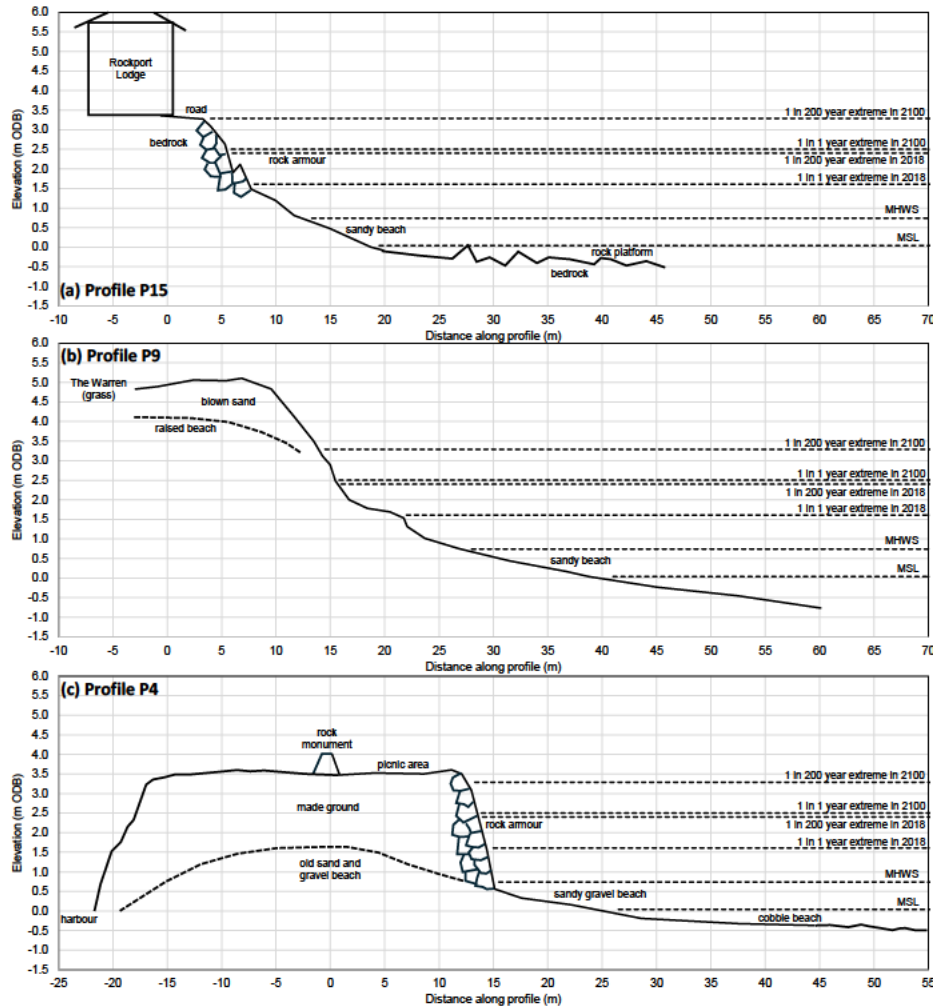
**Figure 11.** Three selected profiles at Cushendun, showing mean tidal levels and 1 in 1 and 1 in 200 year extreme tidal levels for the present (base year 2018), and in the year 2100 under an extreme RCP8.5 scenario (95<sup>th</sup> percentile values)

Figure 11 provides a schematic illustration of the 2018 and 2100 1 in 1 and 1 in 200 still water levels relative to the land at three locations around Cushendun Bay. At Rockport the projected 2100 1 in 200 still water level would reach the level of the concrete road in front of Rockport Lodge. In the centre of the bay the 1 in 200 still water level would stand approximately half-way up the dune cliff at the back of the beach, and at the southern end of the bay the 2100 still water level would be about 1 m below the surface level of the NT harbour car park. The water depth immediately in front of the rock revetment in this area would be more than 3m, allowing waves to reach the revetment (if it was still in existence) without breaking.

As shown schematically in Figure 11, still water levels are projected to increase progressively towards 2100 due to the effects of climate change and this will increase the wave power impacting on the breakwater and the northern revetment. Without major works to upgrade the revetment failure at some point in the relatively near future is highly likely. Should such an event occur the Trust would be faced with the choice of leaving the rubble in place, to degrade and disperse naturally, or removing it and the fill behind in accordance with the total removal option outline above.

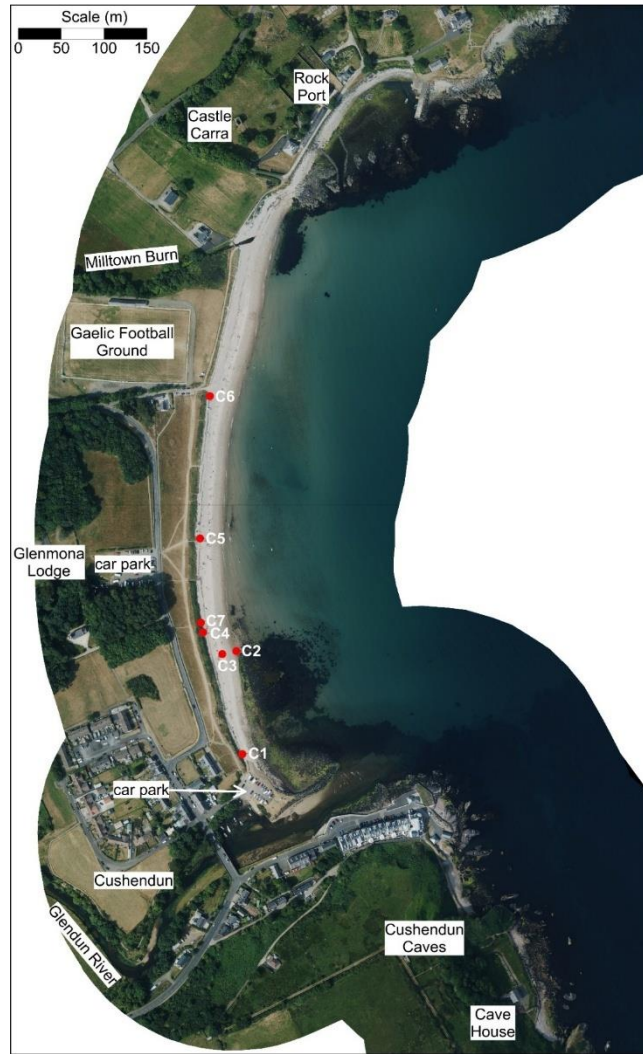
**Figure 12.** Locations of sediment samples collected on 7<sup>th</sup> May 2024 and 19<sup>th</sup> September 2024. Base Aerial photography flown 28/08/2021 by Bluesky and supplied by Northern Ireland Coastal Observatory

Sediment samples were collected for particle size analysis from six locations during site visits in May 2024 and September 2024 (locations shown on Figure 12 and sample details given in Table 5).

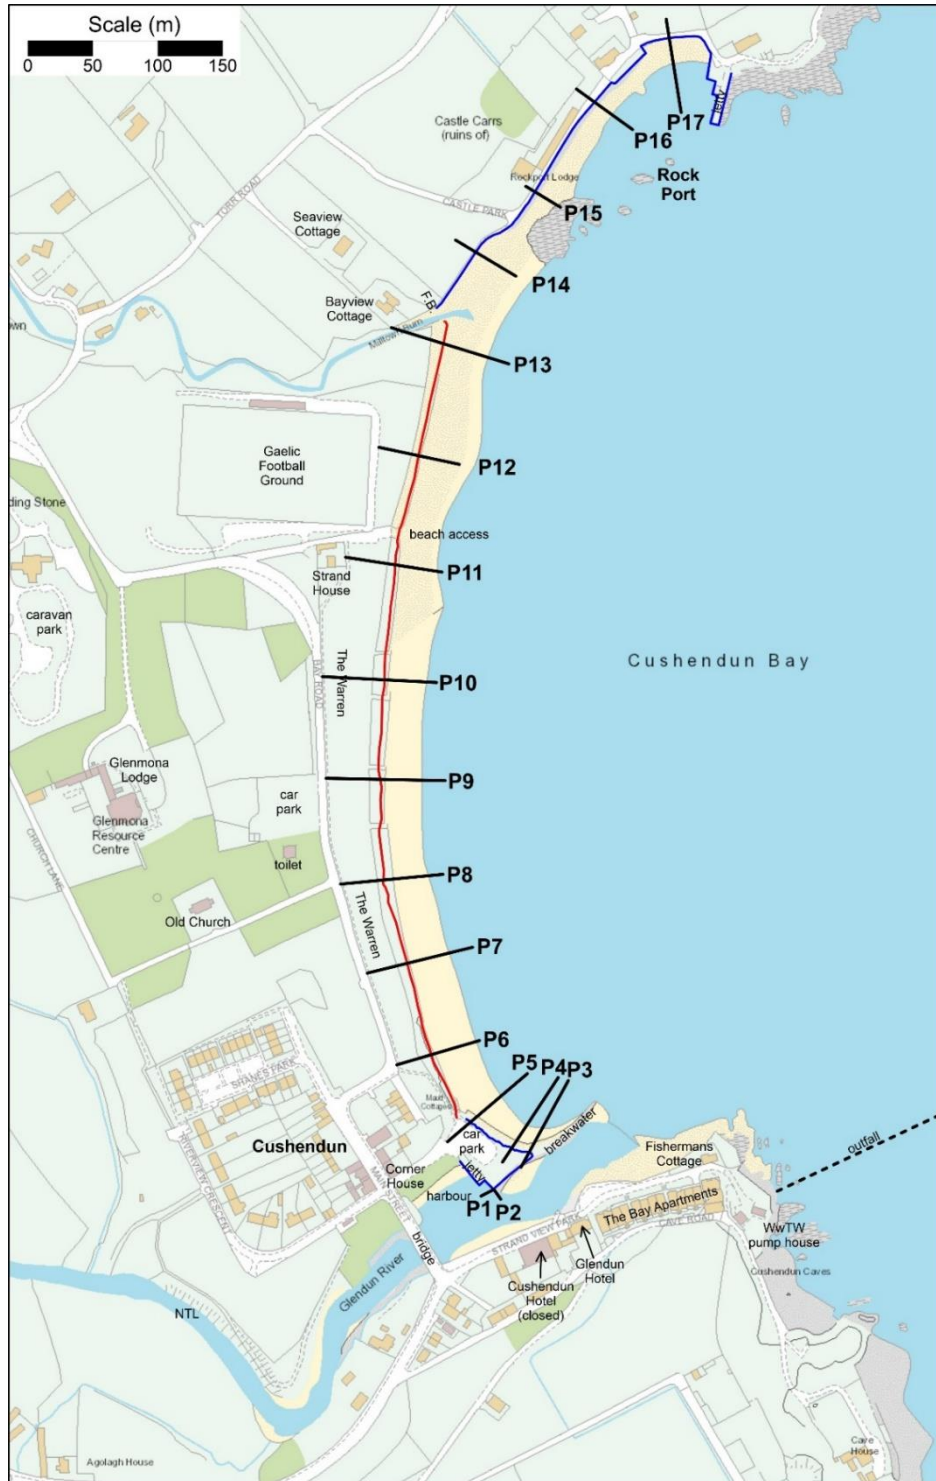
**Figure 14.** Locations of profiles used for RTK-GNSS topographic monitoring in this study. The red line indicates the dune toe and the blue line indicates the seaward limit of vegetation (usually the top of defences or seaward side of paths or roads) surveyed in May 2024

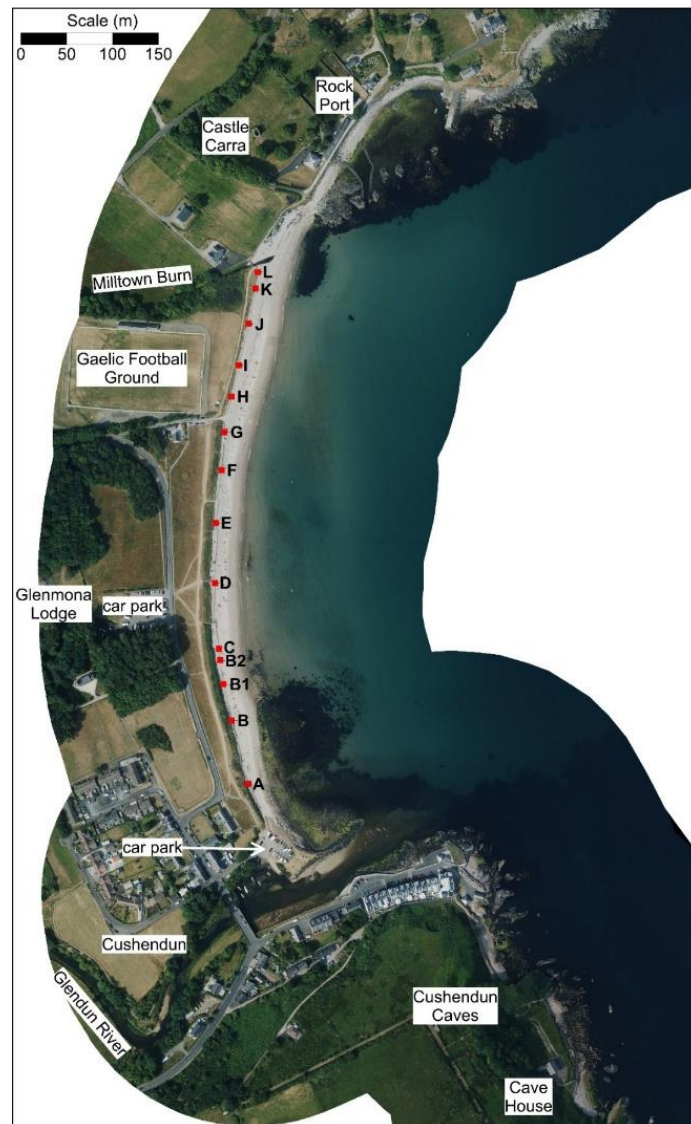
**Figure 19.** Aerial photography flown 28/08/2021 by Bluesky and supplied by Northern Ireland Coastal Observatory, overlaid with locations of posts and sleepers selected for use in beach level monitoring

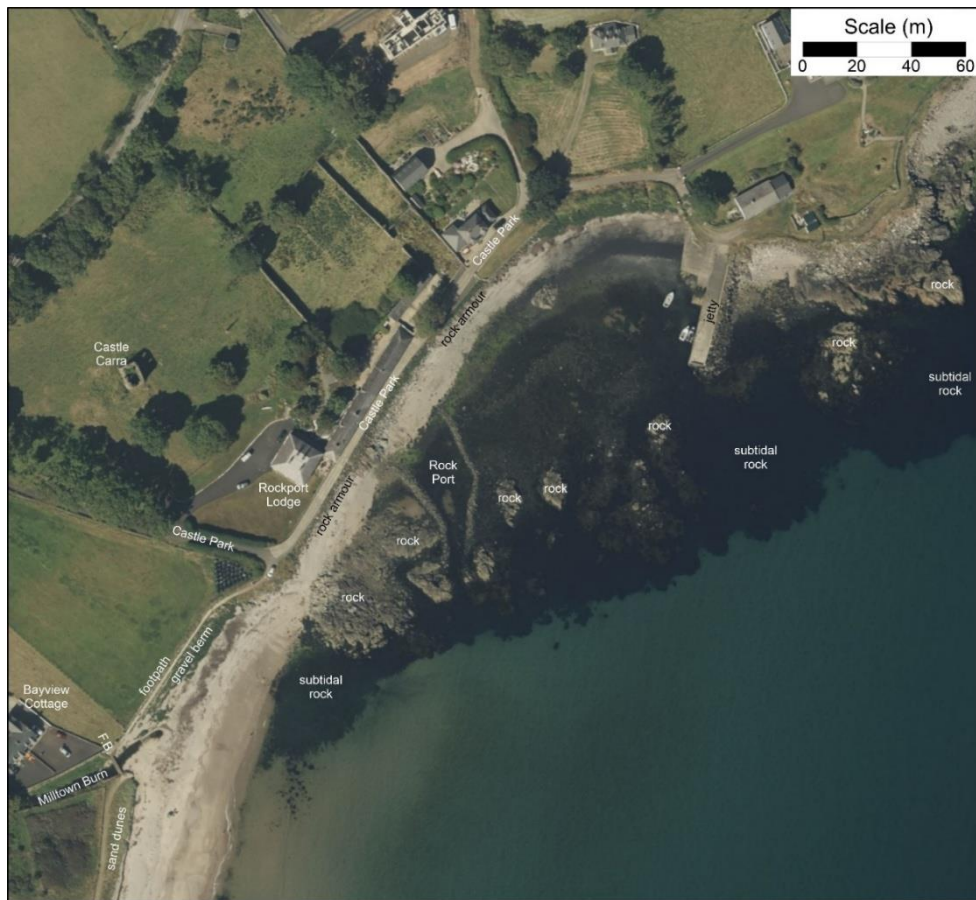
**Figure 24.** Aerial photograph of the Rock Port area flown July 2022. Source: Bing

Although The National Trust owns Rockport Lodge it does not own the concrete road which runs along the front and provides access to other houses at Castle Park, or the protective rock armour revetment on the seaward side of the road. The defences appear to have been built in the 1960s or 1970s and show evidence of localised failure which has allowed waves to undermine the seaward edge of the access road in some places. Localised collapse of the edge of the road was evident during the site visit in February 2024. Although repairs have been made since that time the road remains vulnerable to further damage during storm events (Figures 24 & 25 and photographs in Appendix 2).

The main house and associated outbuildings at Rockport Lodge are sited on ground which is slightly below the level of the concrete road and are at risk of flooding from spray generated by breaking waves. The house is partially protected a surrounding low wall although gateways rely on sandbags for protection against overtopping water. As water levels and nearshore wave heights increase with climate change such wave splash overtopping will become more frequent and more serious. However, mitigation measures could be simply employed, for example by building a low wall along the seaward side of the access road. Due to the fact that the house and outbuildings have a foundation of rock at shallow depth the short to medium term risk of loss due to coastal erosion is considered low.

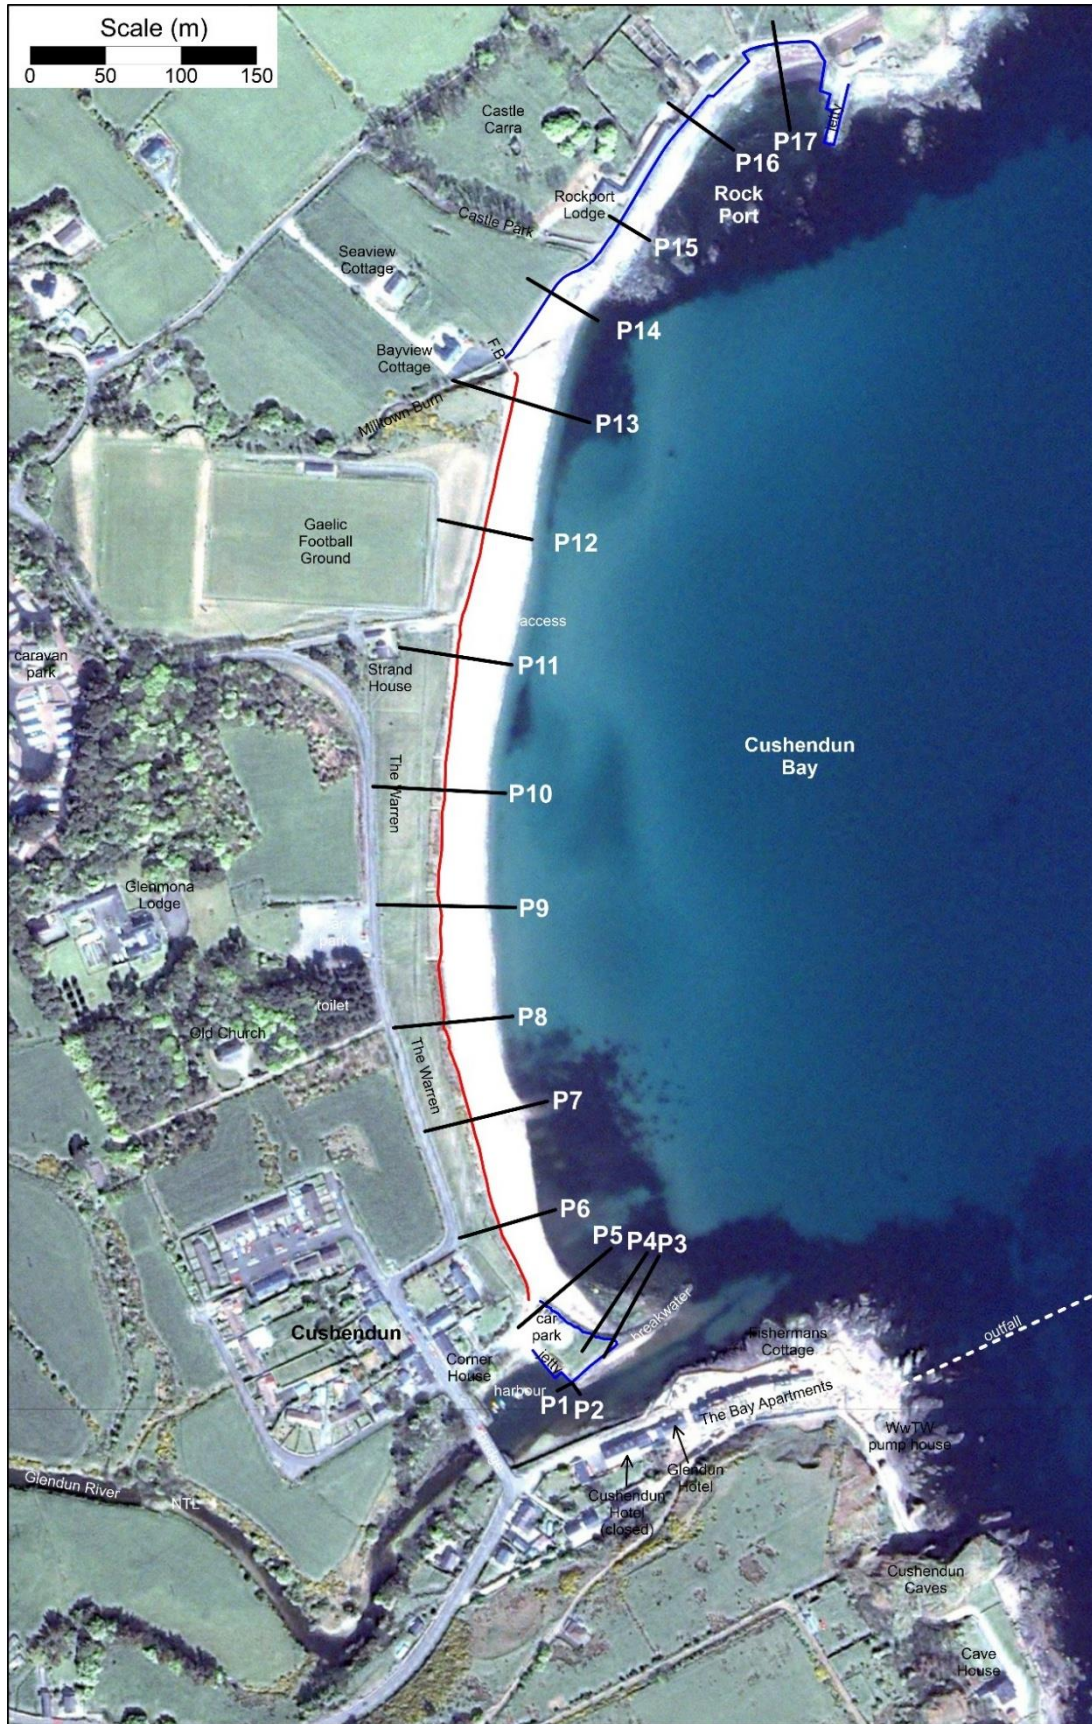
**Figure A2.6** Aerial photo flown 13/05/2001, overlaid with the position of the dune toe (red line), sea defences (blue line) and cross-shore profiles (black lines) surveyed in May 2024. Source: Google Earth

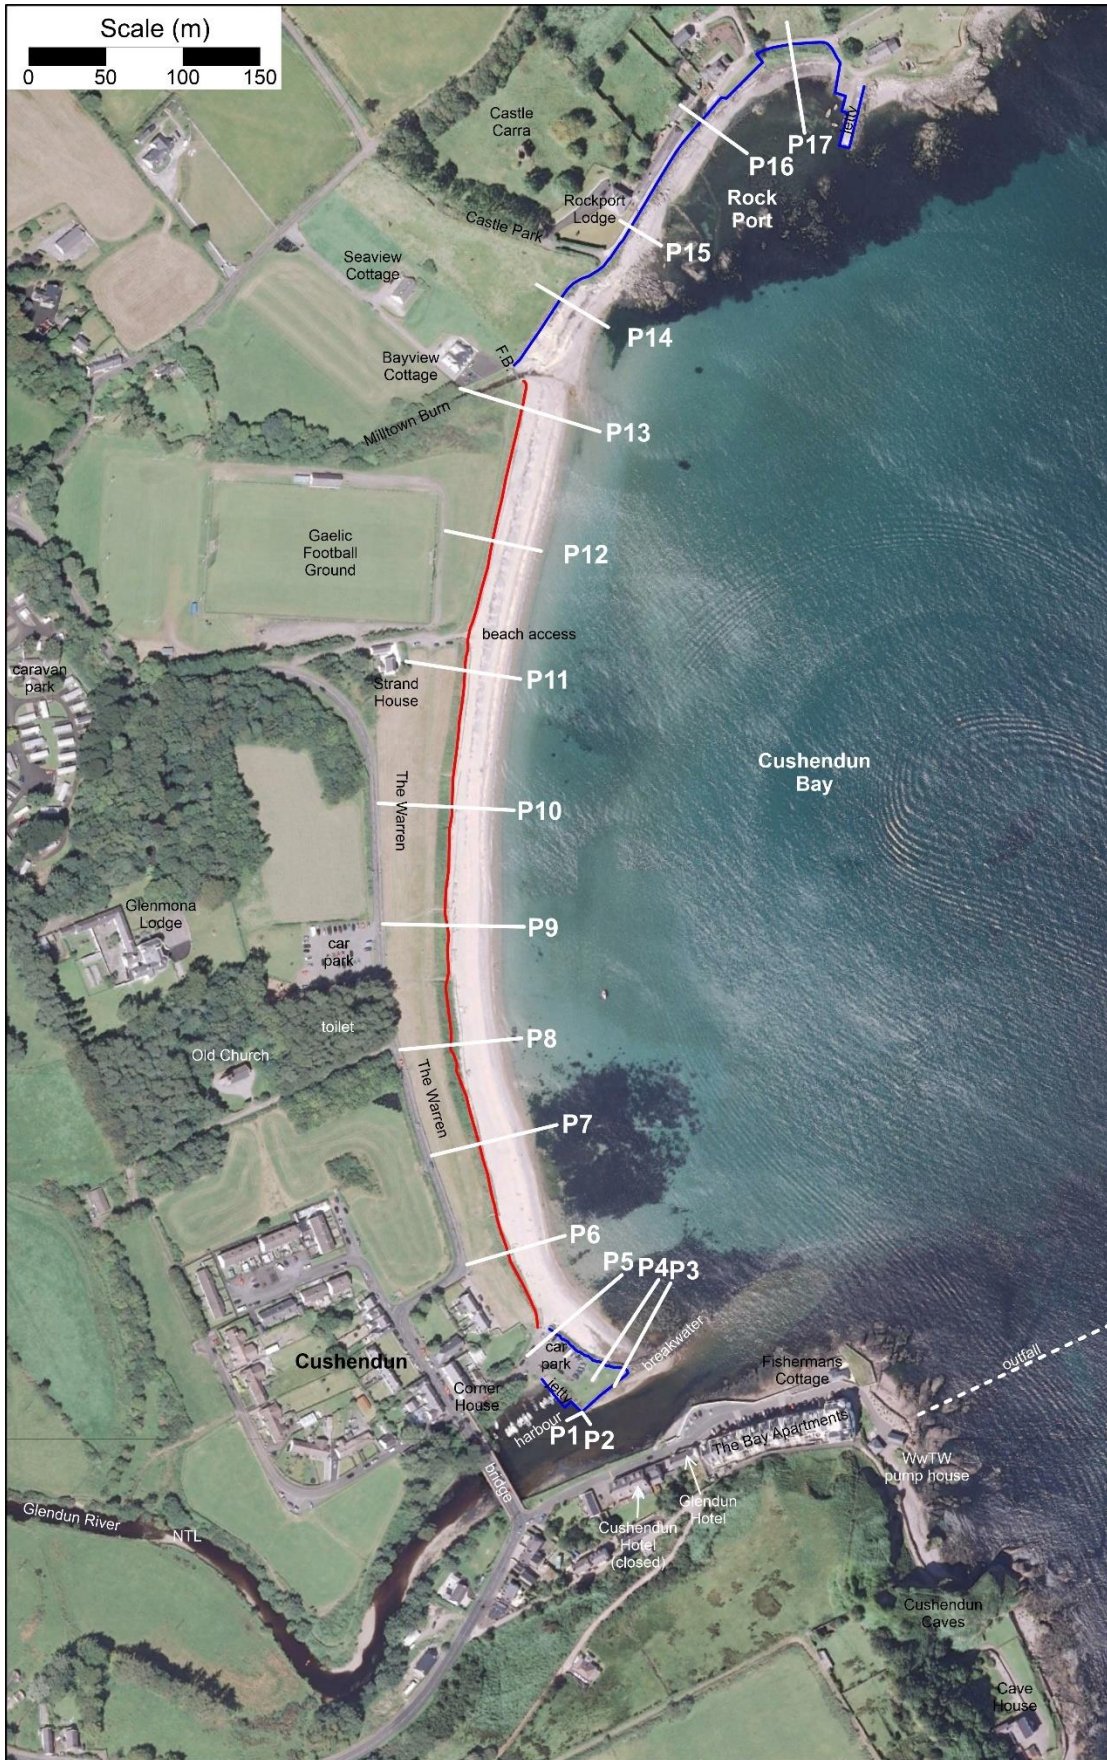
**Figure A2.7** Aerial photo flown 24/07/2011, overlaid with the position of the dune toe (red line), sea defences (blue line) and cross-shore profiles (white lines) surveyed in May 2024. Source: Google Earth

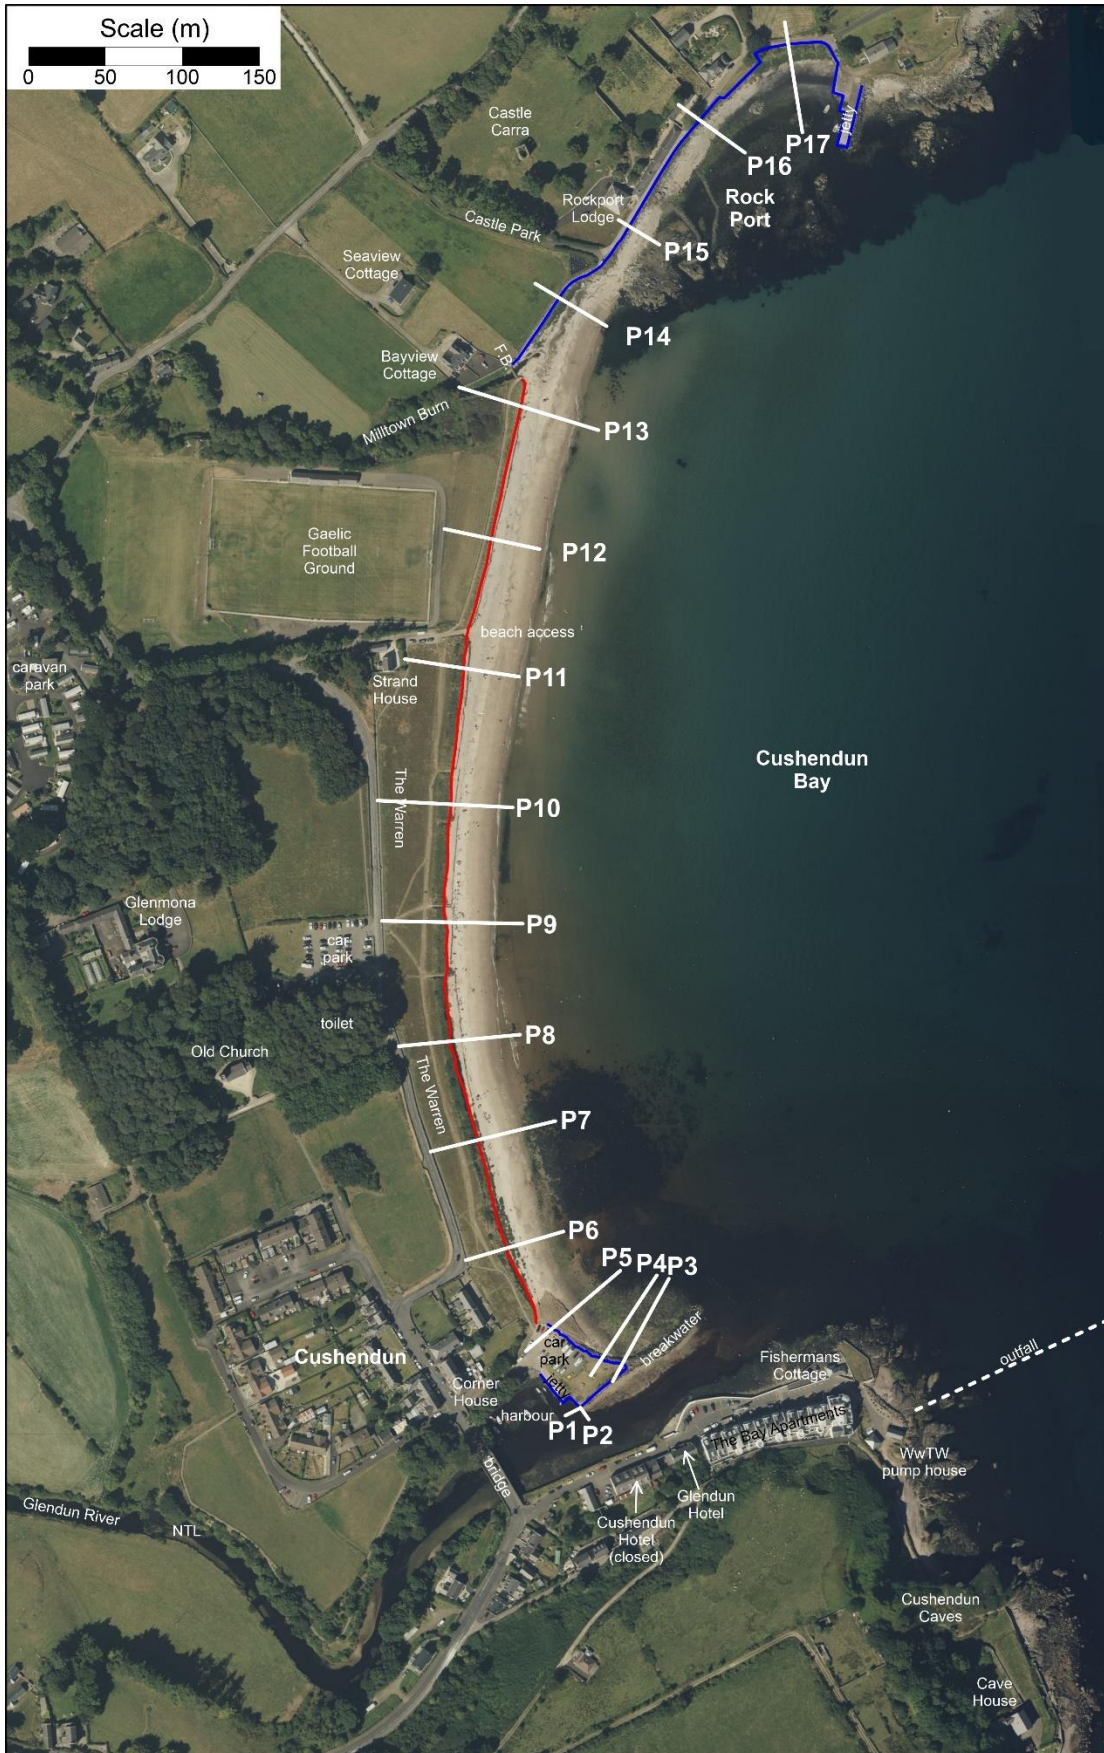
**Figure A2.8** Aerial photograph flown c. July 2022, overlaid with the position of the dune toe (red line), sea defences (blue line) and cross-shore profiles (white lines) surveyed in May 2024. Source: Bing
