# **Historic Structure Assessment**

## **Killough Railway Bridge, County Down**

| Document type | Historic Structure Assessment | | | | |

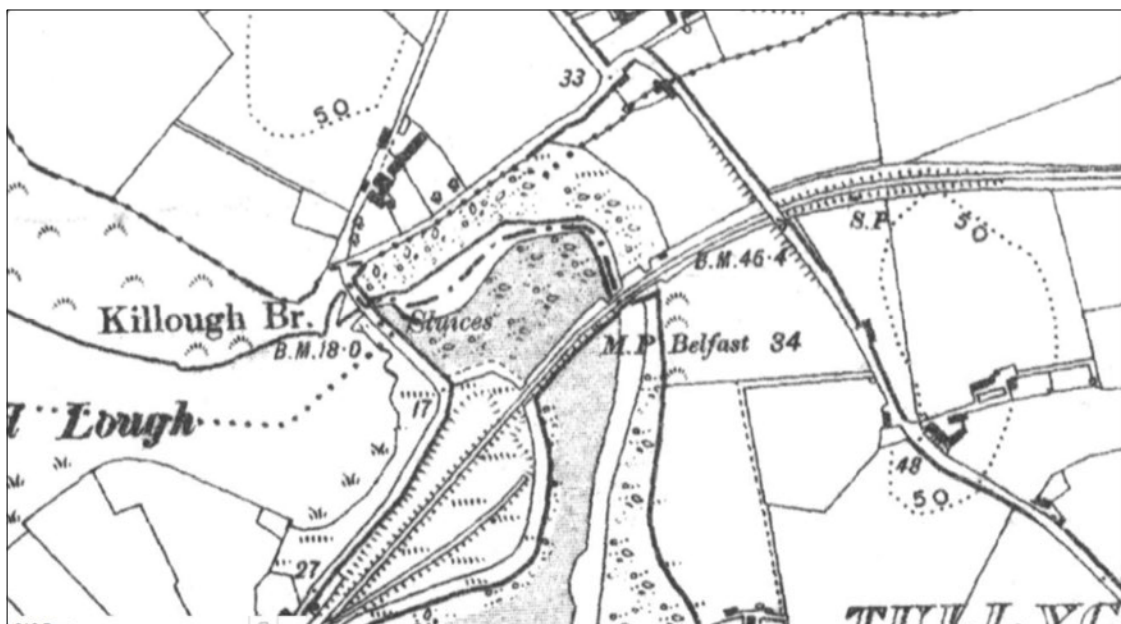
The third edition OS map, surveyed in 1900, shows the railway bridge crossing the water at Killough Harbour (**Figure 5**). There appears to be some railway sidings on the Killough side also. The research demonstrates that traffic on this stretch of the BCDR line was light at this time. The fourth edition map surveyed in 1920-21 shows the railway line and bridge (**Figure 6**). The railway sidings on the Killough side seem to have been removed perhaps indicating the lack of significant railway activity at the time.

**Figure 5:** An extract from the third edition OS map surveyed in 1900 (Source: PRoNI Historical Maps)

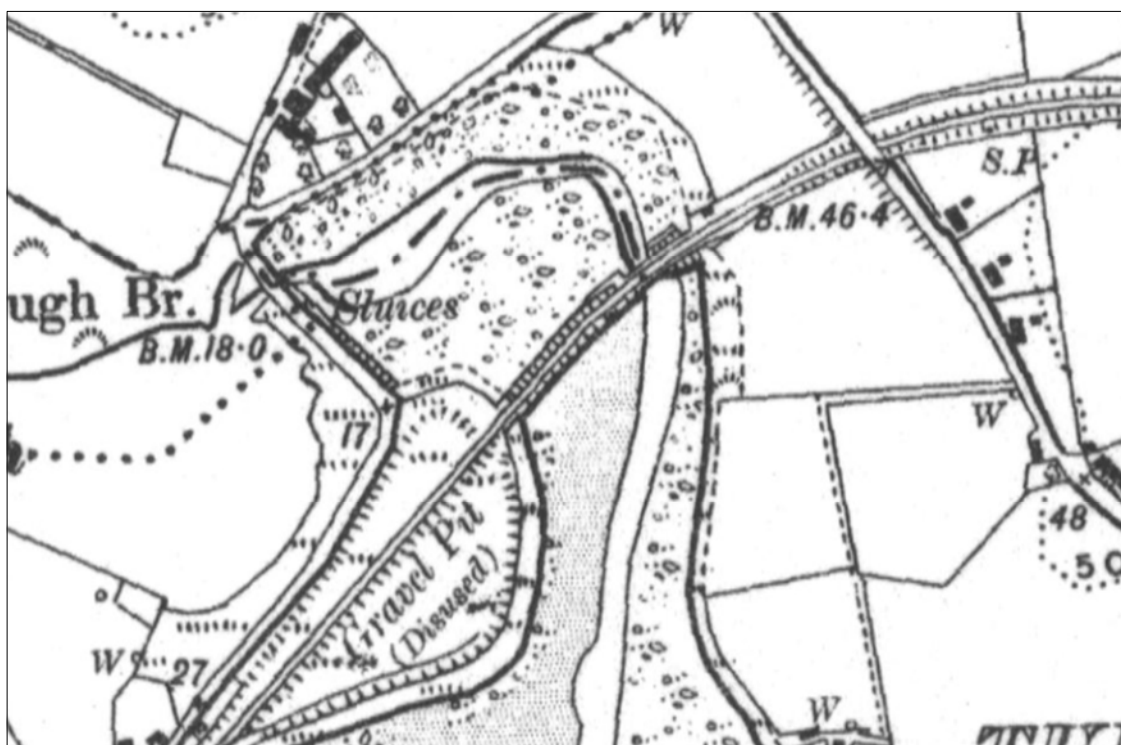
**Figure 6:** An extract from the fourth edition OS map, surveyed in 1920-21 (Source: PRoNI Historical Maps)

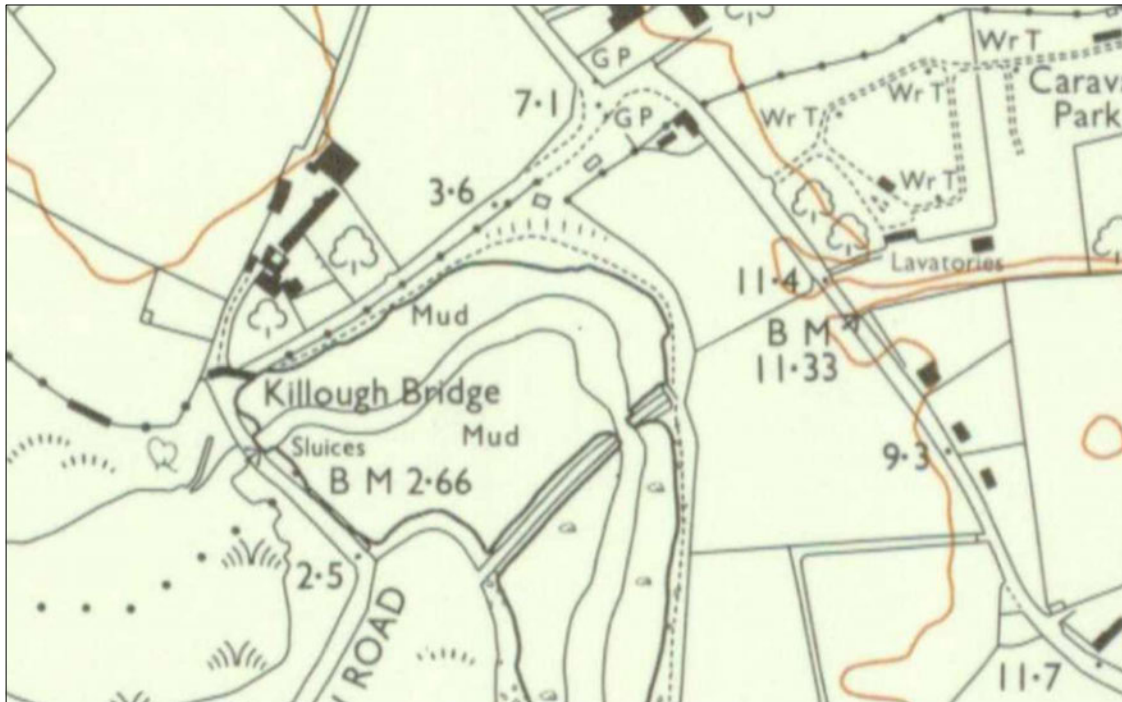
The OS 1:10,000 Metric Scale Irish Grid map surveyed in 1977-78 (see **Figure 7** below) shows that the railway, which closed in 1950, had been largely removed by the time of surveying. Only the causeway built for the bridge is shown to survive at this time.

**Figure 7:** An extract from the OS 1:10,000 Metric Scale Irish Grid map surveyed in 1977-78 (Source: PRoNI Historical Maps)

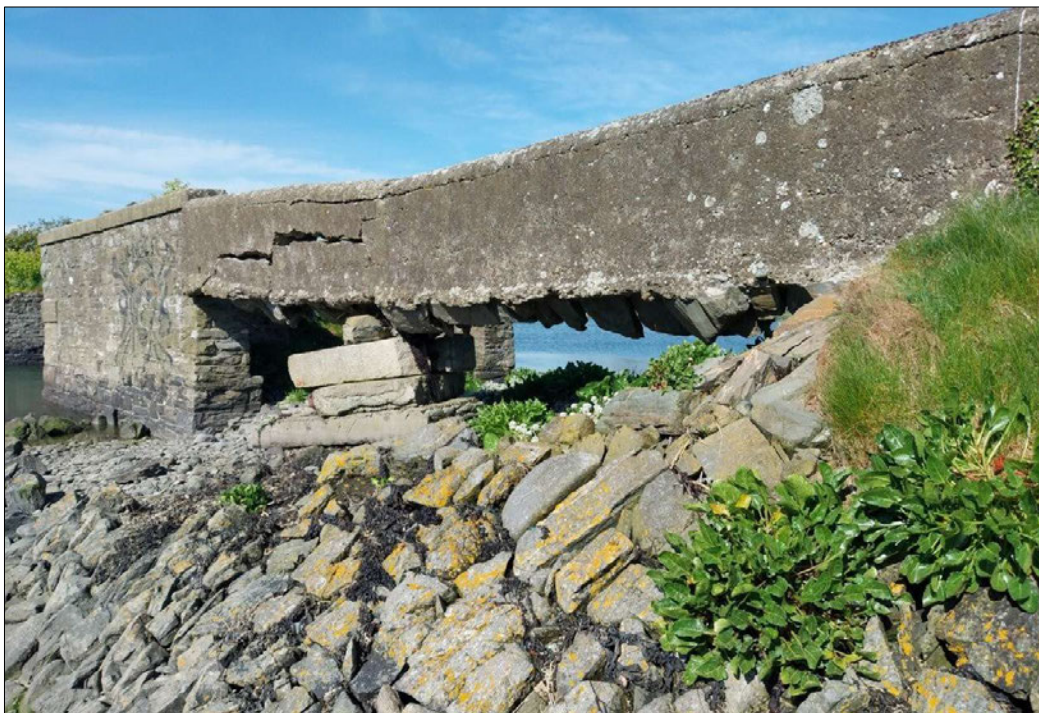
The subject site consists of a c.10m-long section of railway embankment/causeway between stone abutments on the eastern side of the inlet leading to Strand Lough. The site is set within the marine environment, and although not at a high-energy environment, tidal forces, along with periodic storms and inundation, as well as neglect have resulted in incremental damage to the embankment over time. A section of the embankment has eroded away, leaving a large void under a section of the parapets (unsupported parapets), which are suspended precariously between the stone abutments. The parapets consist of large stones set within a concrete matrix, coarse rendered, with rounded tops, measuring c.0.5m in width and 0.8m in height (**Figure 8-11**). Large cracks have formed due to the pressure caused by the weight of the parapet structures and the lack of underlying support. Recent erosion of the soil and gravel fill within the abutment adjoining the parapet to the west was also noted during the site visit (**Figure 12**). A section of supported parapet, attached to the northeastern abutment is overgrown but appears to be structurally sound at present (**Figure 13**). However, over time, this portion of causeway/embankment will also succumb to erosion. The masonry of the adjacent stone abutments are visually in good condition, although the internal fill is subject to erosion.

**Figure 8:** Photograph of the eroded section of embankment/causeway, with the parapets suspended between the stone abutments, facing west (Source: Client)

The *Structural Report* for the project recommends that the unsupported section of parapet should be removed as a matter of urgency. It is agreed that the unsupported section of parapet should be dismantled to make the site safe.

The dismantlement and removal of the sections of parapet should be undertaken in a controlled manner. Care and precaution should be taken to ensure that the dismantlement does not damage the retained structural elements, including the stone abutments.

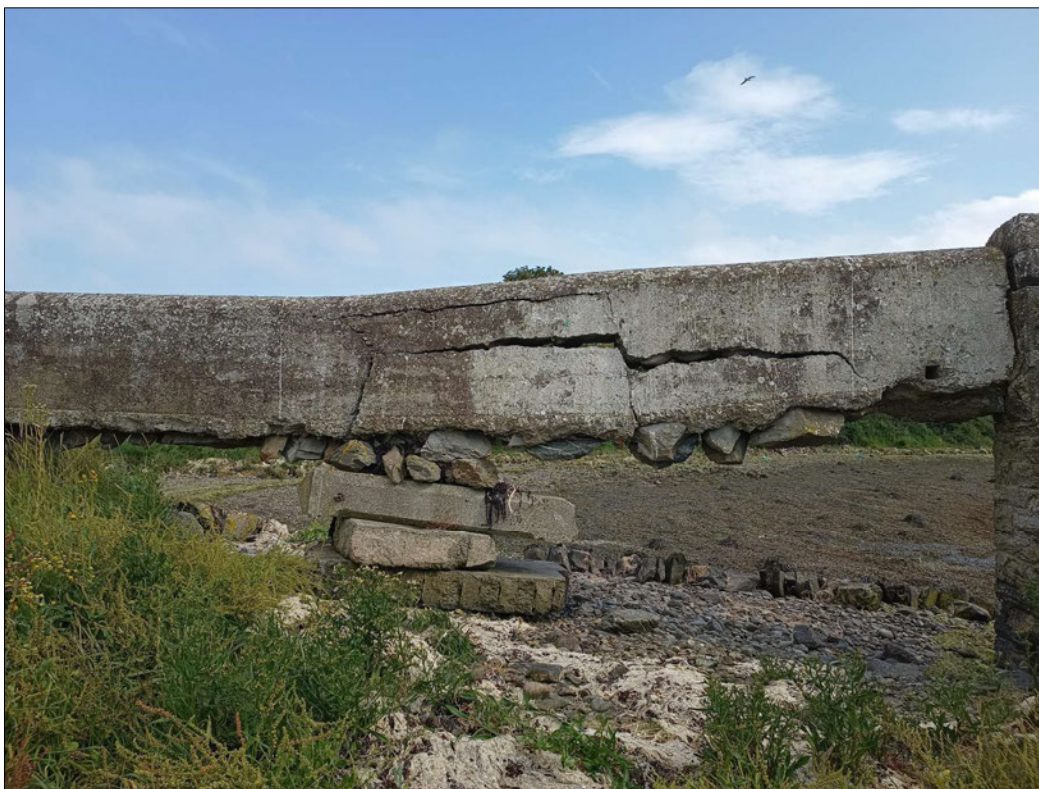
**Figure 9:** Photograph of the failed parapet suspended between the stone abutments, facing southeast

A *Structural Report* produced by BWM Structural and Civil Consulting Engineers has assessed the condition of the section of parapet and states the following in its conclusions 'The section of wall currently suspended in the air with no support along its base has structurally failed, and is in an unsafe condition, with a full collapse inevitable with time.' This report recommends that this unsupported section of parapet should be removed as a matter of urgency and that a further 10-15m section of supported parapet, adjoining to the east should also be removed to avoid similar issues in the future.

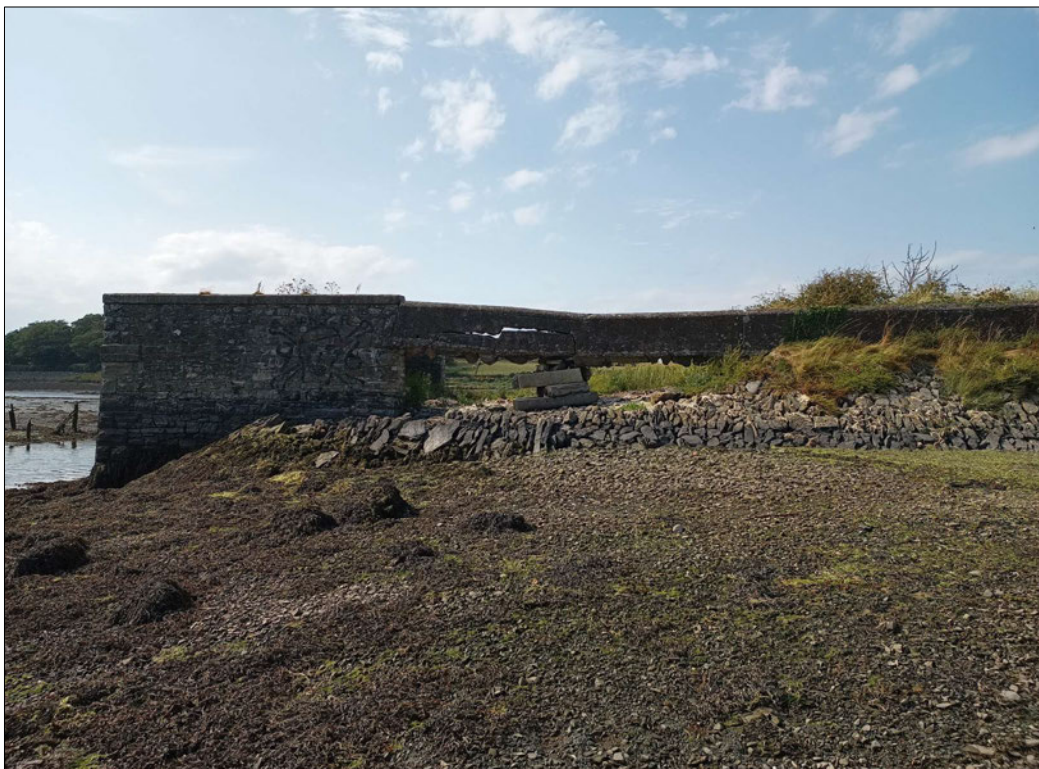
**Figure 10:** Photograph of the stone embankment/causeway below with the parapets suspended between the stone abutments, facing northwest

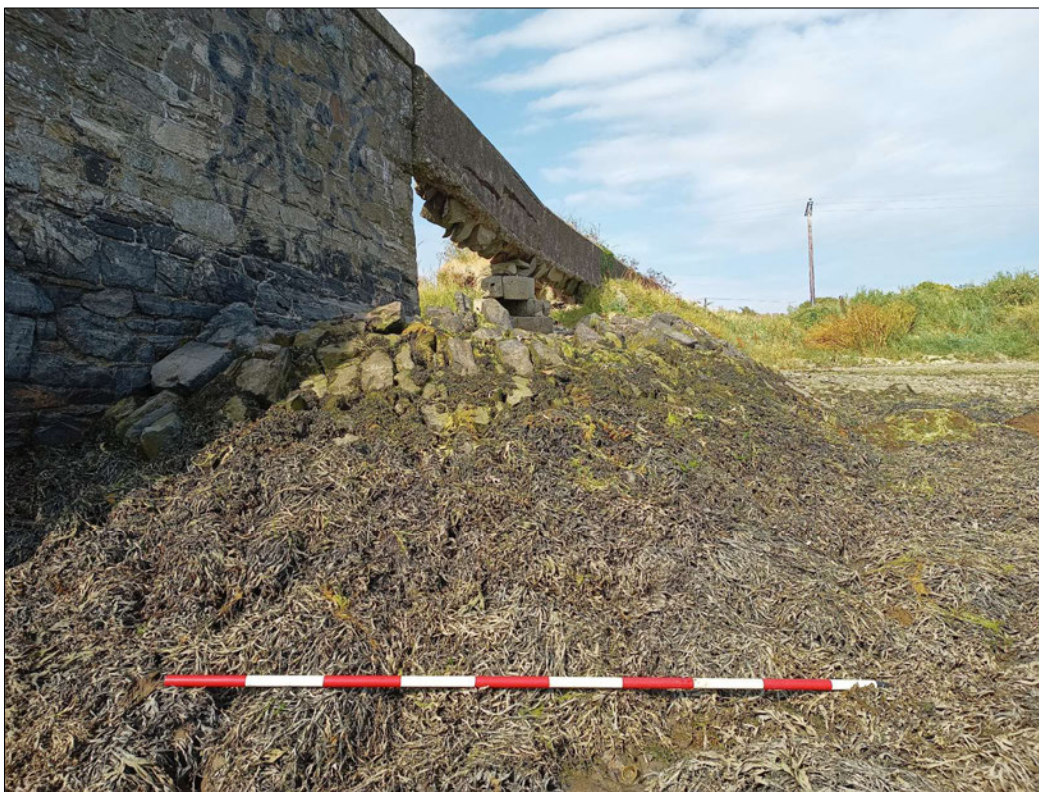
**Figure 11:** Photograph of the battered stone buttress/foundation to the base of the embankment/causeway below the parapets and abutment facing northeast

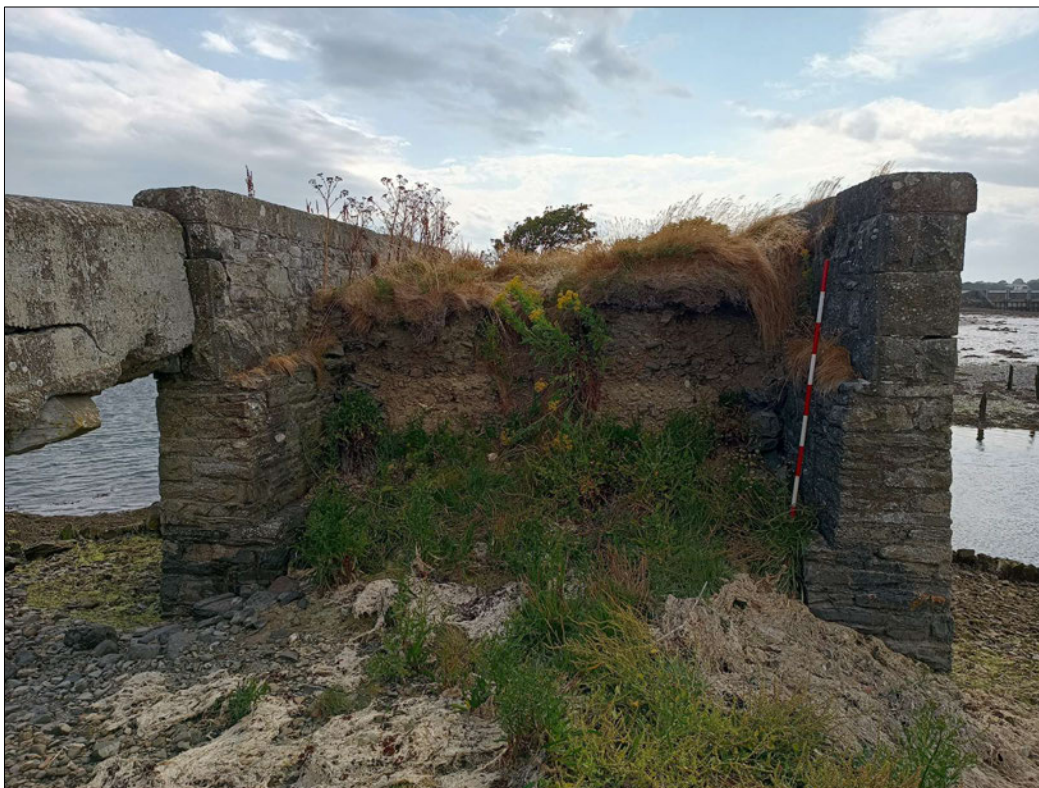
**Figure 12:** Photograph of erosion within the stone abutment adjacent to the parapet, facing southwest

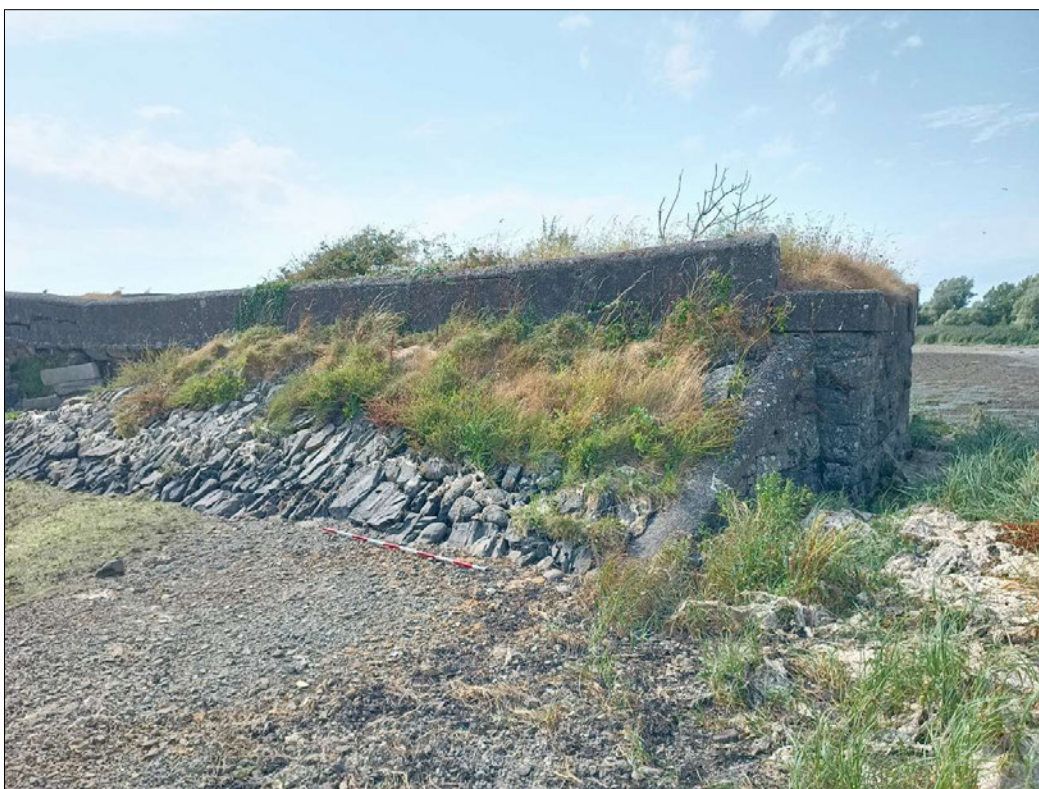
**Figure 13:** View of section of supported parapet and northeast abutment, facing northeast

While noting the recommendation within the *Structural Report* for a further section of supported parapet to be removed at this time, this portion of parapet appears to be in good condition currently and therefore would preferably be retained and further protected. However, given the intertidal location, the potential for storm events, *etc.* it is likely that erosion over time will damage this section of parapet in a similar manner, leading to a need for further demolition and removal works in the future. Therefore, as recommended in the *Structural Report* the section of supported parapet should also be dismantled at this time.

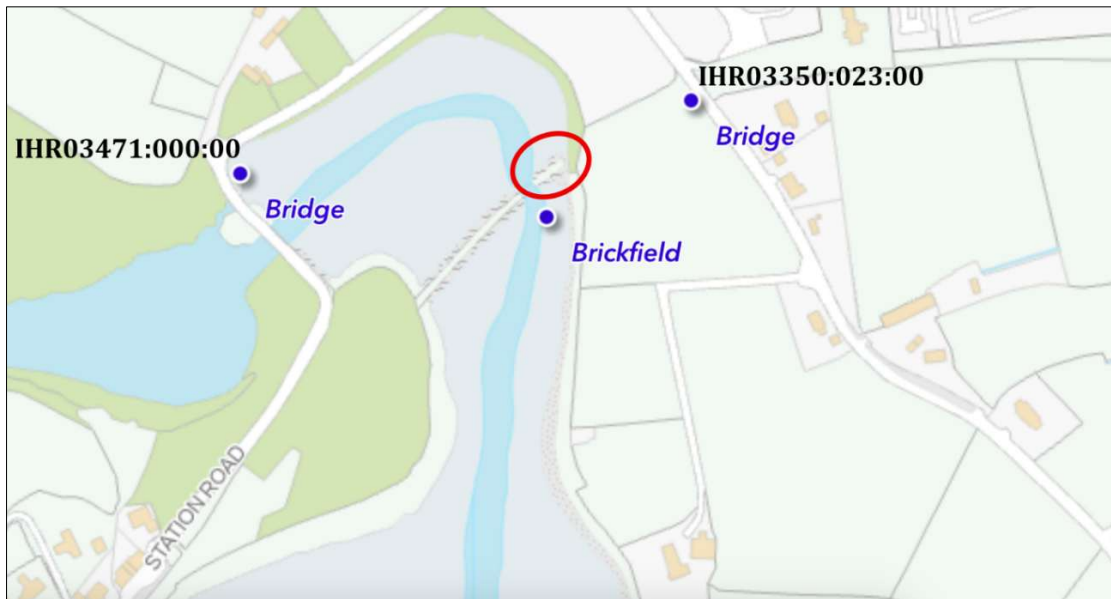
**Figure 14:** Map showing the location of the portion of parapet to be demolished and the nearby Industrial Heritage Record (IHR) sites (Source: DfC: Historic Environment Map Viewer)
