Mobuoy Remediation Project – Updated Waste Quantity Estimate – June 2023

Mobuoy Remediation Project - Distribution and Type of Waste Present

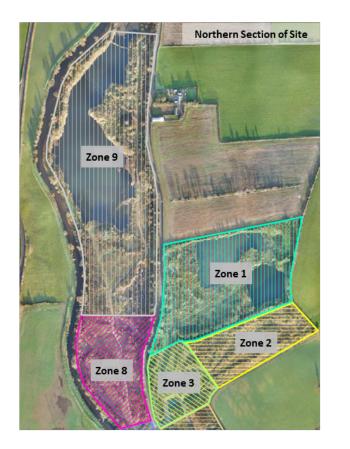
Waste Zone	Waste Profile (Description of Waste) ⁱ	Estimated Waste Quantity (m ³) ⁱⁱⁱ
Zone 1	Domestic and mixed (domestic and Construction and Demolition)	358,907
Zone 2	Domestic and mixed (domestic and Construction and Demolition)	234,496
Zone 3	Predominantly domestic or municipal ⁱⁱ	229,415
Zone 8	Mixed organic, occasional domestic and C&D wastes	127,058
Zone 9	Construction & demolition wastes with occasional domestic/municipal waste.	229,139

A description of the main type of waste identified, and the total quantity of waste estimated to be present within each of the ten waste zones, has been presented in the graphics below (figure 1 and figure 2). Further detailed information on all of the waste types present and potential contaminants of concern are presented at Appendix B (Zone Profile Summary) of the Remediation Options Appraisal Report which can be accessed on our website here.

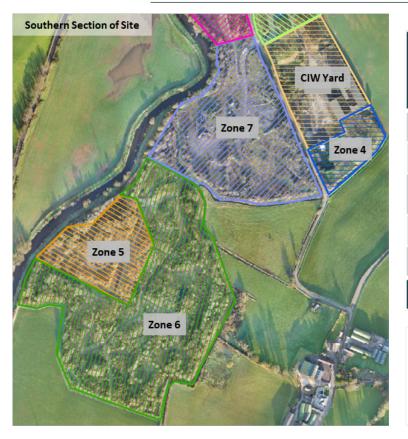
Figure 2

Mobuoy Remediation Project - Distribution and Type of Waste Present

Waste Zone	Waste Profile (Description of Waste) ⁱ	Estimated Waste Quantity (m³) ⁱⁱⁱ
CIW Yard	Predominantly domestic or municipal	45,616
Zone 4	Mixed waste of domestic and construction & demolition	42,854
Zone 5	Construction and demolition waste, with some mixed domestic Waste $^{\rm ii}$	30,619
Zone 6	Mixed construction & demolition and domestic waste	161,554
Zone 7	Construction and demolition waste	170,786
Total Wast	e Volume Estimate for the Site	1,630,444

Total Waste Quantity Estimate - 1,630,444m³

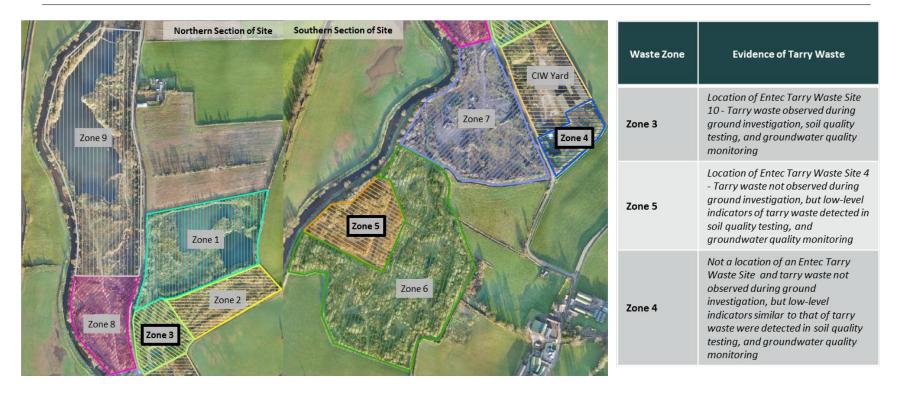
Mobuoy Remediation Project – Locations of Tarry Waste or Evidence of Tarry Waste

Yes, tarry waste was identified in zone 3 of the site. Historical documentary evidence, known as the Entec Report, identified two potential tarry waste deposits on the Mobuoy site. These deposits are located in Waste Zone 3 (Entec Site 10) and Waste Zone 5 (Entec Site 4). Site investigations confirmed a deposit of tarry waste in Waste Zone 3, however ground investigation across Waste Zone 5 did not encounter a deposit of tarry waste. For further detail please see graphic below (figure 3).
