Department of the Environment Marine Division

Bathing Water Profile

Carnlough

May 2015

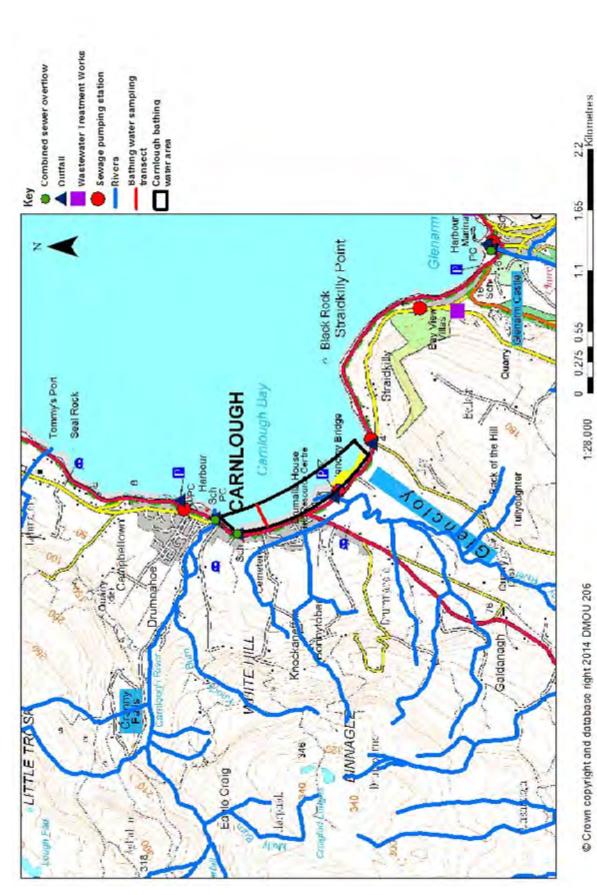
Map 1 Carnlough Bathing Water -Potential Pollution Sources

The municipal collection and treatment of waste water has the potential to cause pollution because all combined collection systems must be designed to overflow in periods of extreme wet weather or following failure of the system. If systems are not designed in that way, then sewers may overflow into residential areas. Within Carnlough bathing area there are combined sewer overflows (CSO), emergency overflows and sewage pumping stations (SPS) with associated emergency overflows as shown on Map 1.
