# **NI Water's Contribution to the Environment**

## **Bush & Glens Catchment Stakeholder Group**

**25<sup>th</sup> April 2012**

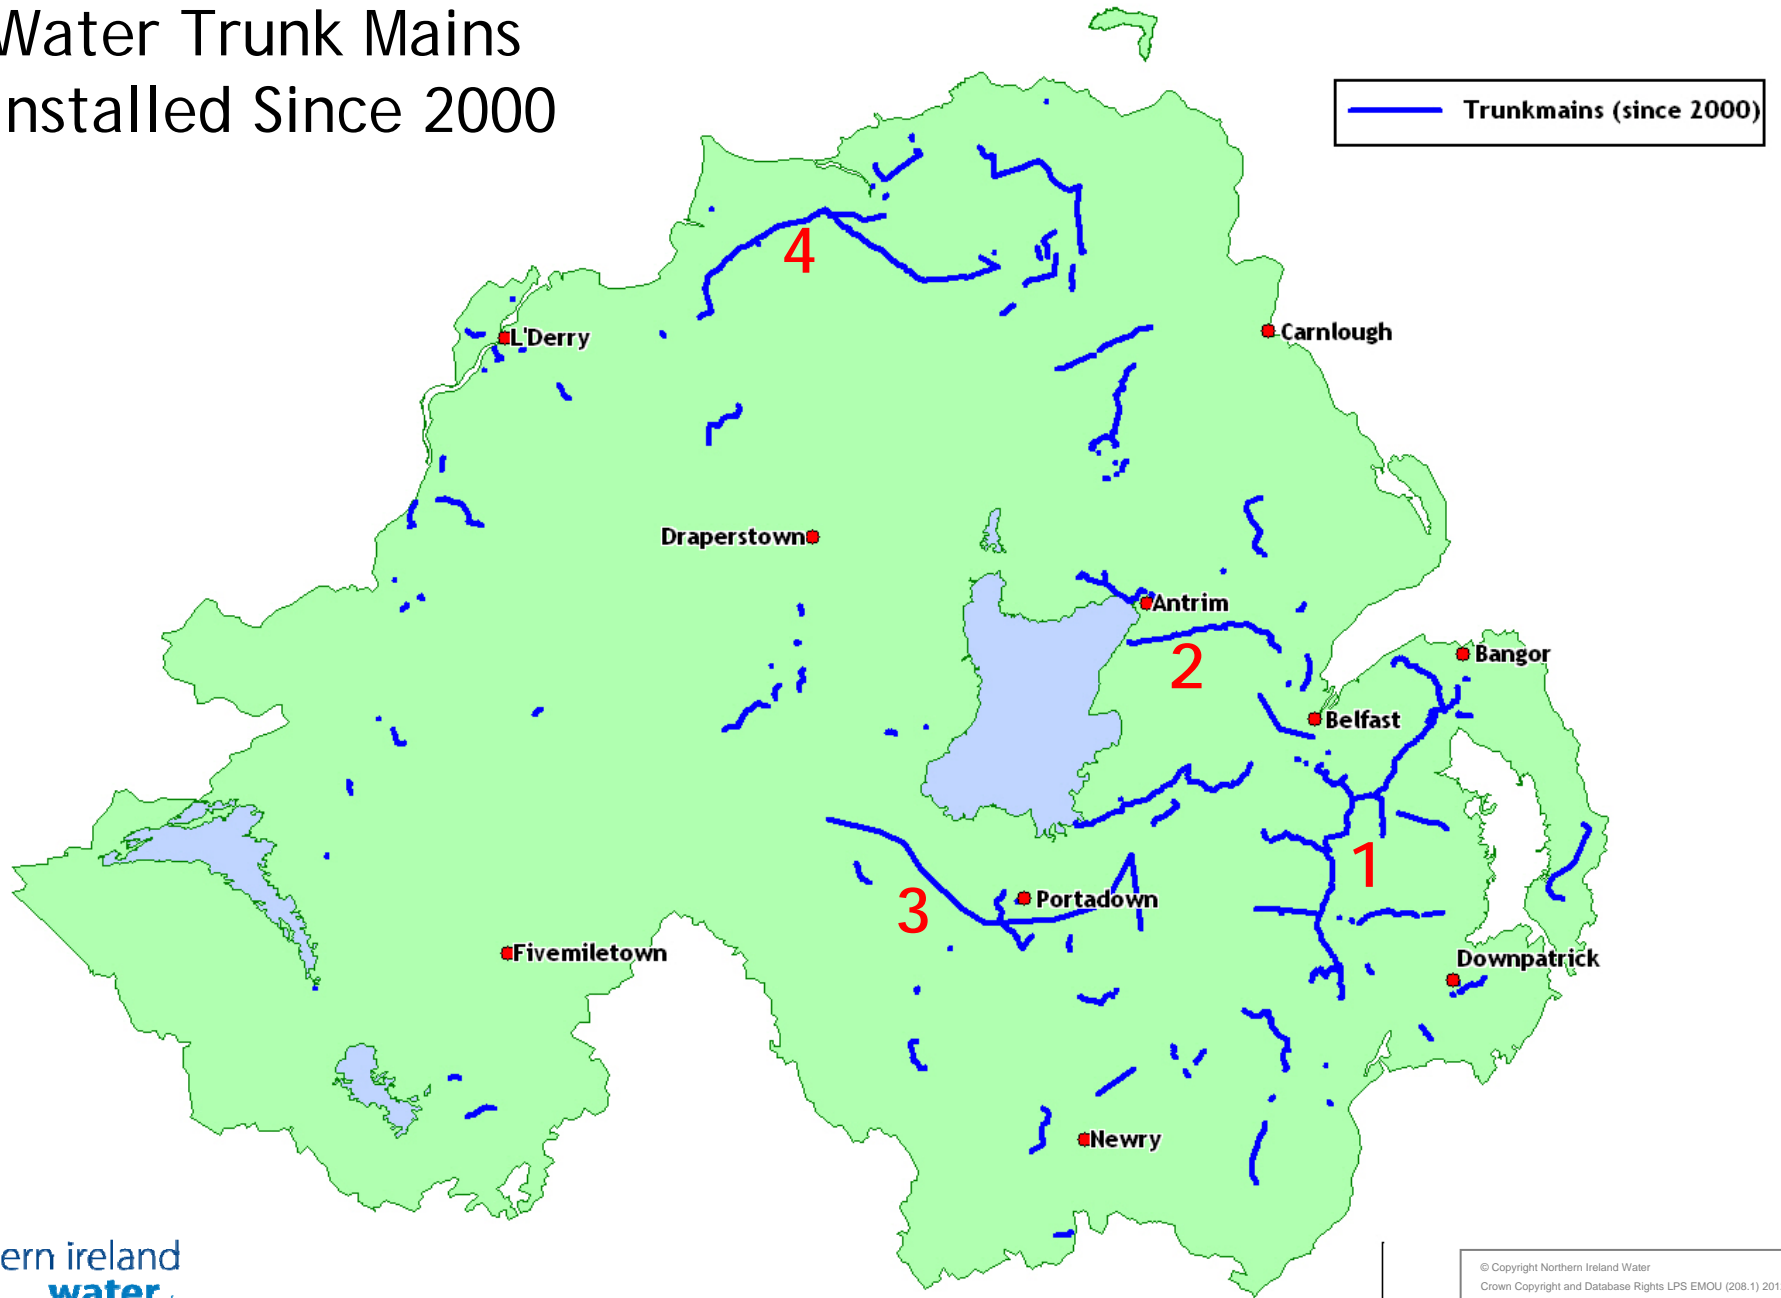
# Water Trunk Mains Installed Since 2000

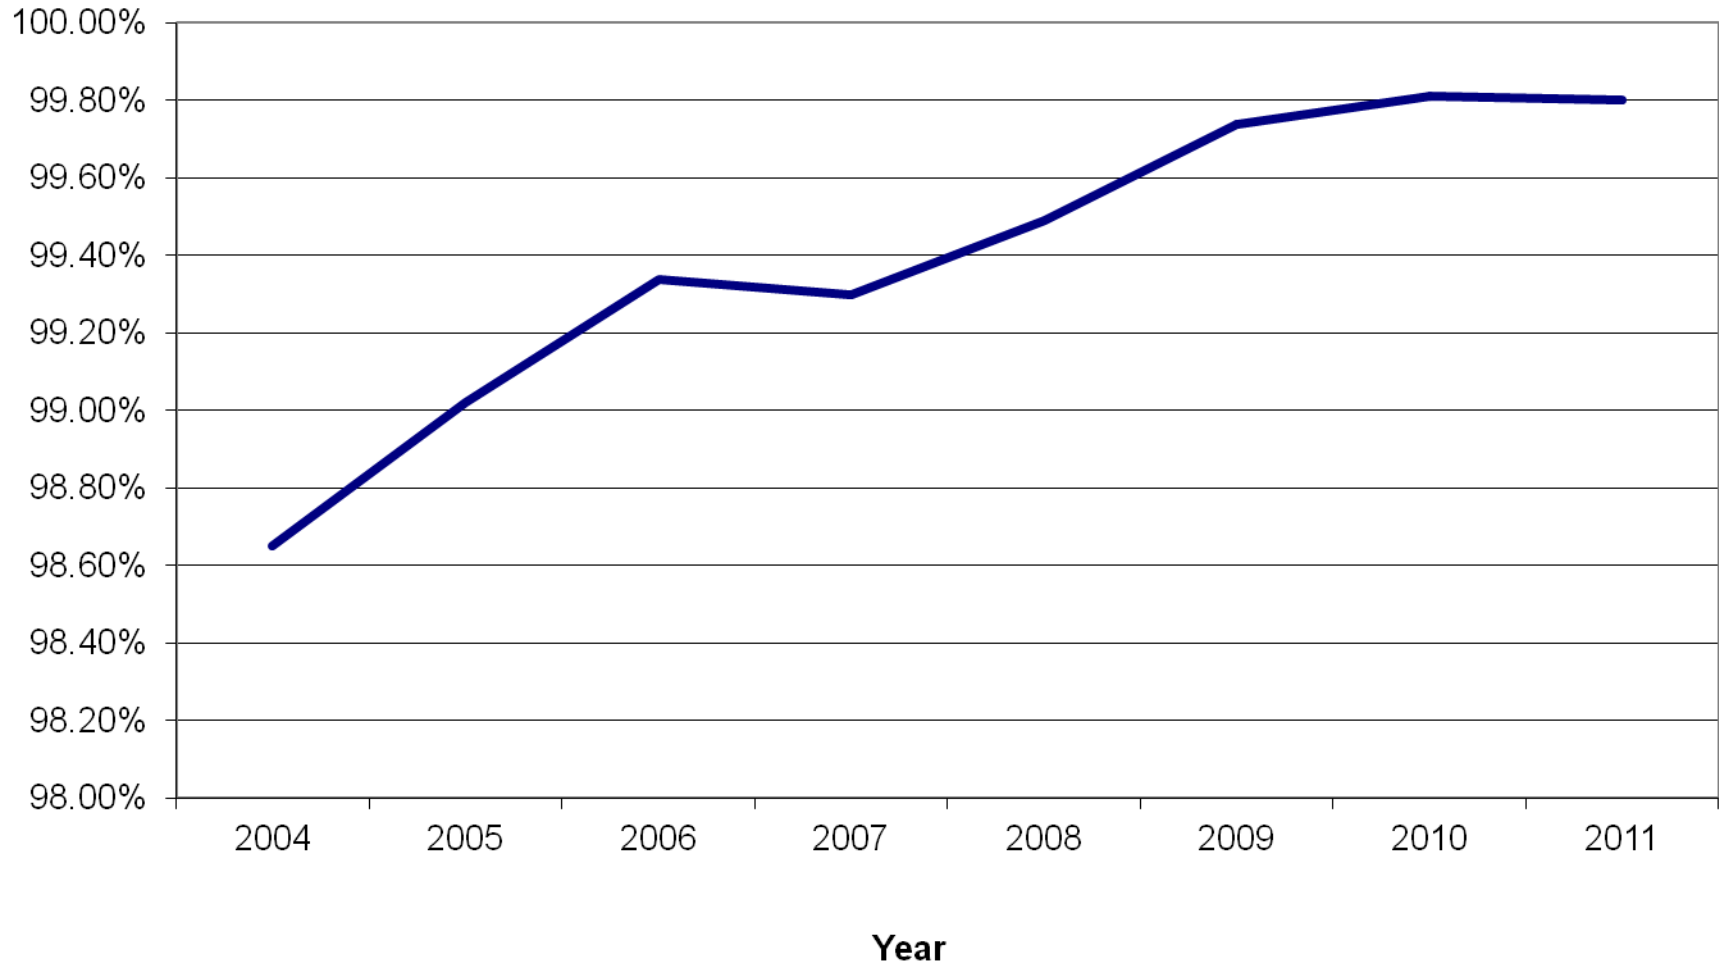
# Drinking Water Quality - Mean Zonal Compliance (MZC)

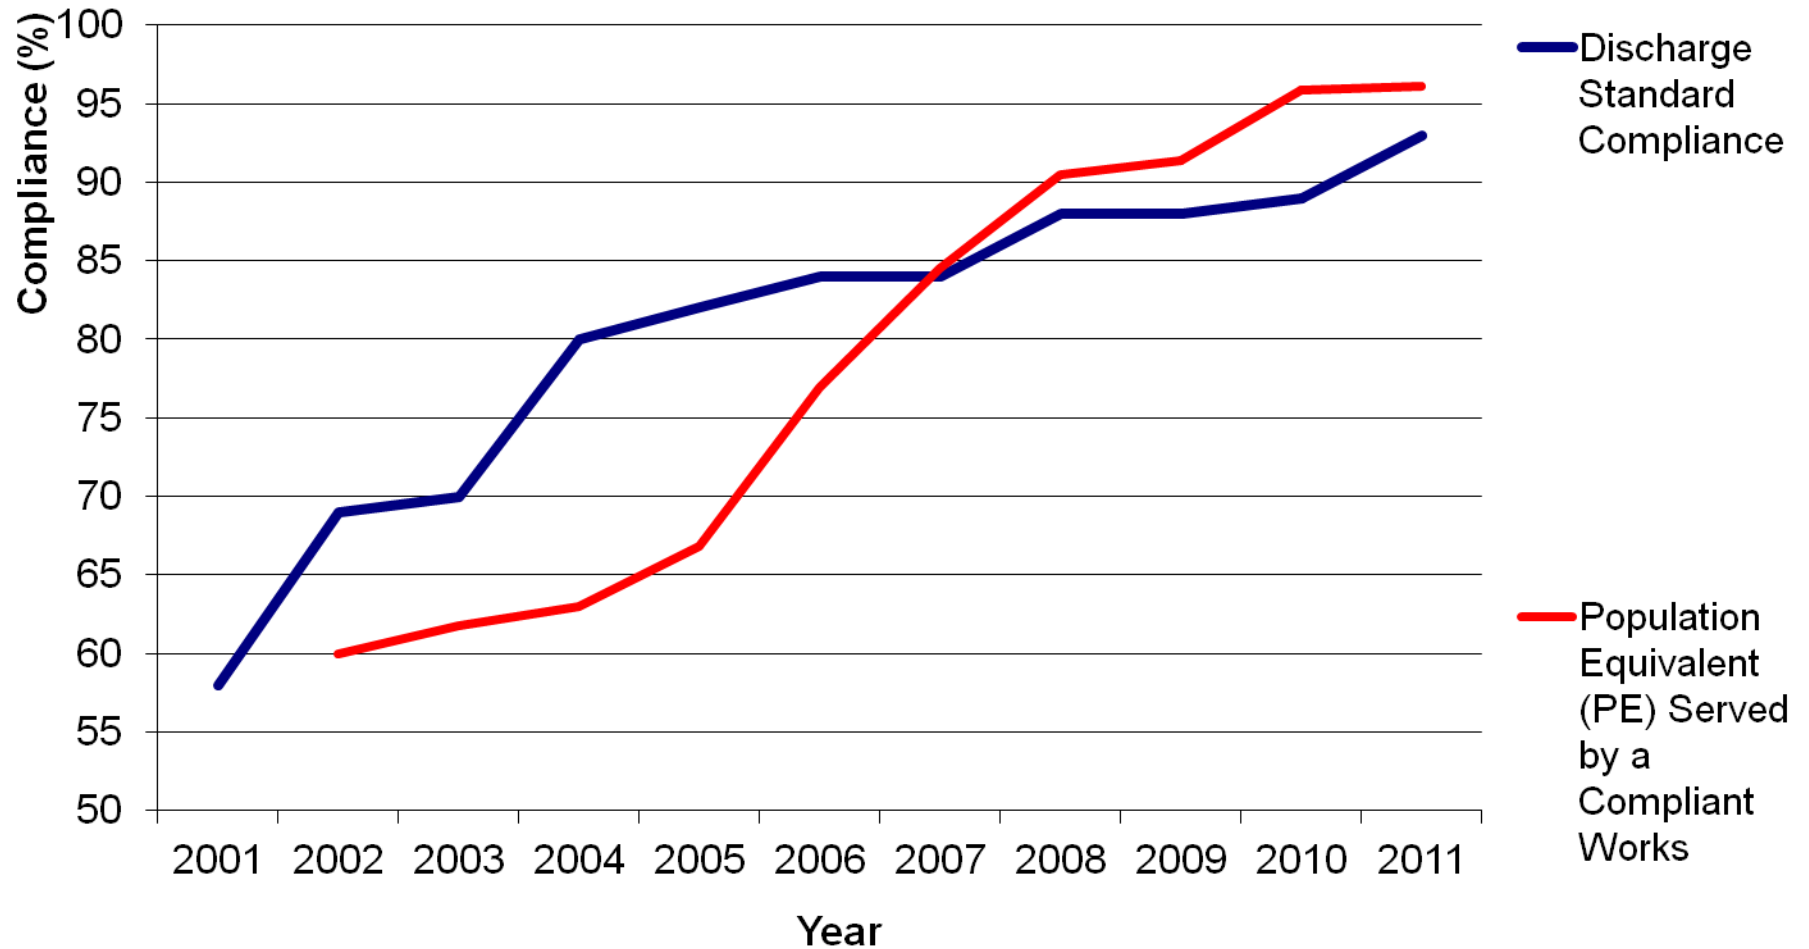
## Wastewater Treatment - Discharge Standard Compliance

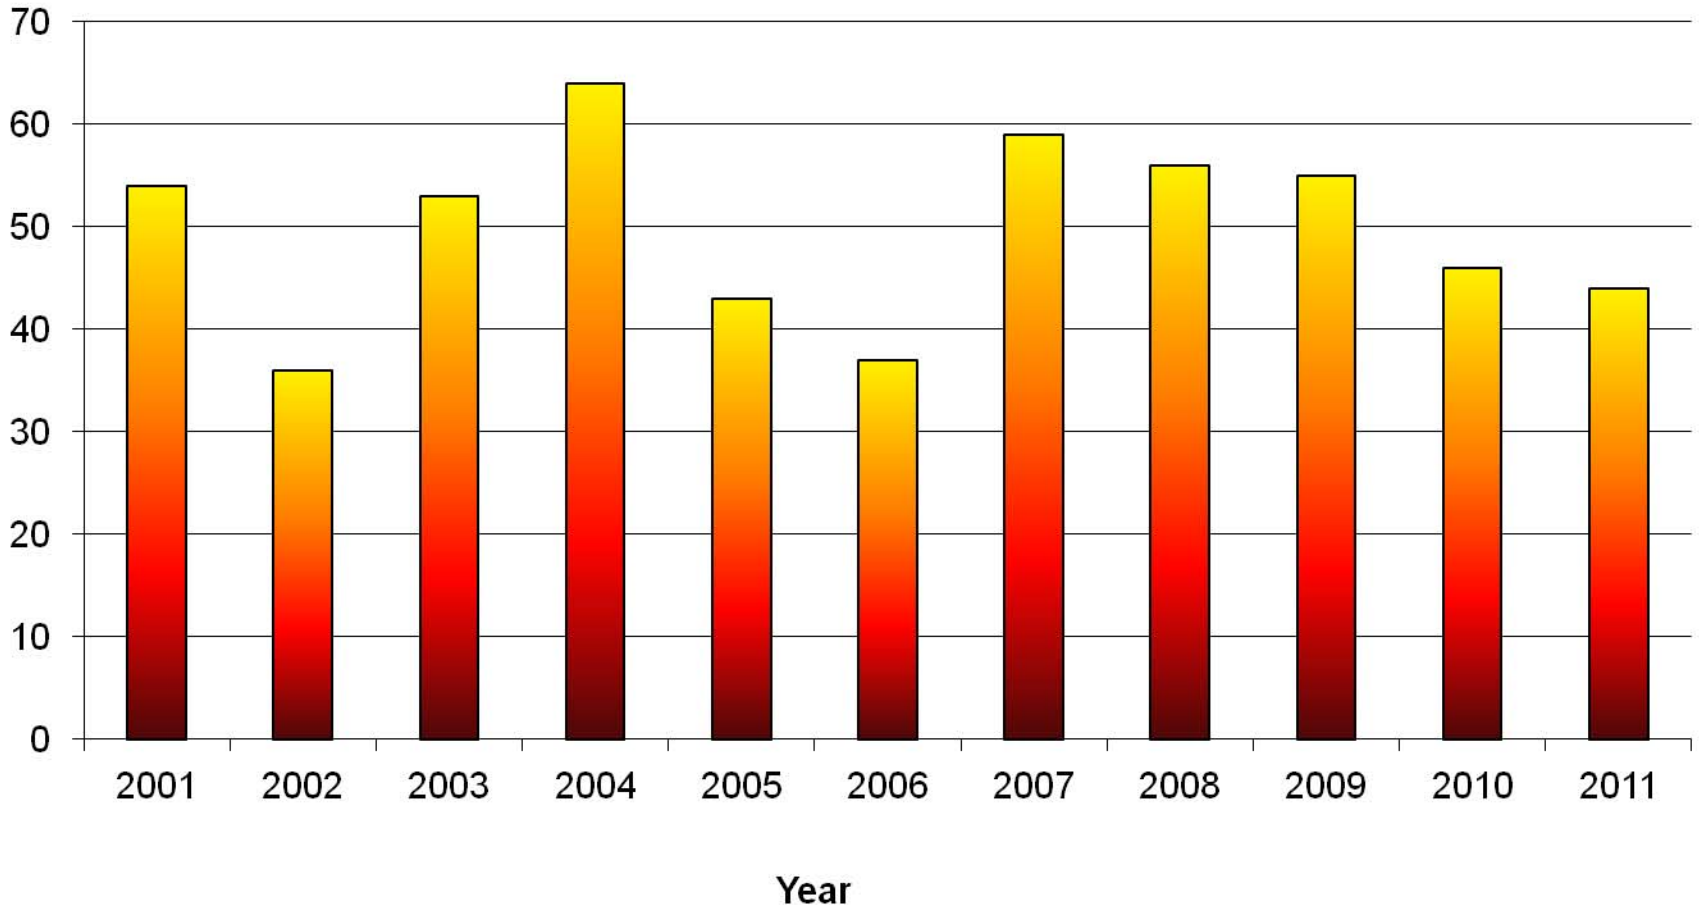
# High / Medium Pollution Incidents attributed to NIW

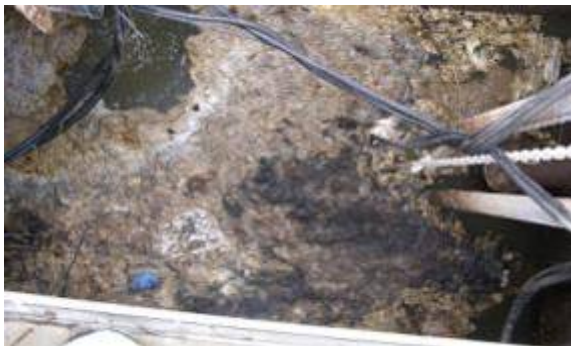
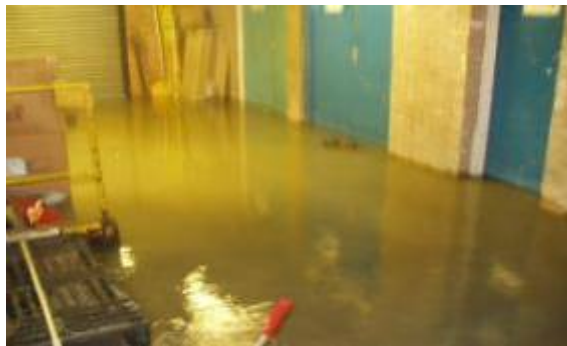
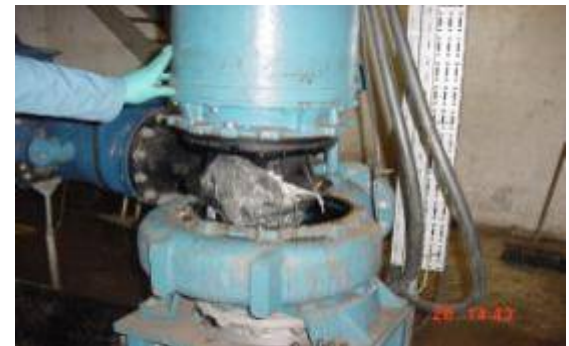
- Sewer flooding is caused by both hydraulic overload and other causes
- **Hydraulic overload** - due to heavy rain and insufficient capacity in sewer network. (10%)

- **Other cause flooding** - due to blockages (90%), pump failure and sewer collapses.

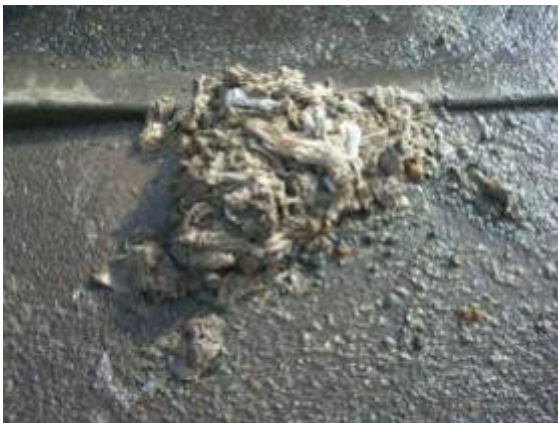
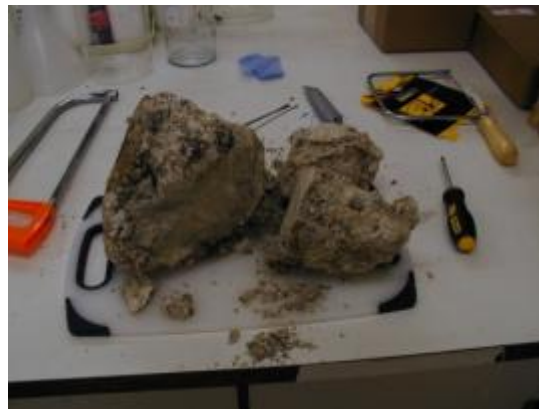
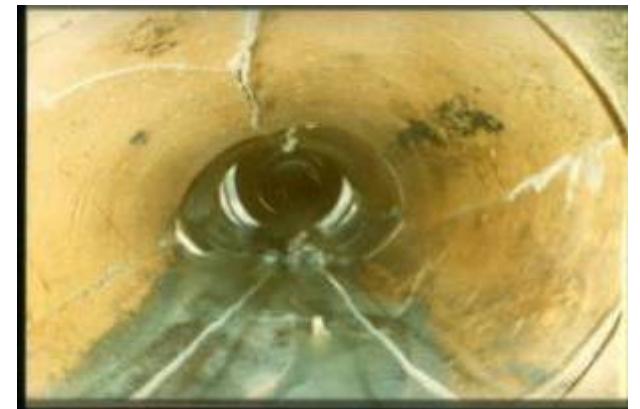
- Current NIW records suggests that:
  - 2/3 of blockages are caused by rags;
  - almost 1/3 by fats, oils and greases (FOG); and
  - only 2% by problem in a pipe.

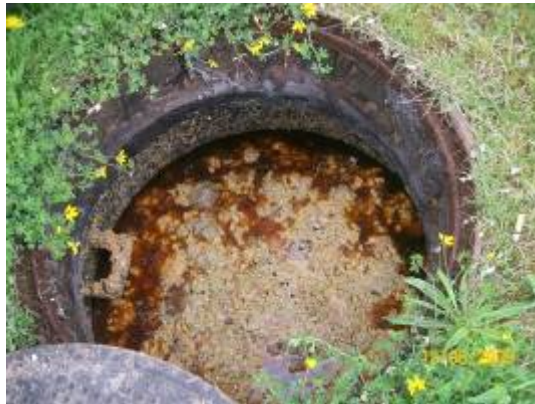
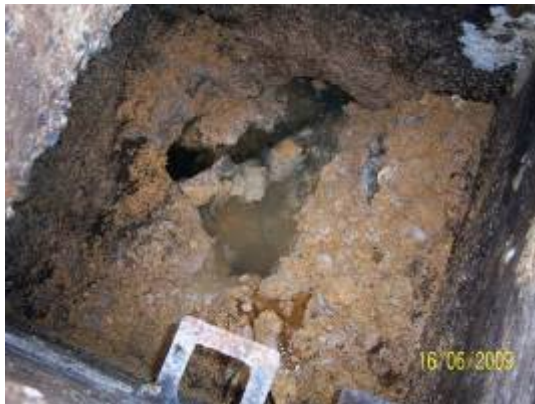
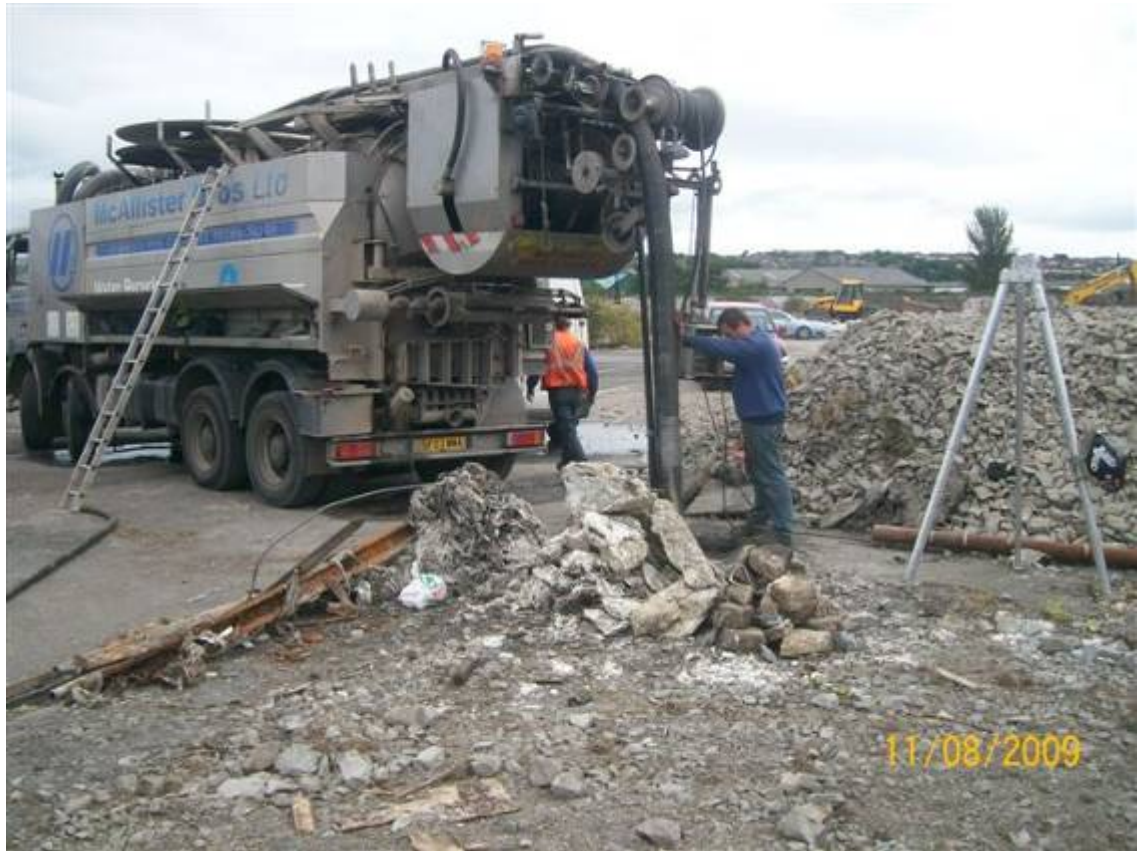
# Severe grease build up

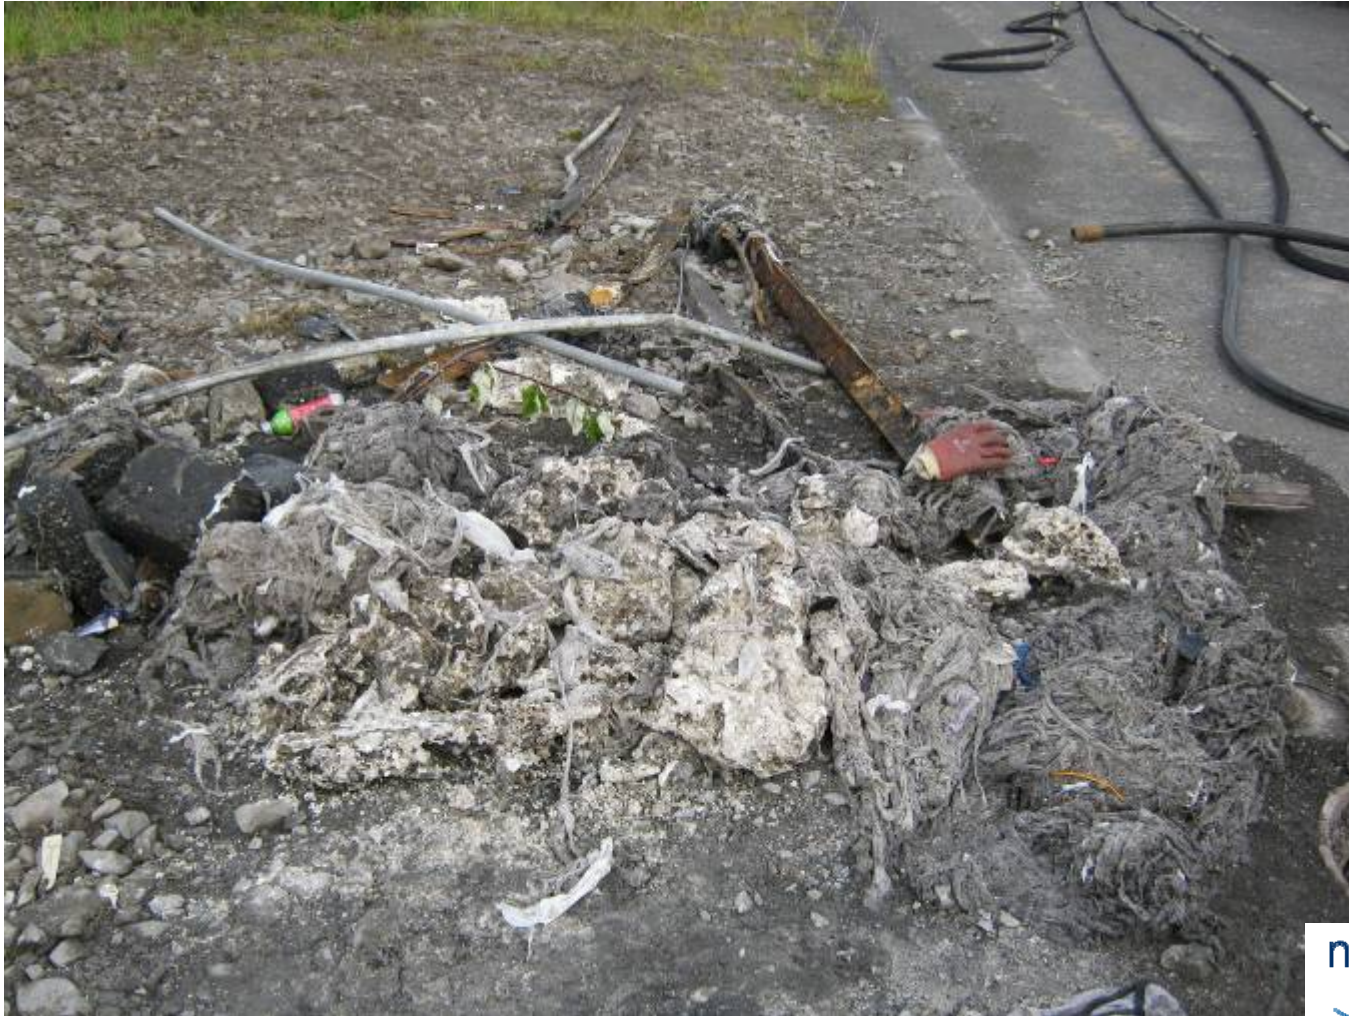
# Rags, grease and debris

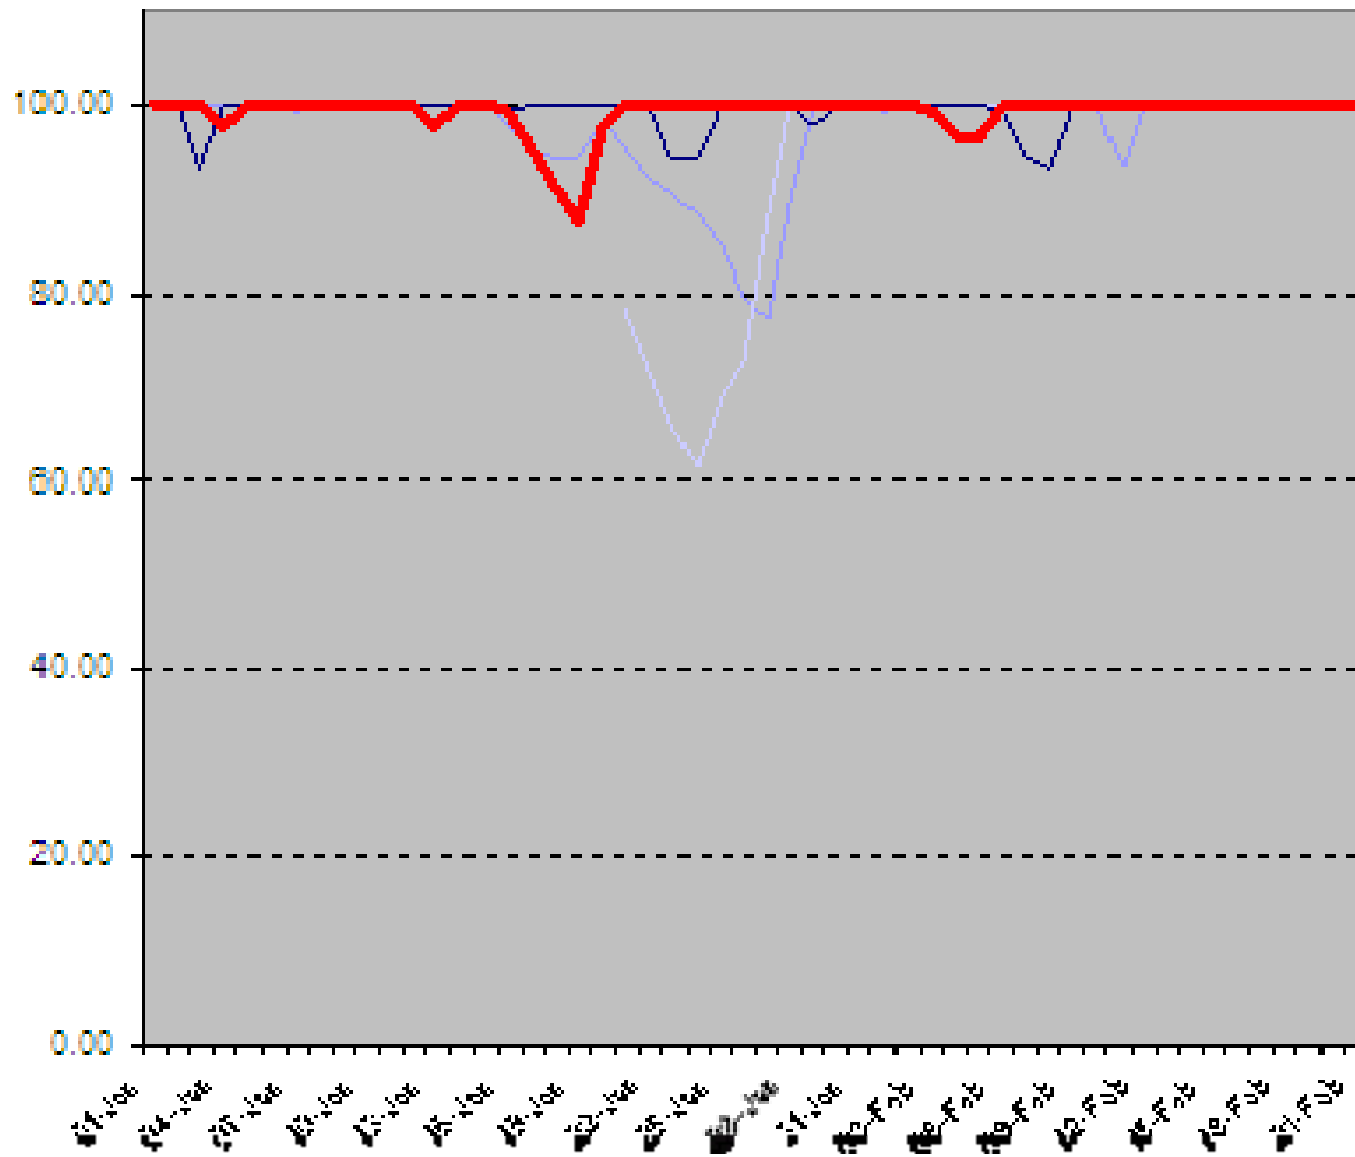
% Full

# 2011 Altnahinch Dam Level

- The compensation flow is set at 3.21 MI/d which is the minimum flow that will bypass the dam and re-enter the River Bush.
- At times when the dam is overflowing then the excess water plus the 3.21 MI/d will be returned to the river.
