Aghaveagh Stream Water Quality Improvement Project

Upper Neagh Bann CSG Meeting
14th November 2013
Cohannon Inn

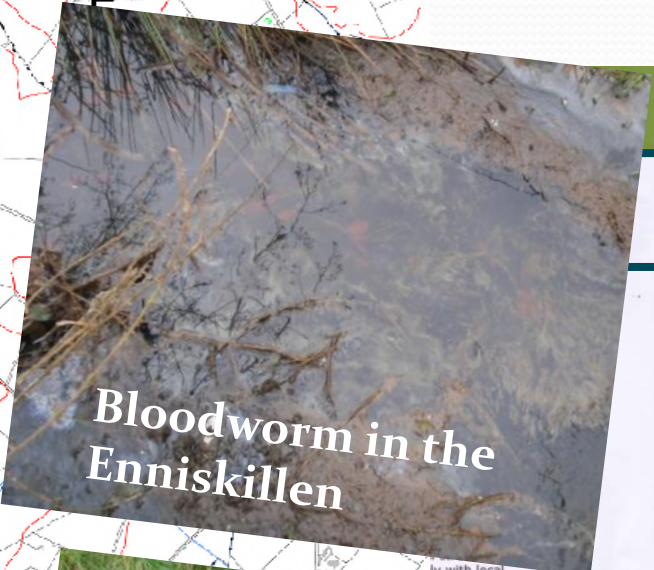
Bloodworm in the Enniskillen

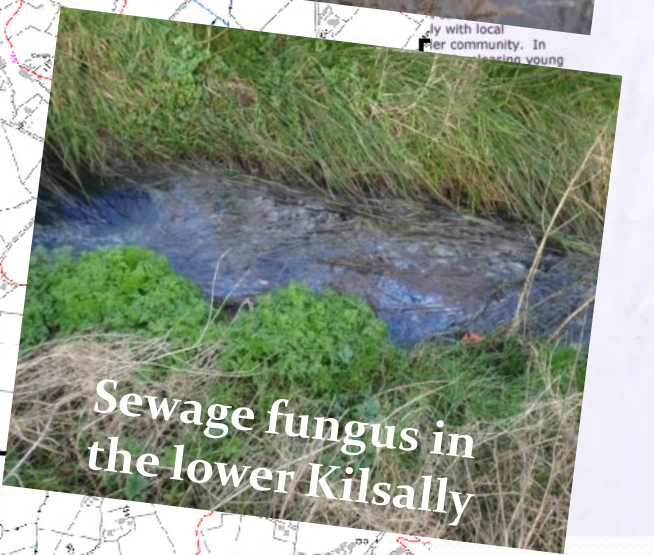
Sewage fungus in the lower Kilsally

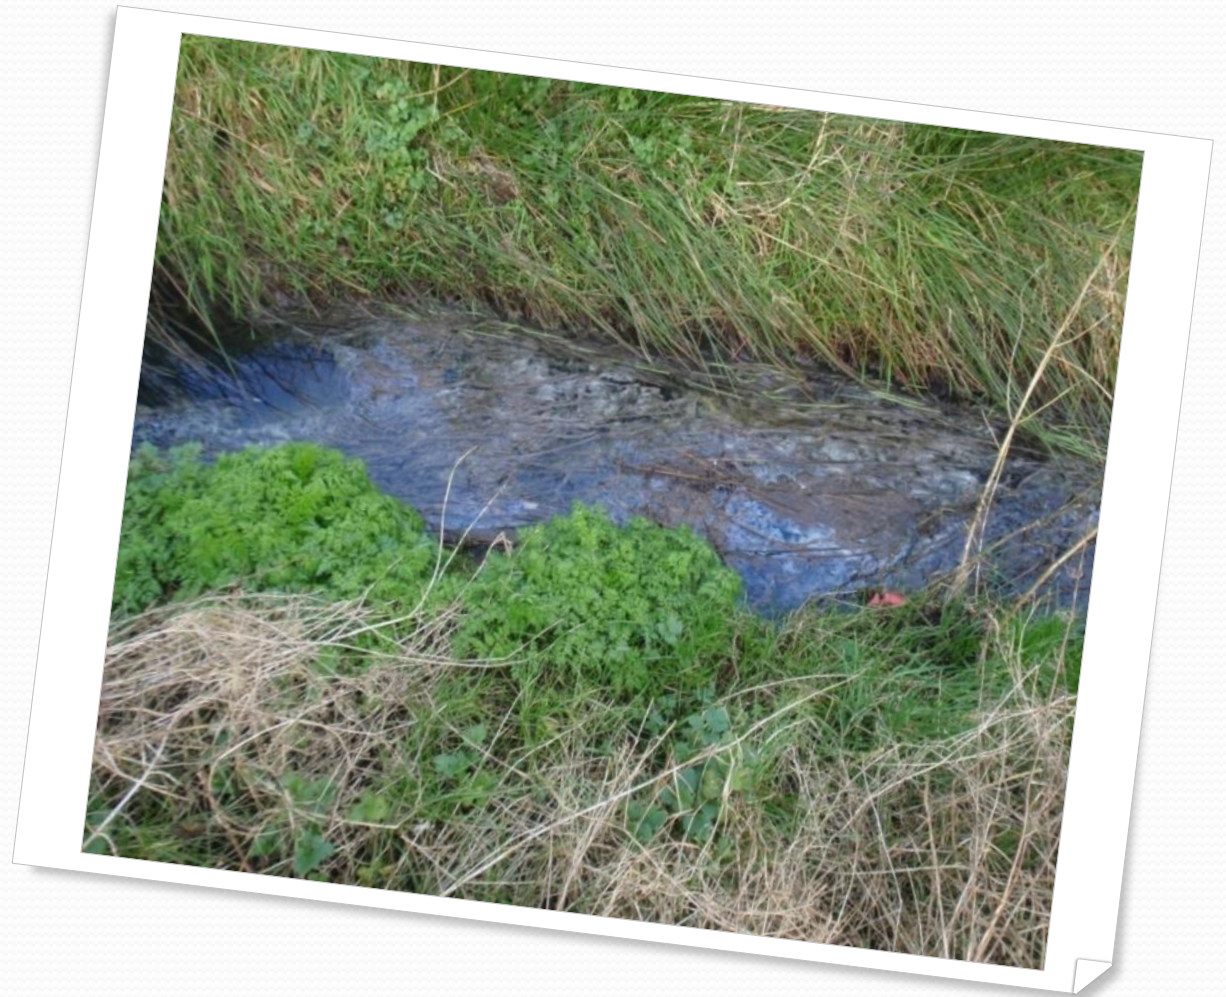
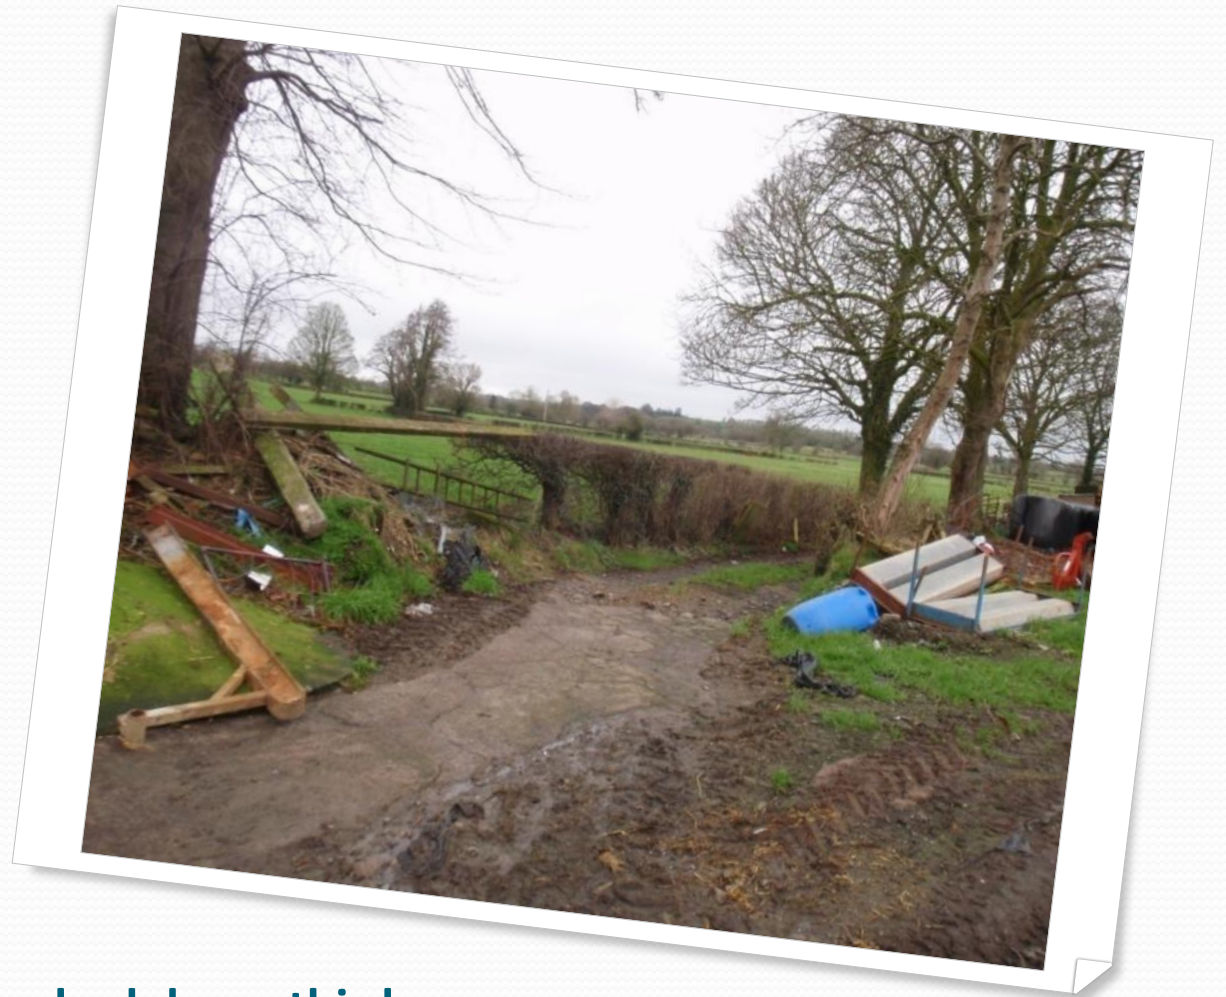
**Pollution at Kilsally
before septic tanks
were cleaned out**

General yard run-off is washed down this lane towards the adjacent stream

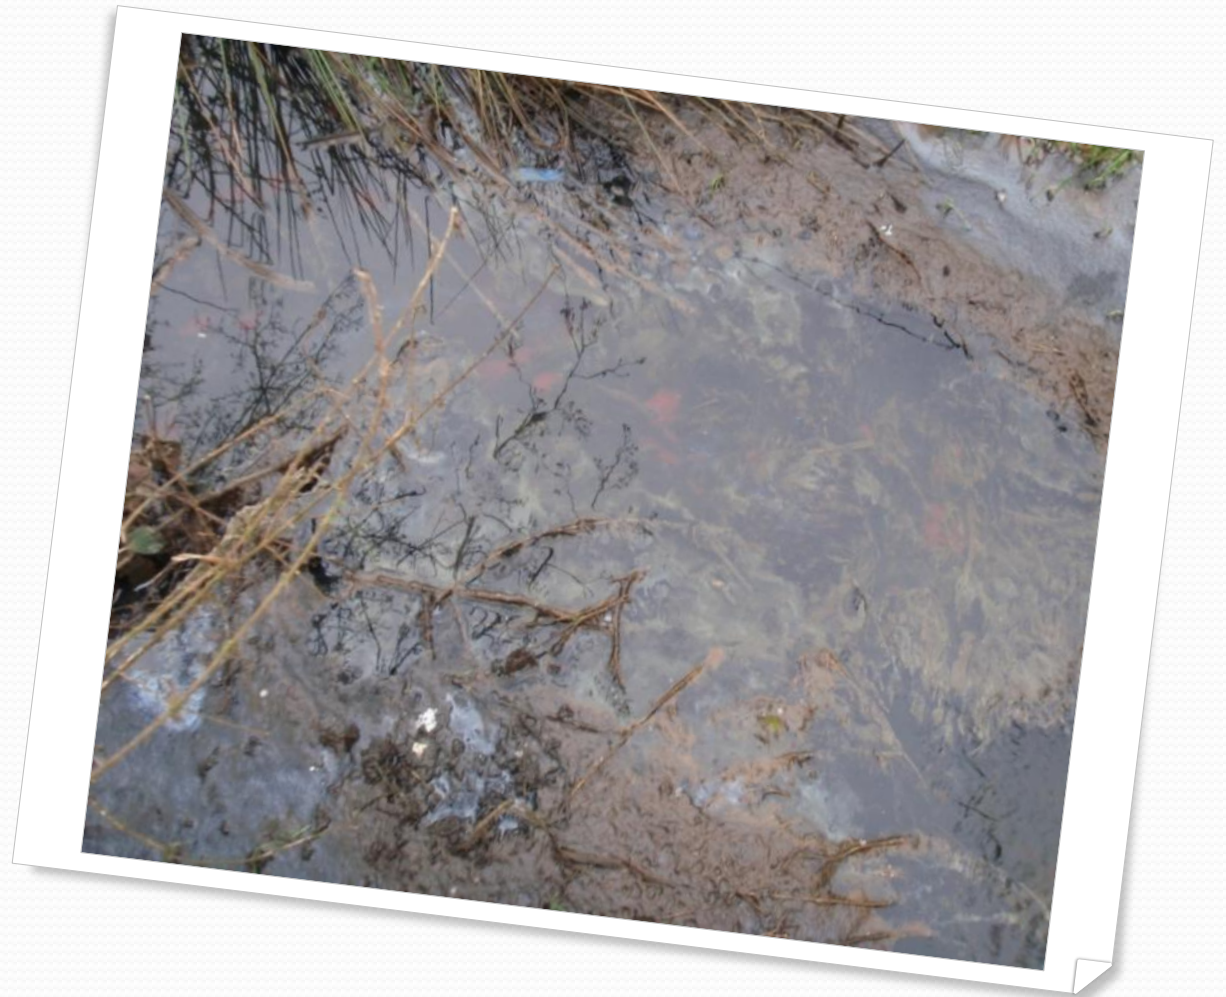
**Plumes of
bloodworm in the
Enniskillen sub-
catchment**

Another overflowing dirty water tank in the Enniskillen sub-catchment

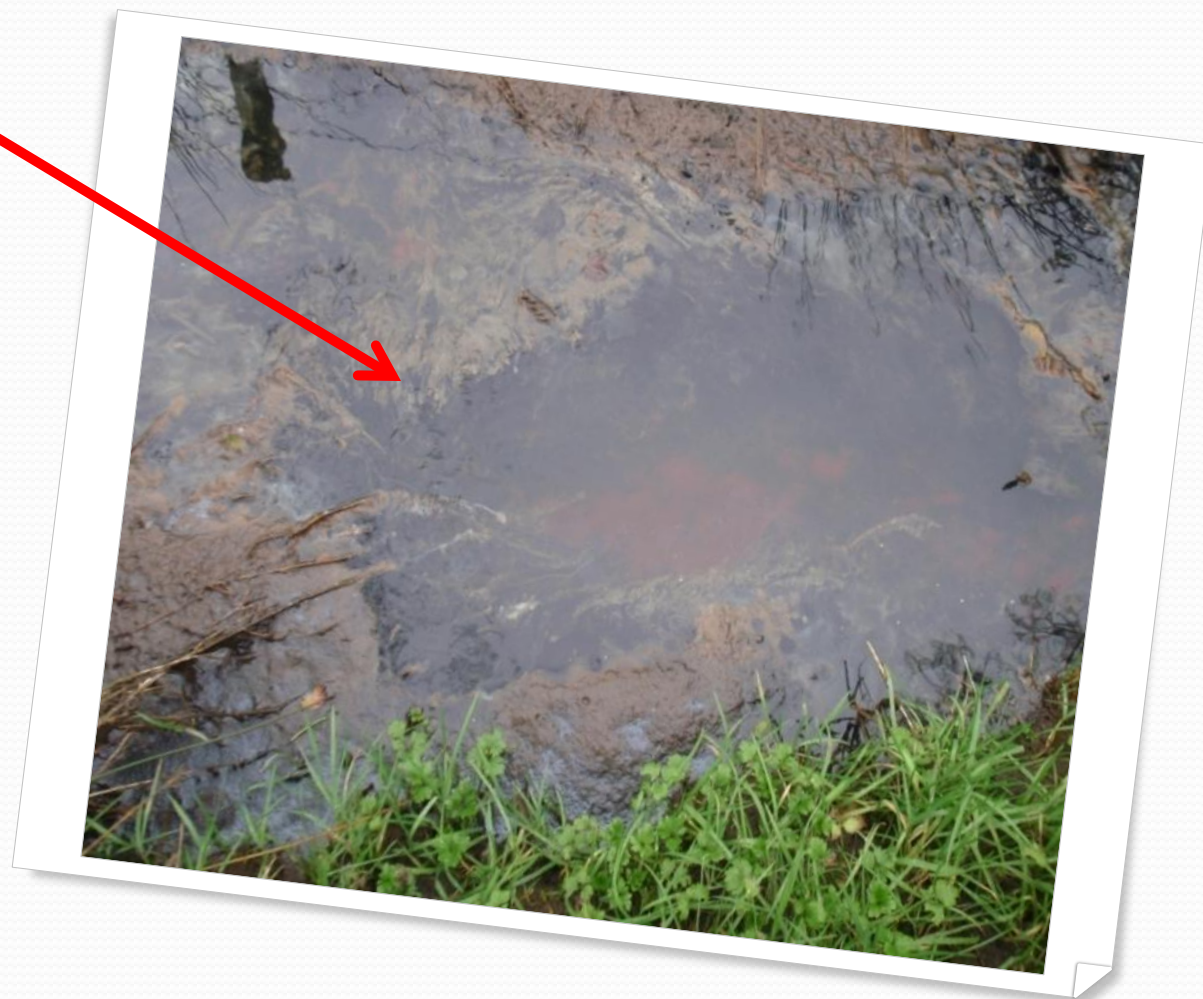
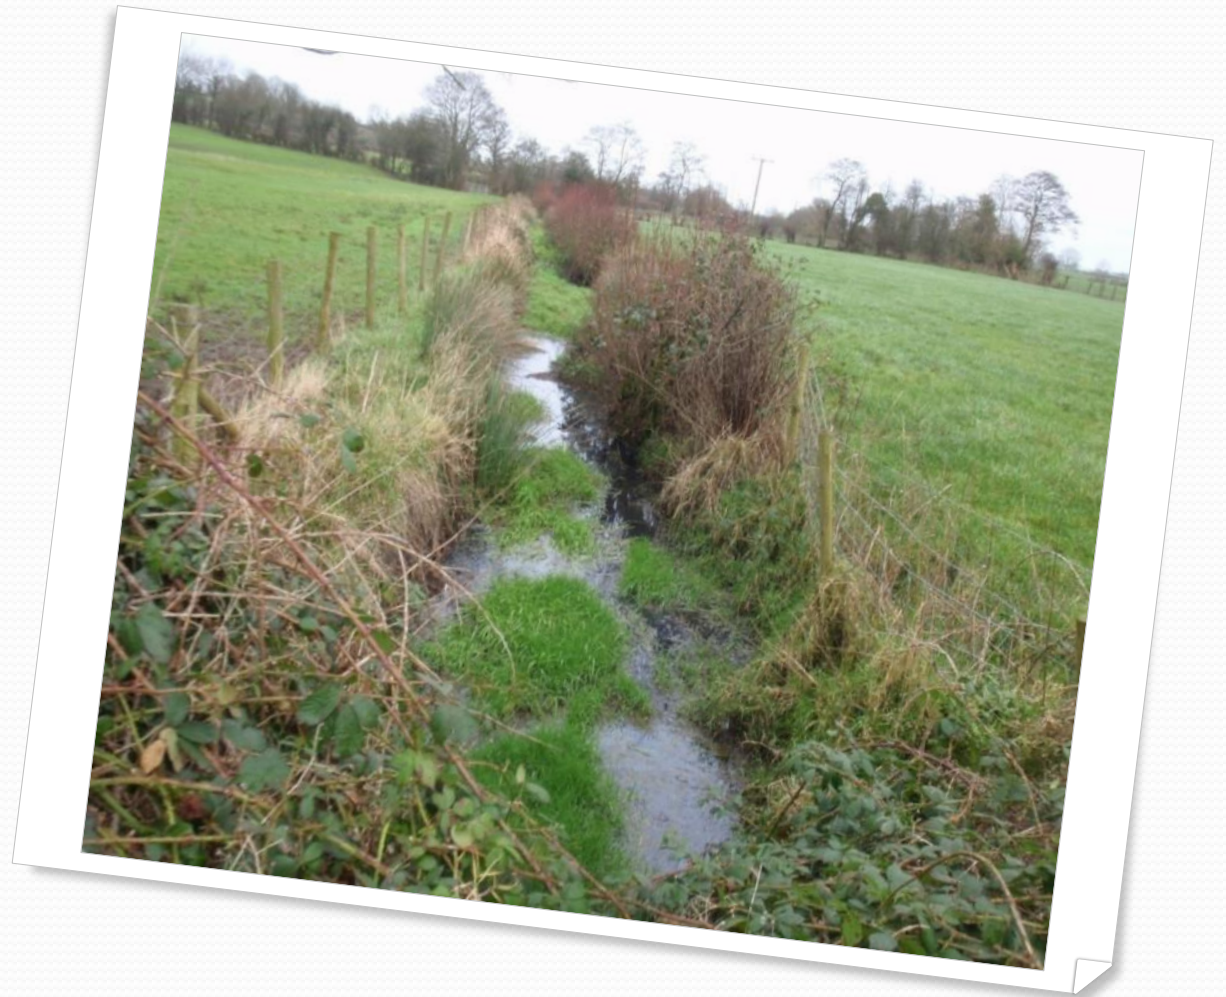
**The result of
pollution in the
Enniskillen sub-
catchment.**

Flocks of teal duck where found feeding on the hoglice, leeches and snails along the Enniskillen drain.

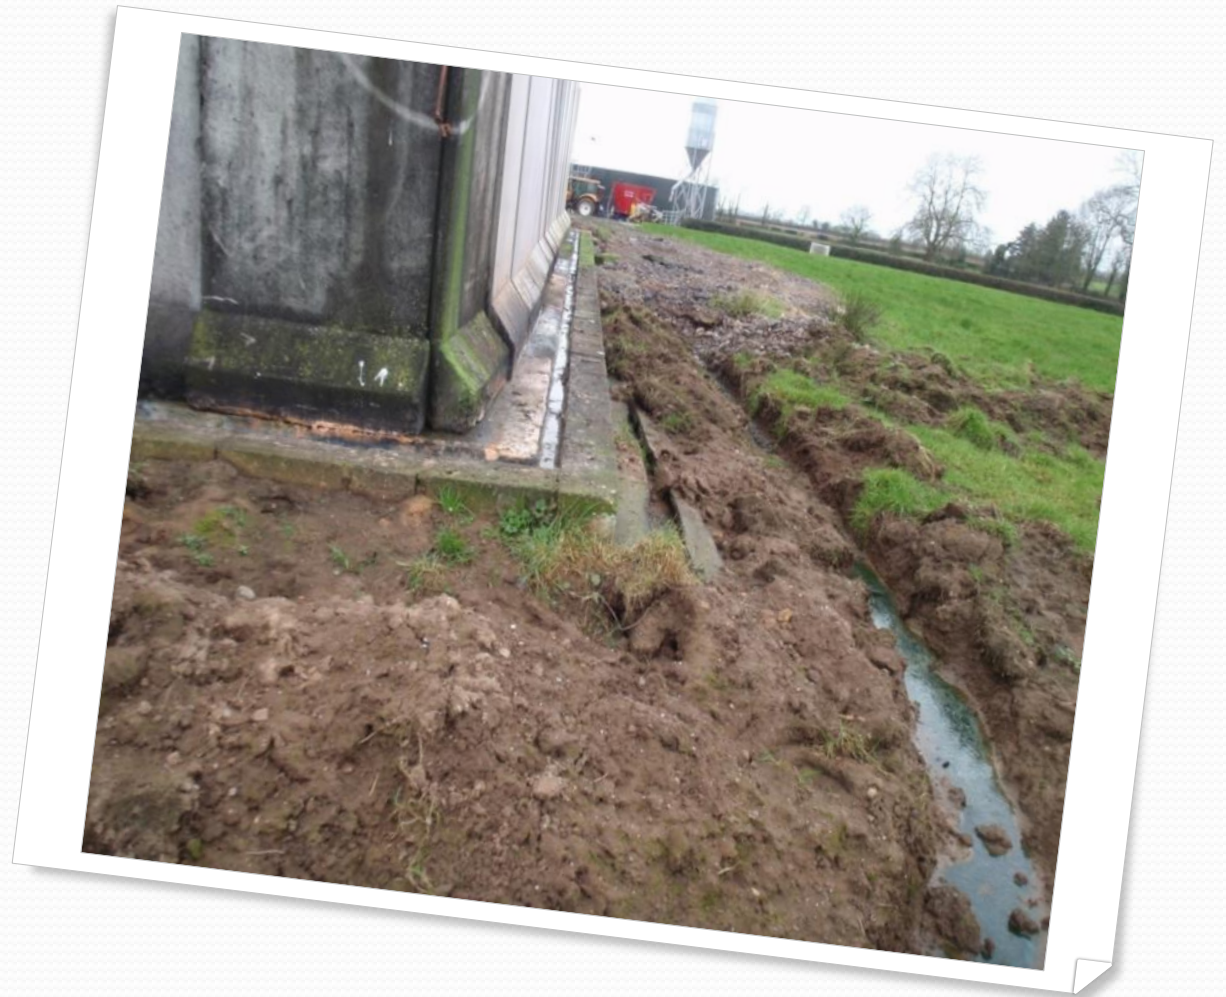
**Silage effluent leaking from a silo.
This problem was resolved quickly.**

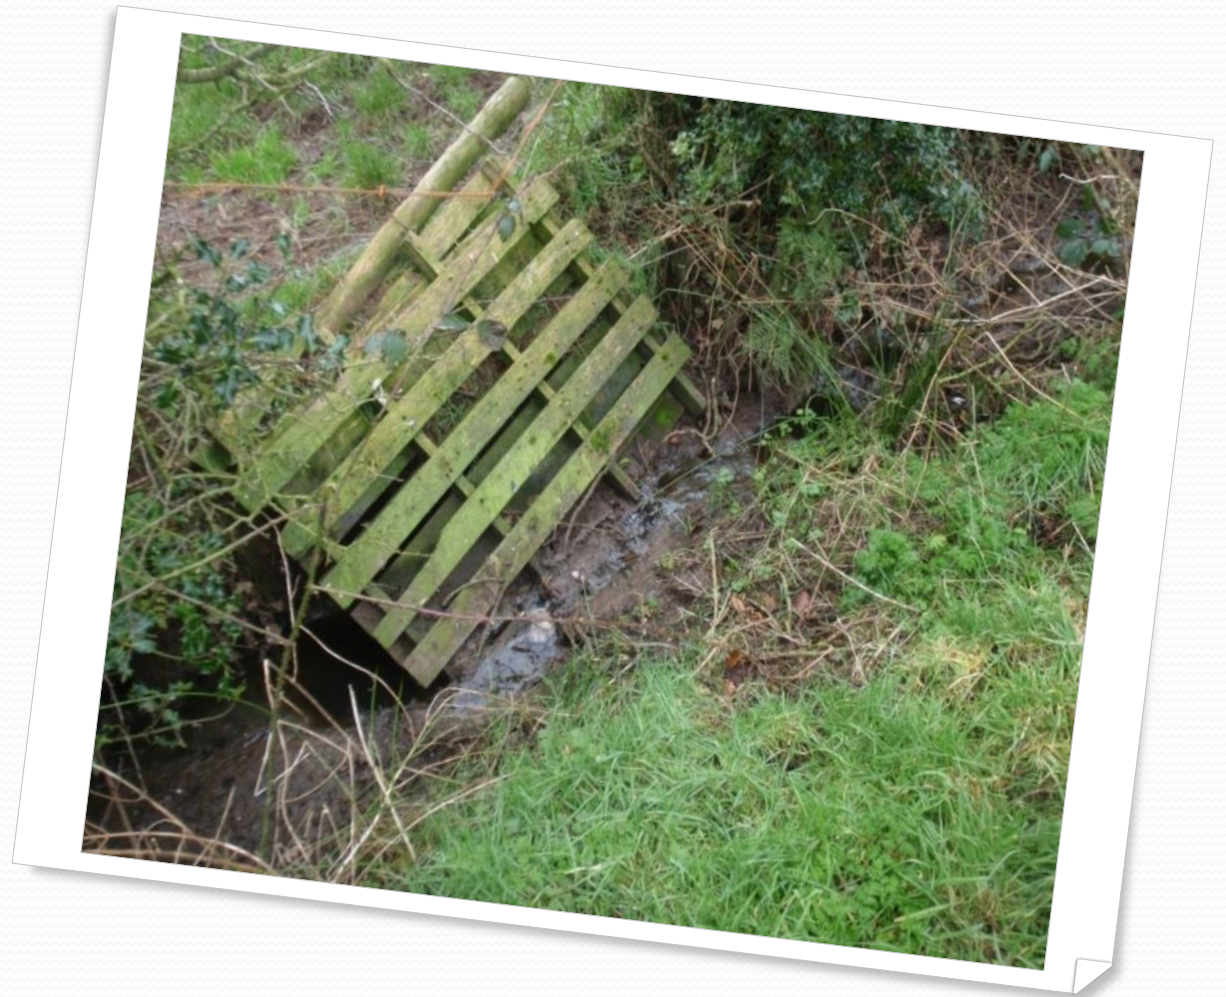
Sheugh carrying silage effluent, slurry and the discharge from a septic tank to the Ballymaguire stream.

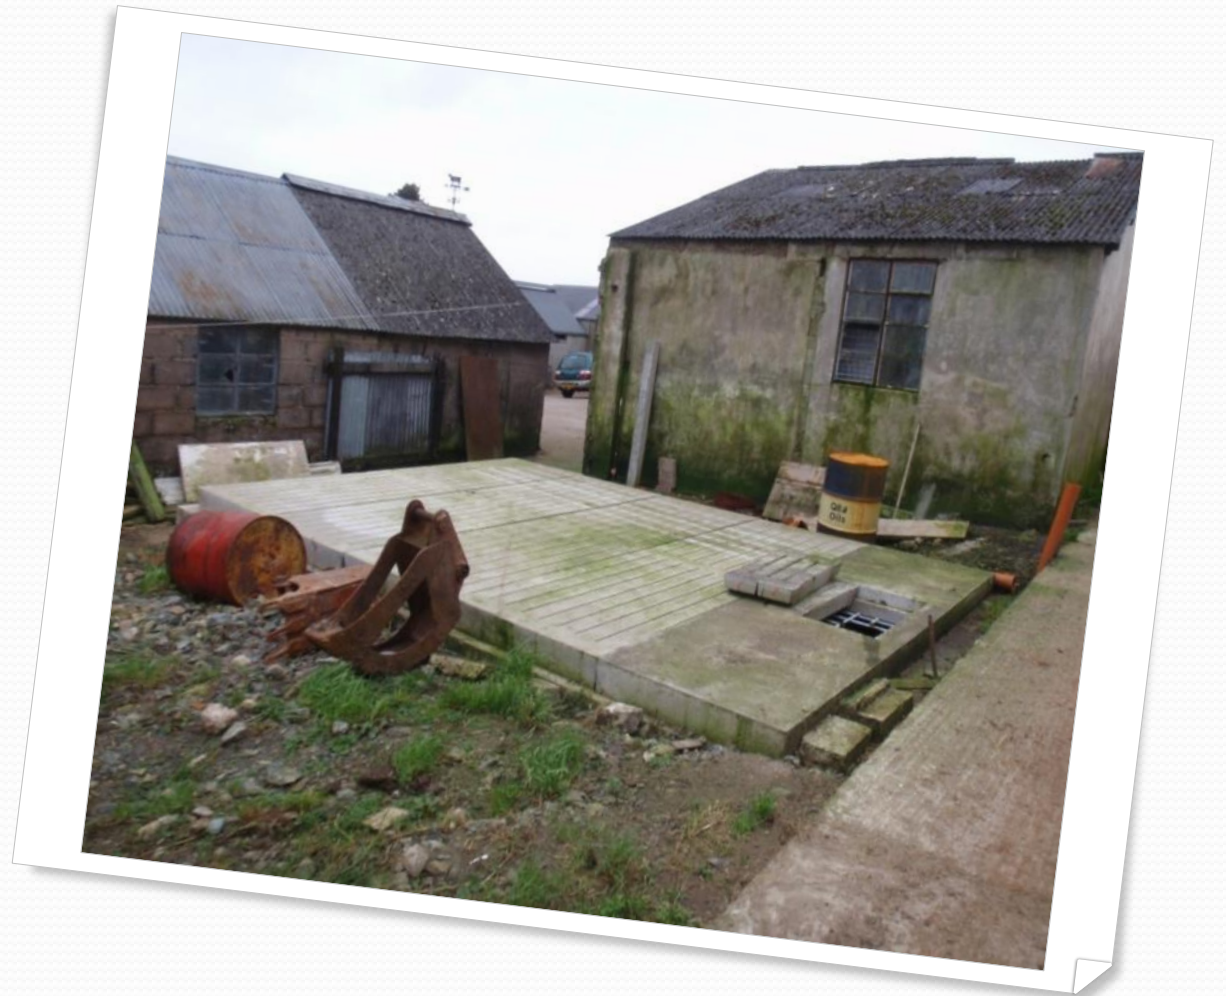
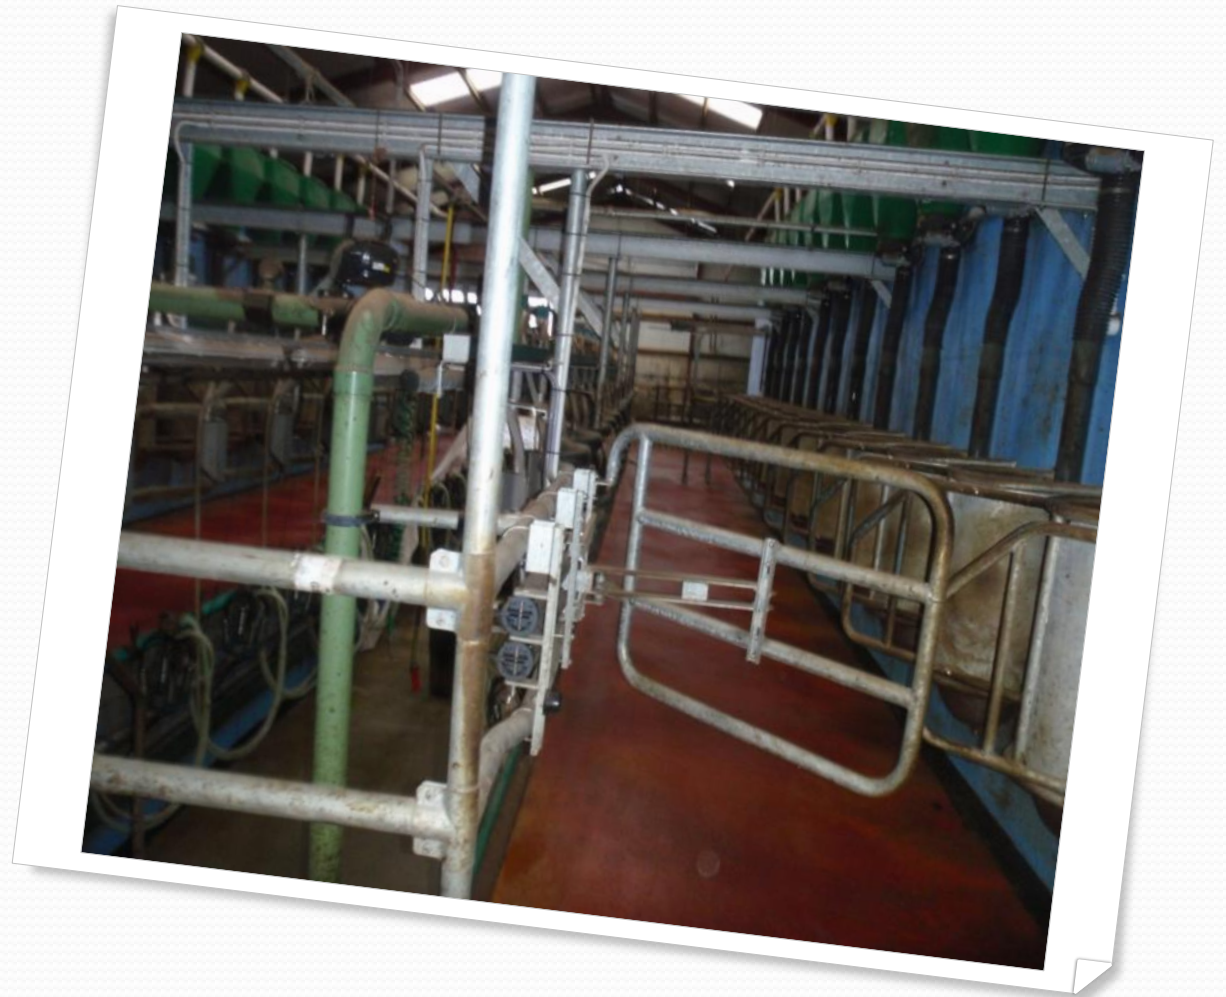
A new dirty water tank which holds milk washings and yard run-off.

An underground slurry store beyond the new milking parlour, ensures there is no escapement of milk or slurry.

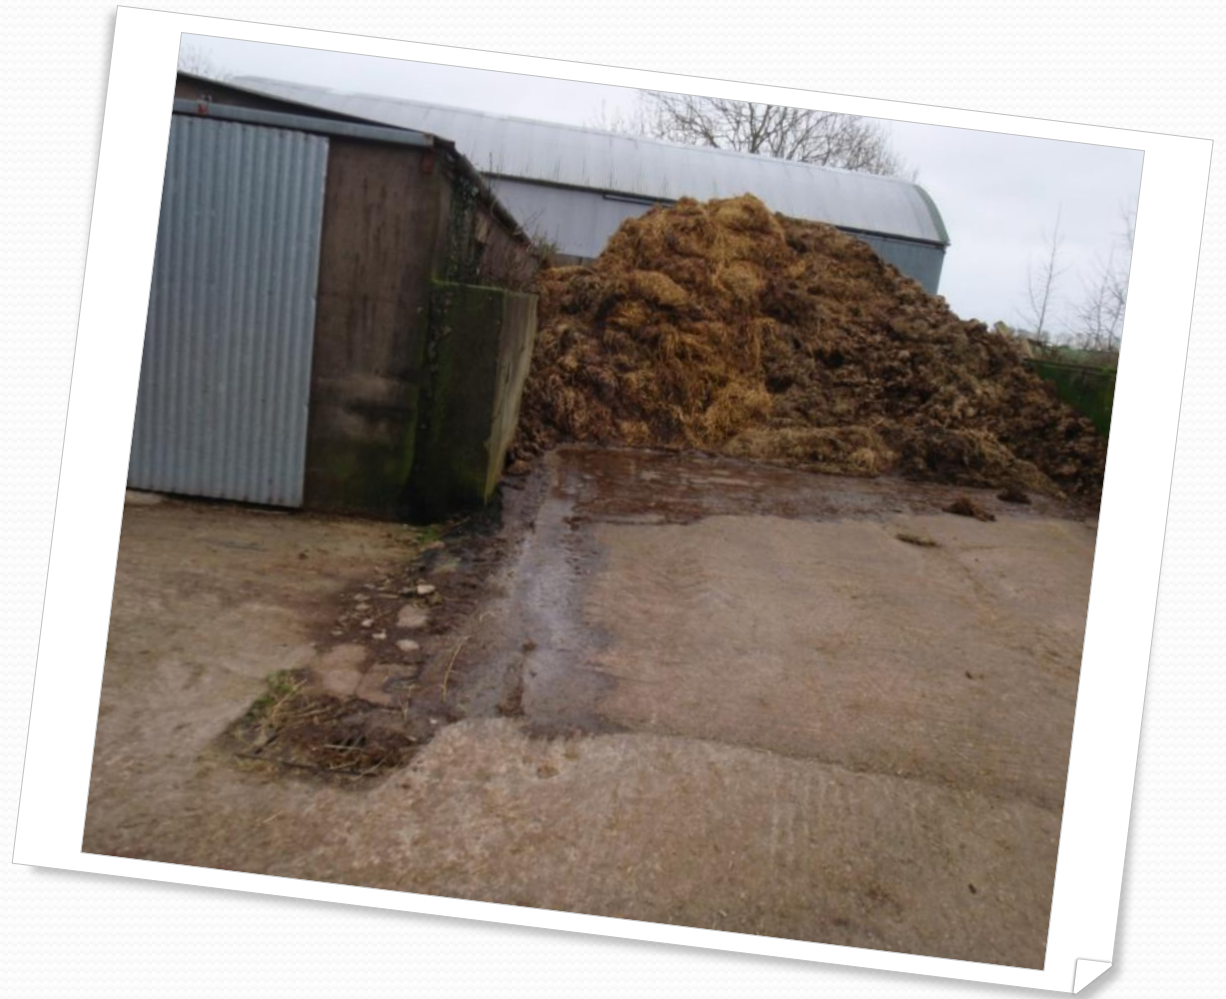
Grating collects any run-off from an open midden and carries it to an underground slurry store.

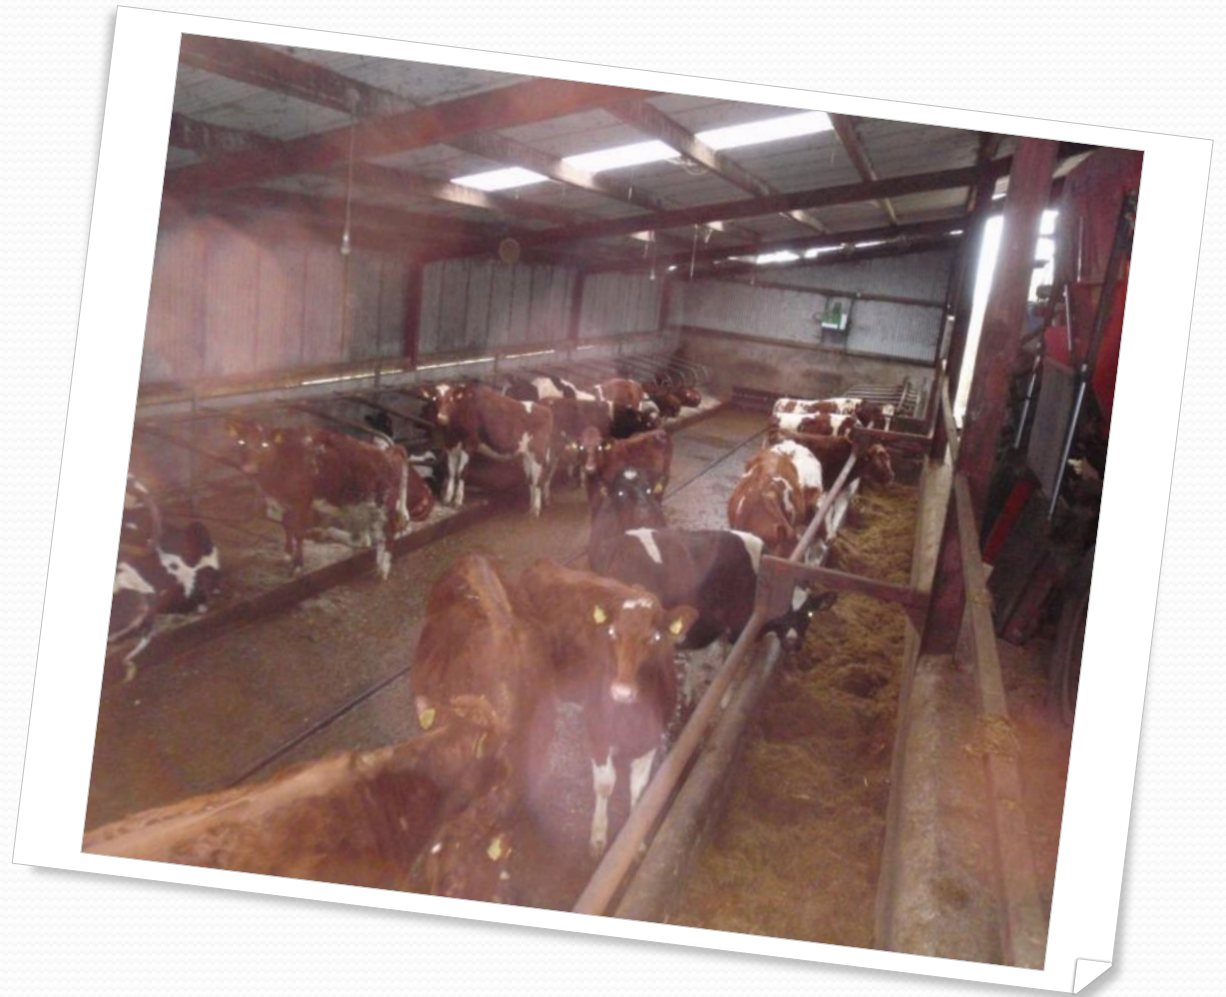
**Automatic scraper
removes manure,
several times a day.**

The manure is pumped to a new above-ground concrete slurry store.

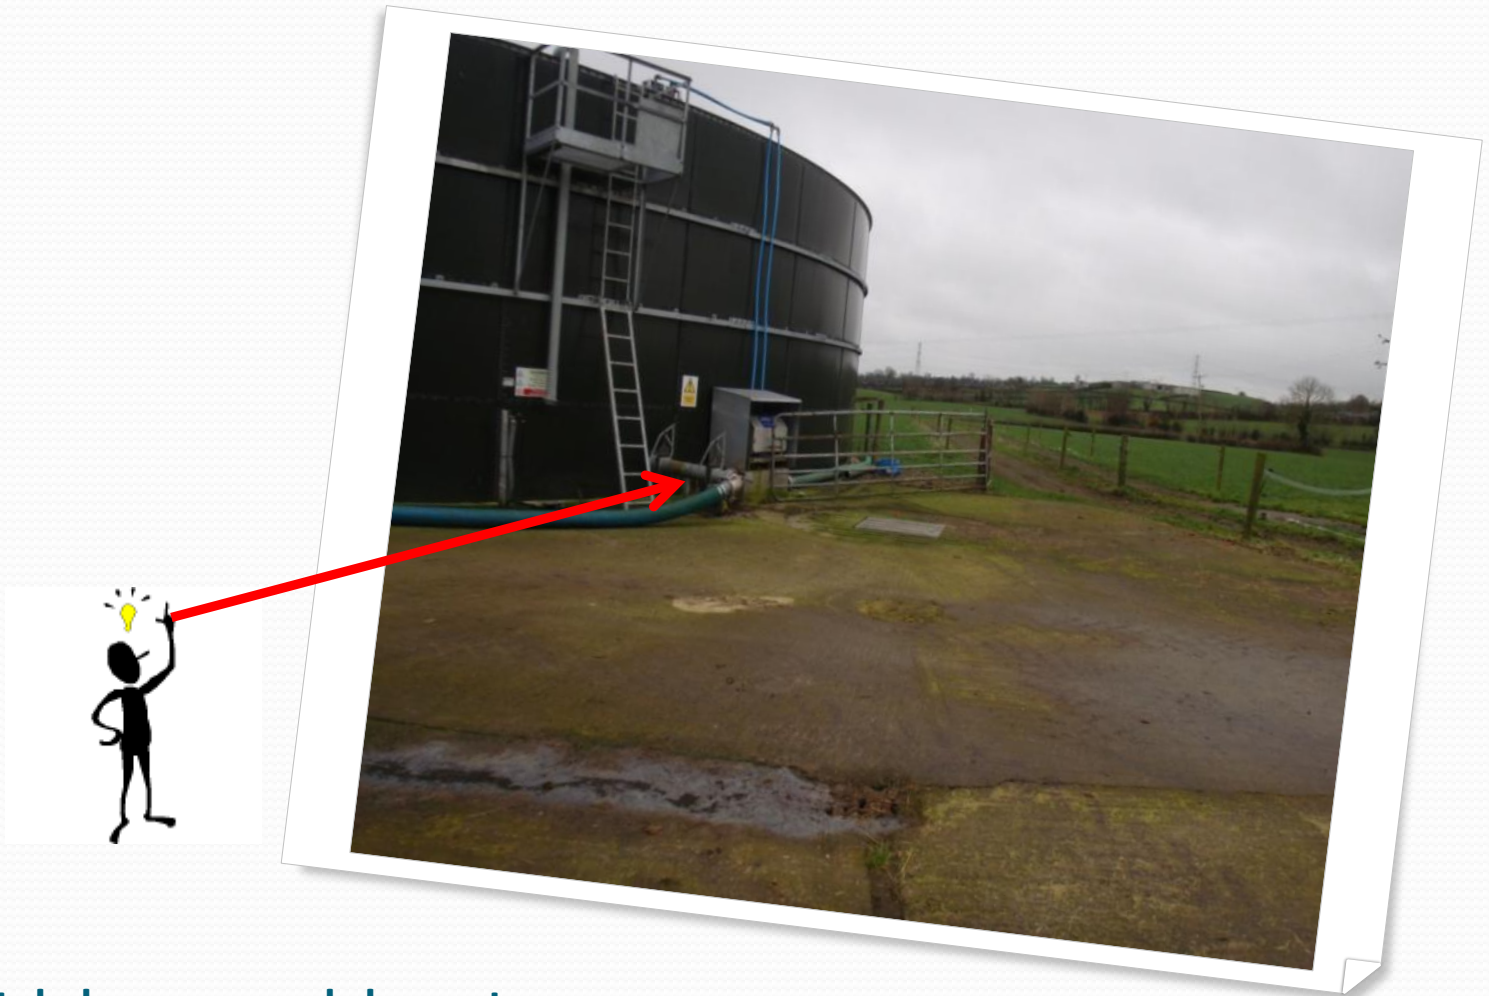
Enamelled metal above-ground slurry stores, are more prone to corrosion than concrete stores. The levers of both valves on this 5 year old store are showing signs of wear already.
