An Archival Assessment of World War I Wrecks in Northern Irish Waters

Department of Environment
Northern Ireland

CA Project: 770001

CA Report: 15191

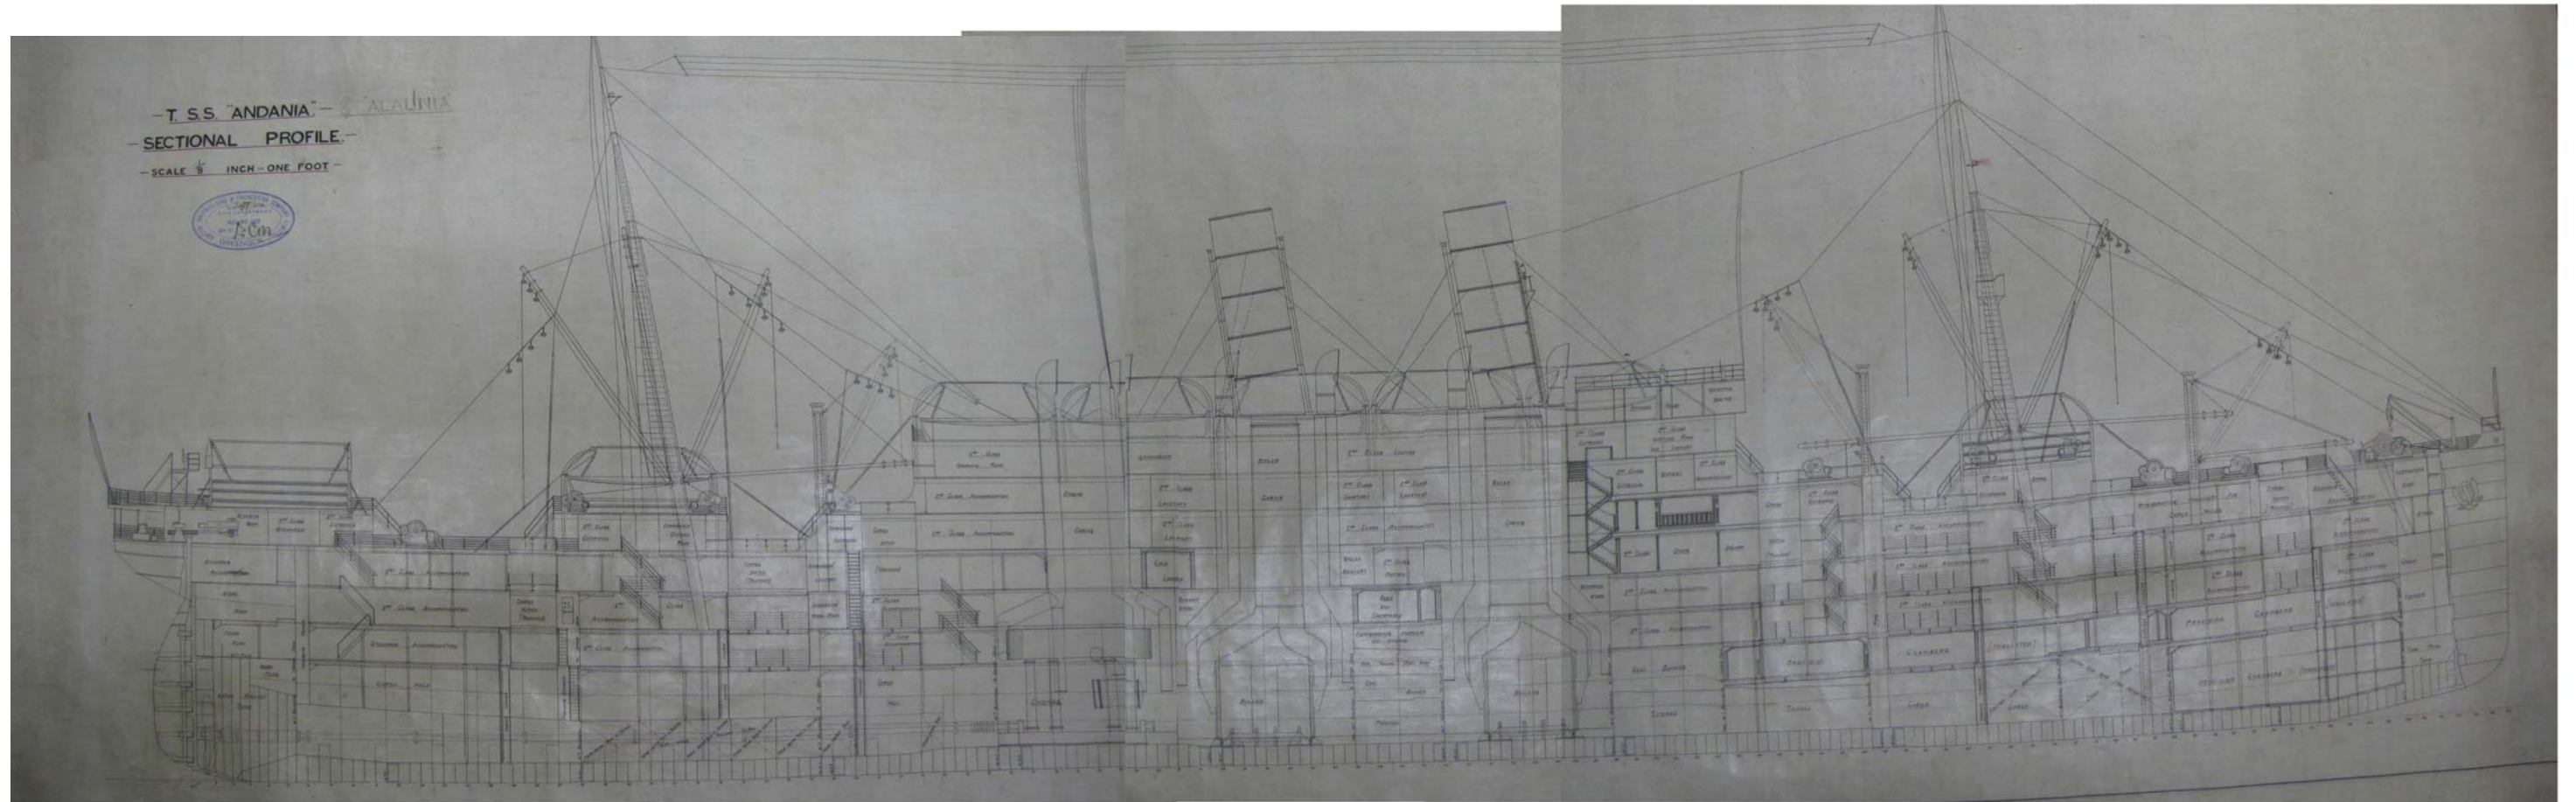
DRAWN BY	JB	PROJECT NO.	770001	FIGURE NO.
CHECKED BY	JB	DATE	10-03-1015	2
APPROVED BY	SE	SCALE	@A3 NA

FIGURE TITLE
Sectional Profile of the Andania

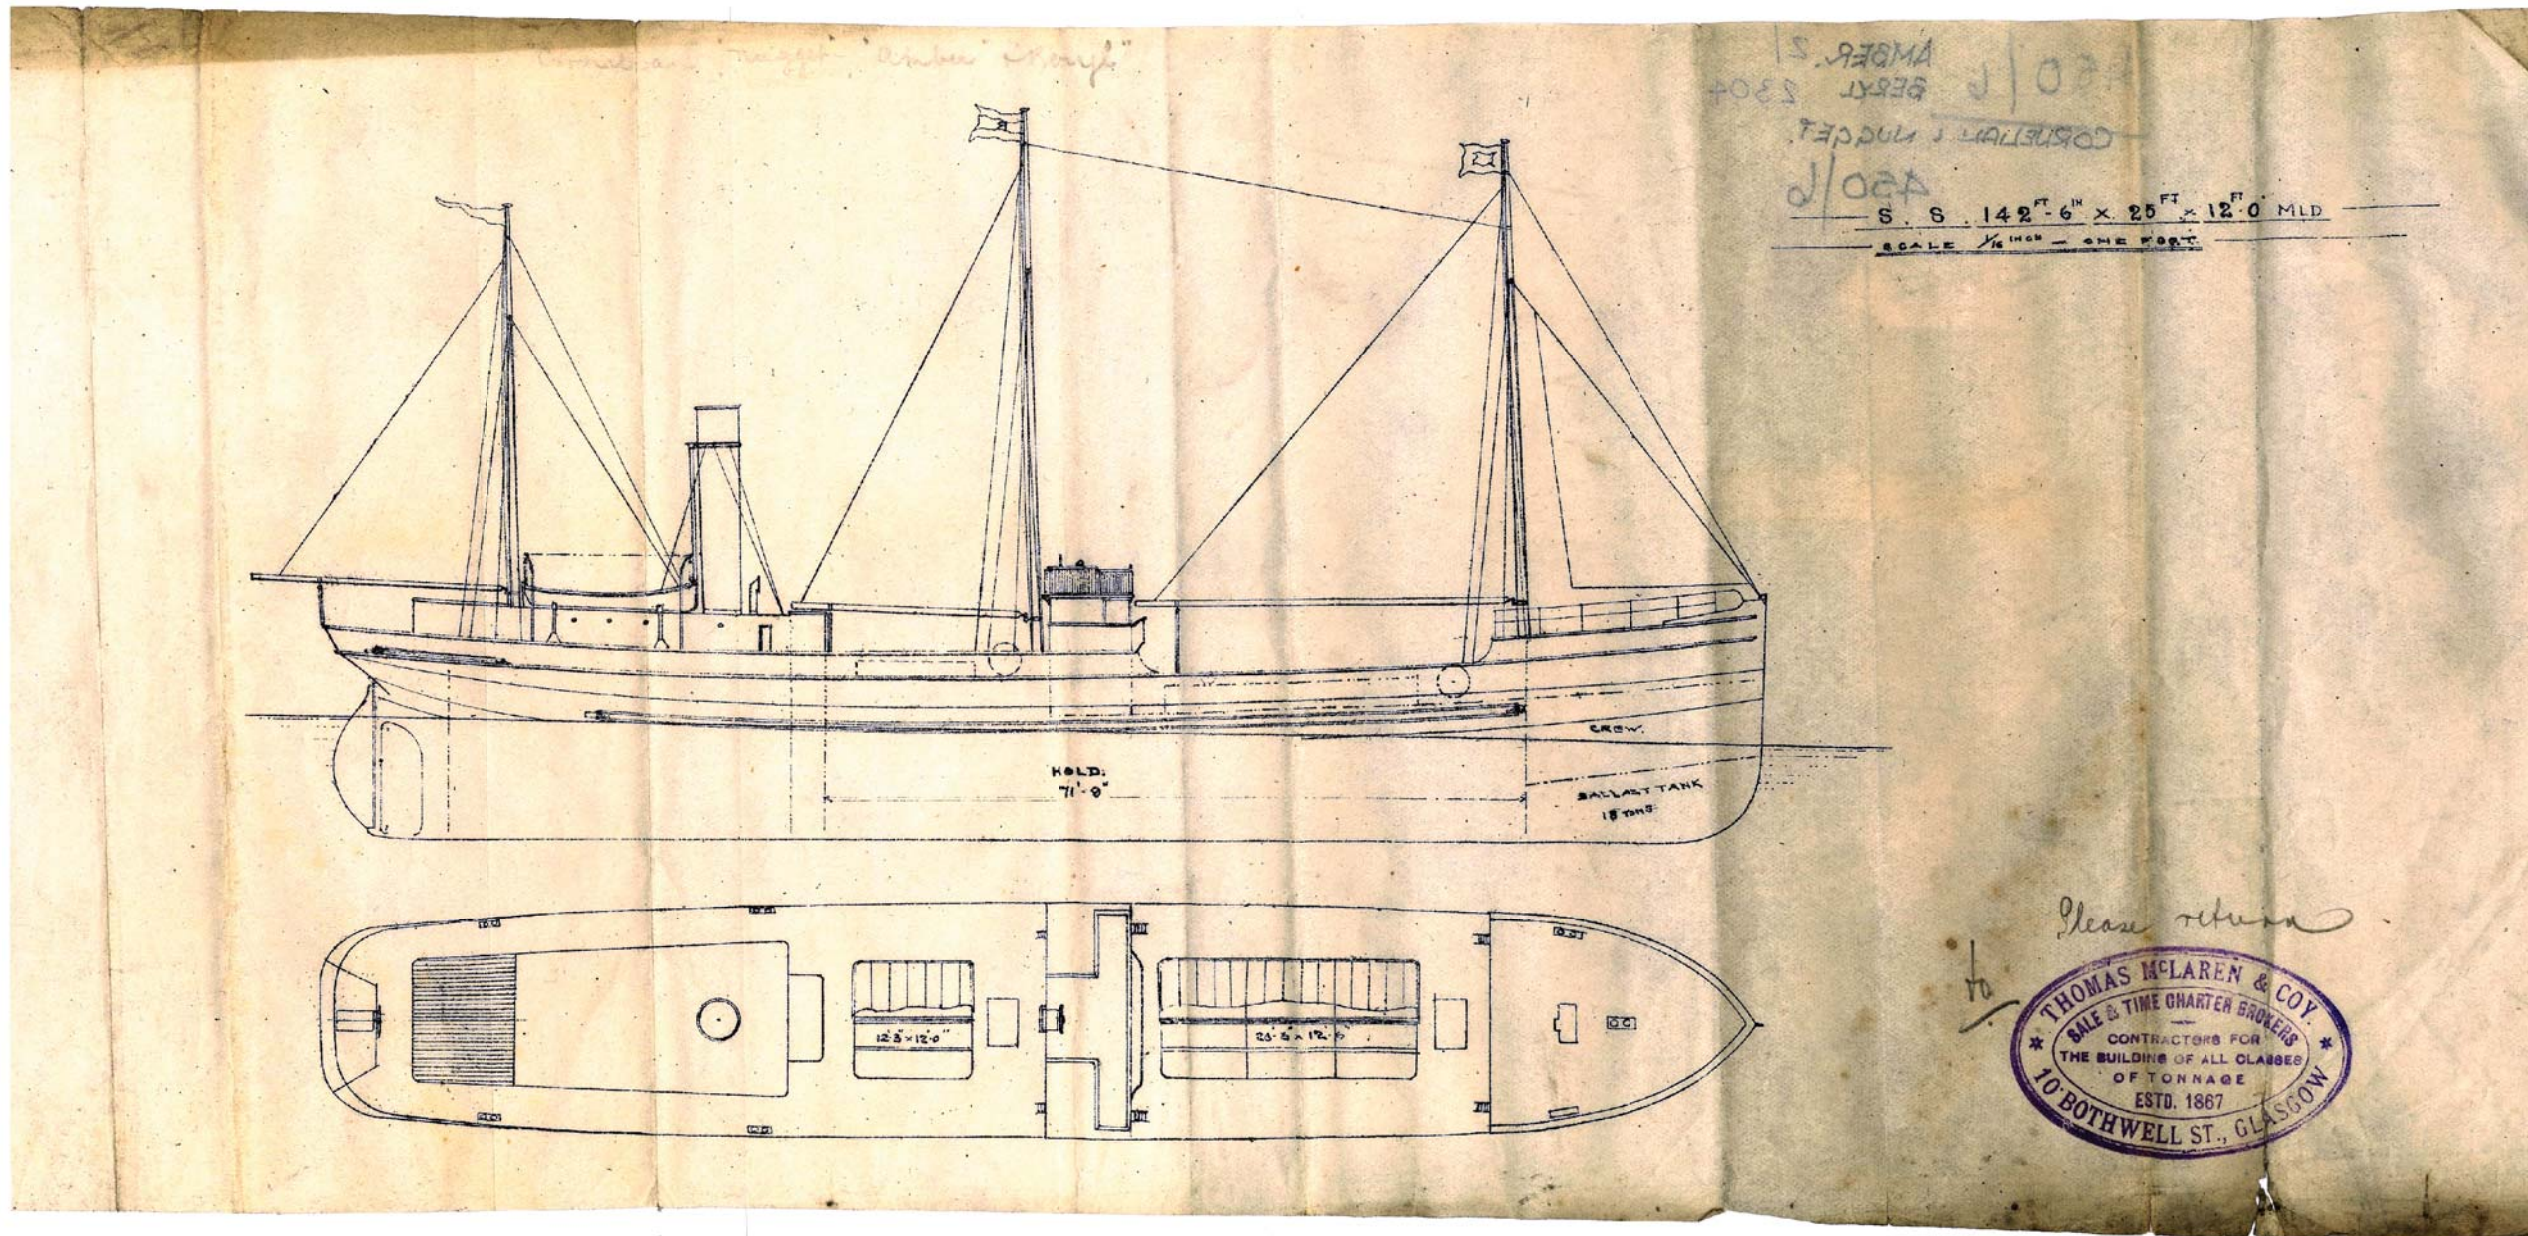
450/1
 CORNELIUS J. MURPHY
 1804
 AMBER S.
 S. S. 142'-6" x 25' x 12'-0" MLD
 SCALE 1/4" = 1 FT
