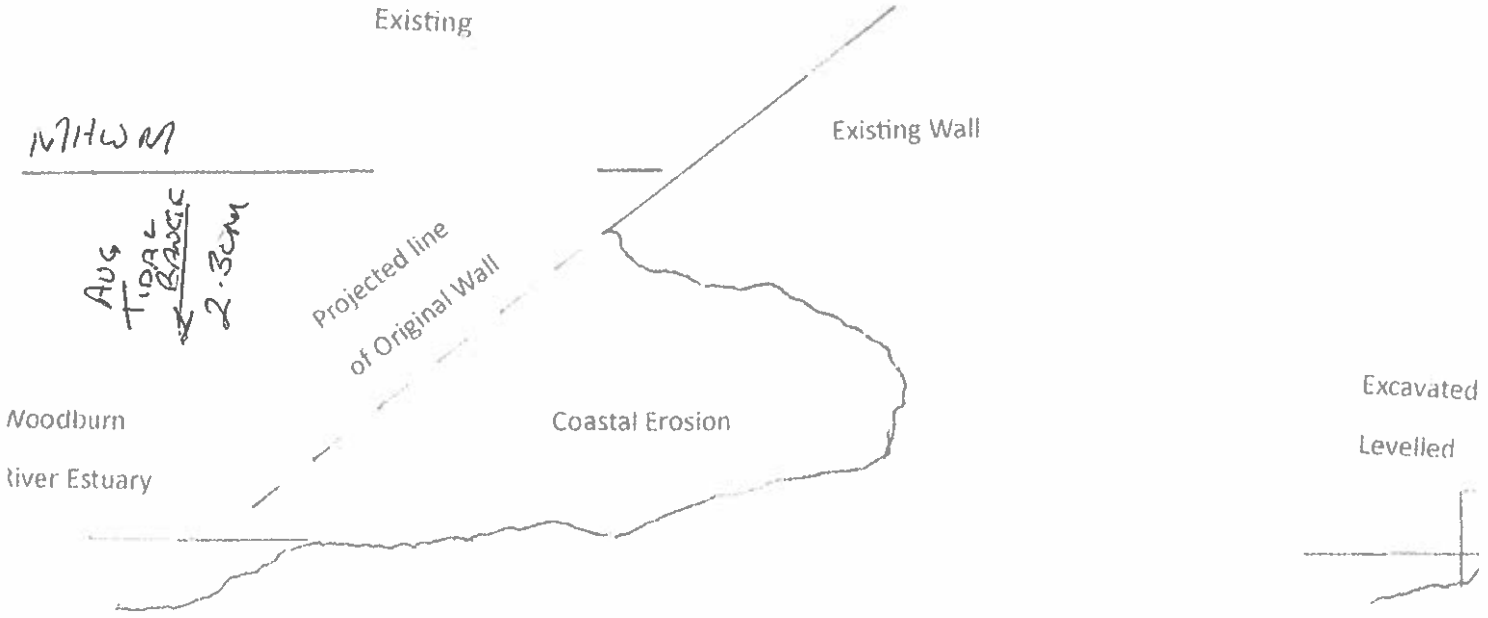
Existing
MHWM
AUG TIDAL BANDE 2.3CMM
Existing Wall
Projected line of Original Wall
Coastal Erosion
Excavated
Levelled
