Compliance Assessment Report 1 for Landfill Sites

Craigmore Landfill Site : P0087/05A : River Ridge Recycling (Portadown) Ltd.

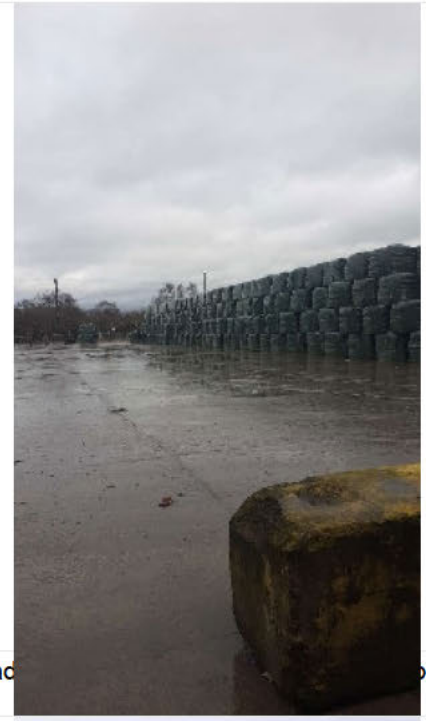
7* (2) Observed heavy fungal growth in waterway downstream of MRF1 which is visually impacting waterway for approx 200meters. Riverridge still in ongoing discussions with [redacted] for a longterm fix. Plans have been produced however another meeting is to be held this week to discuss.

7*.Silt trap at SW1 had been dredged. However fungal growth observed on vegetation which leads to reed bed system. Results to be monitored closely at SW1.
2* Bale quantity in compliance. Fire breaks to be installed in line with recommendations.
No issues in product yard at time of visit.

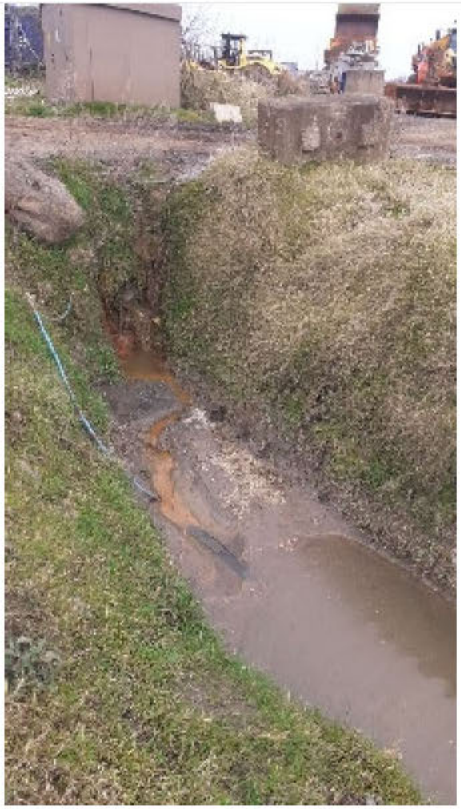
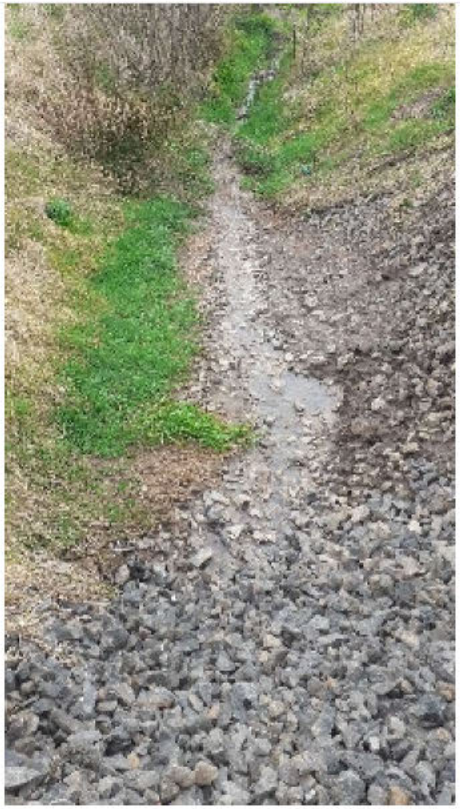
7* Impact downstream from MRF1 still evident but pipe was dry at time of inspection. See above comments.
Carried out followup inspection at SW12 after previous complaint. Discharge visually clean and no further impacts. Silt fencing also in place as precautionary measure. A report is being sent through regarding route causes and analysis by end of week.
No other issues identified at time of visit.

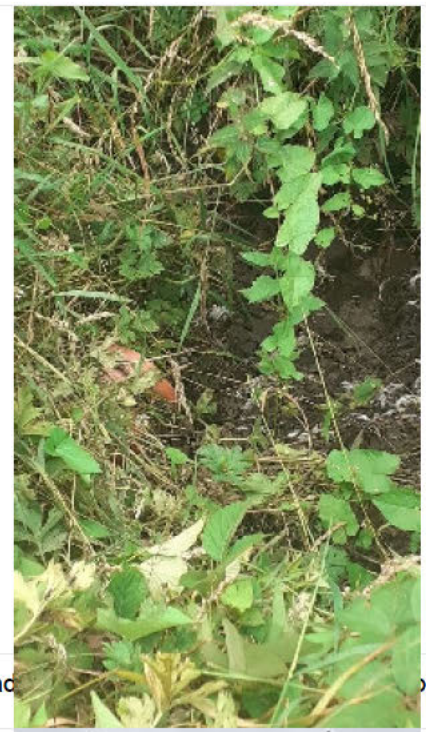
7* MRF1 issue ongoing with exceedance in June. Sample point dry at time of inspection.
Plans now in place for a dirt buster to be tried out in August and if successful to be made a permanent fixture by Nov/Dec26. A Warning Letter now to be issued to get works carried out as this issue has been going on for a long time. This will be followed by an Enforcement Notice if required.
23* (score 1) Non-compliance noted for number of seagulls on site. Operator to investigate obtaining a licence to cull. There was a hawk onsite but not able to remedy the issue.
In relation to landill - 11a has been filled to a point, 11b now active.
Capping works at 8, 9 and 10 and earthworks ongoing for cell 12.
Bales within compliance limits.
Reed beds inspected and looked in good condition.
Soil in product yard to be moved to another bay or location as it is to close to storm drain.

23* Operator to investigate obtaining a licence to cull.

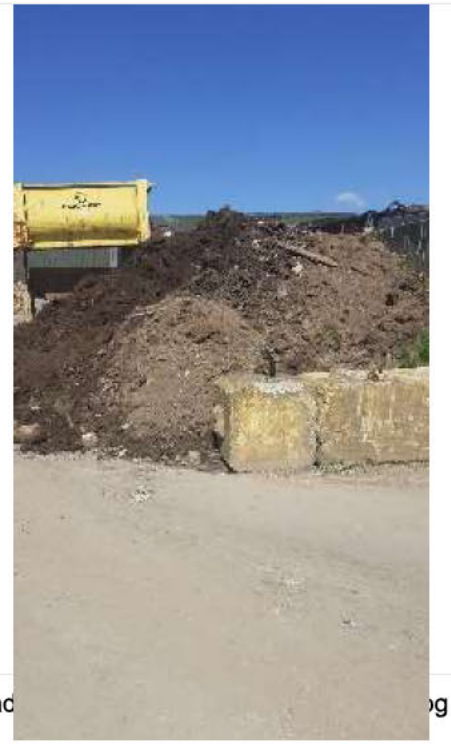
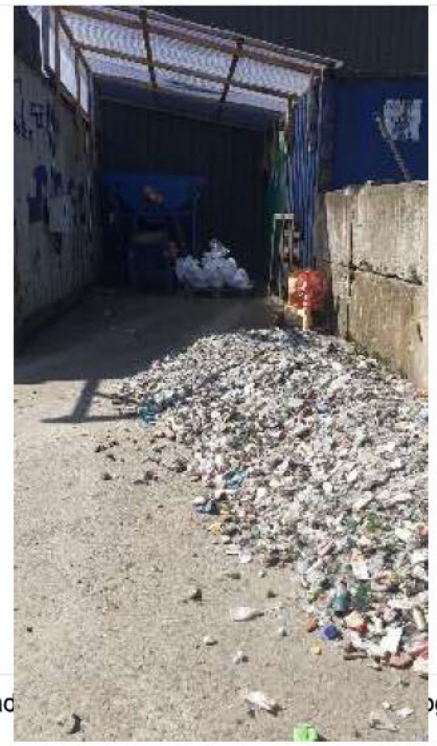
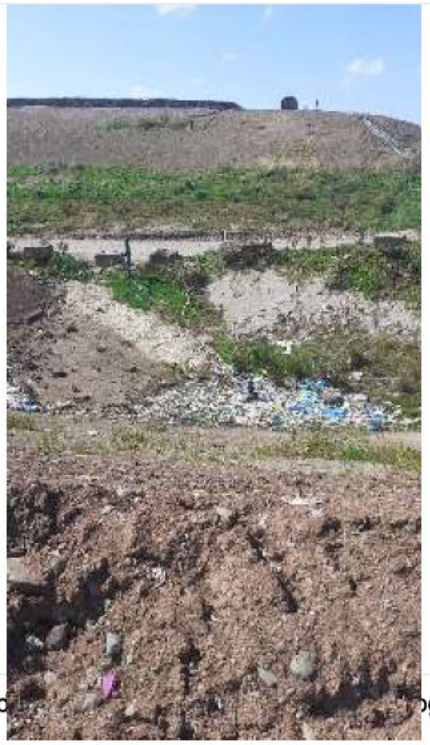
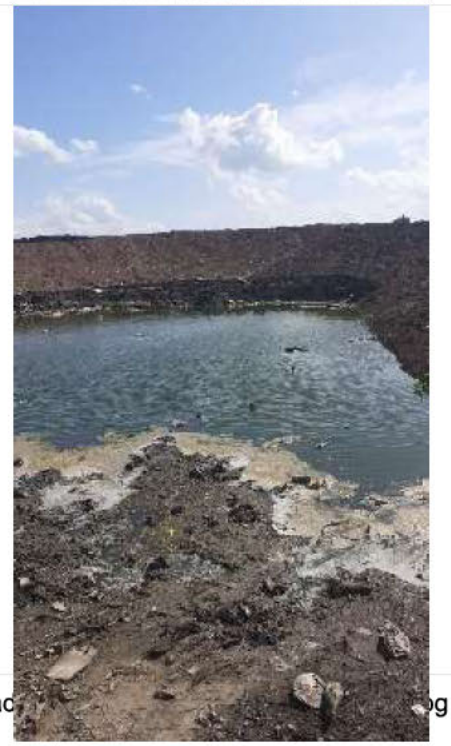
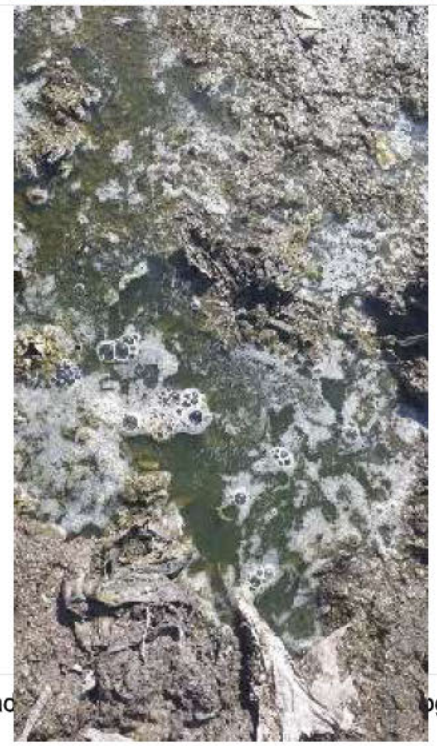
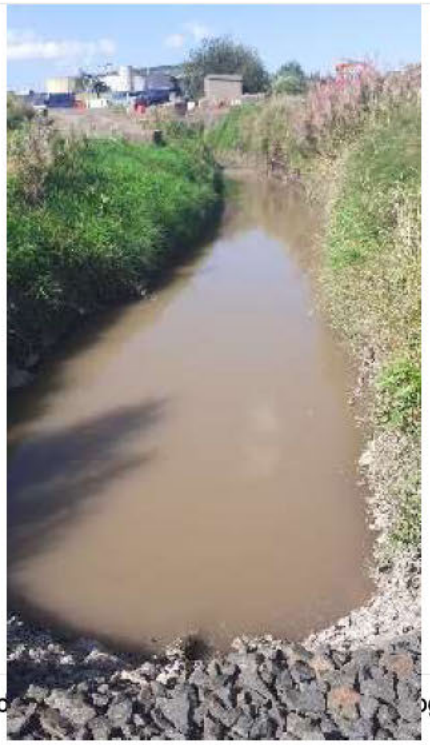
23. Seagull issue resolved at minute. 1 month Trial period of taking waste direct to end user as opposed to unloading and loading of waste inside shed.
7. Plans have been submitted to NIEA for approval of silt buster trial. Once approved Operator to install within 2 week period. When rainfall occurs samples to be collected and sent for testing. NIEA to be advised of results. At time of visit waterway dry and no discharge from MRF1.
Mud still stored outside of bays in product yard. Potential pollution risk as storm drain close by. To look into relocating.
14.Pile of fines observed over beside storage sheds which had been used for sampling purposes. To be removed by end of day.
6.Some intermittent gaseous odour on top of landfill. Capping is underway and to be completed in next 3 to 4 weeks.

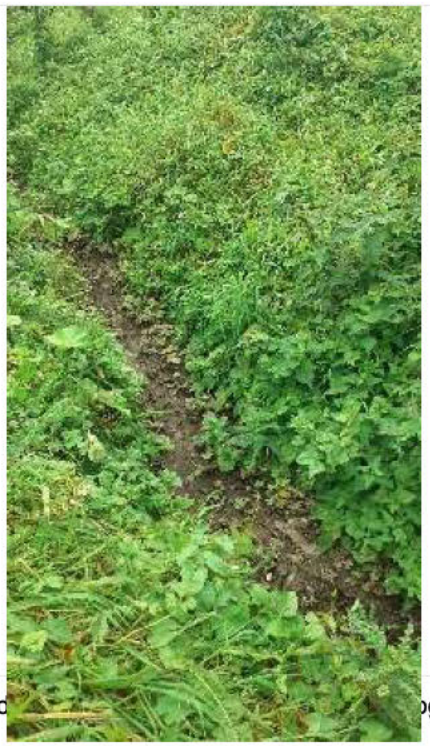
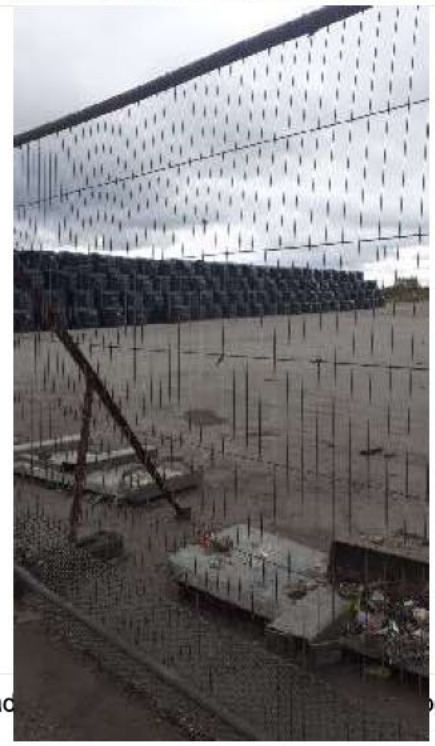
***7 Pad location being determined by [redacted] for Silt Buster in relation to getting best fall. Silt Buster providing a chemical dosing plant for part of trial period along with silt buster units.**
Waterway and MRF1 dry at time of inspection.
Observed digger adjacent to silt trap for SW1. To be dredged out in next day or two.
***11 Soil & C&D waste bring moved into more suitable bays in product yard at time of visit.**
***6 Gas connections being made 1st week in October. No gas odours detected at time of inspection. [redacted] confirmed CQA report coming in October as leak detection survey being completed next week of new cell.**
***23 No further issues with birds in yard or landfill as feed stock going straight to end user and hawk on site.**

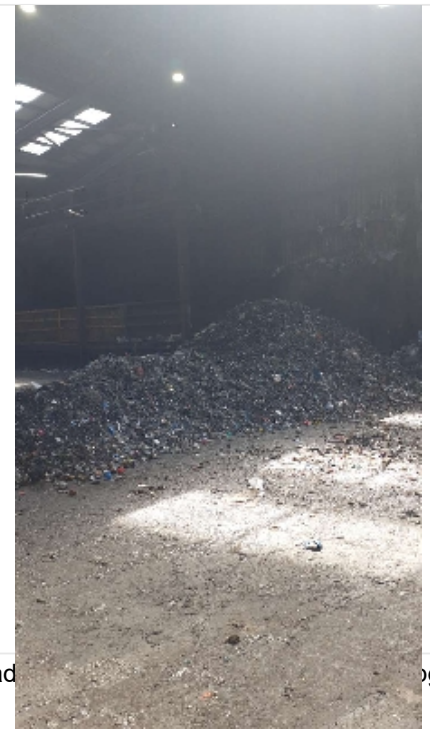
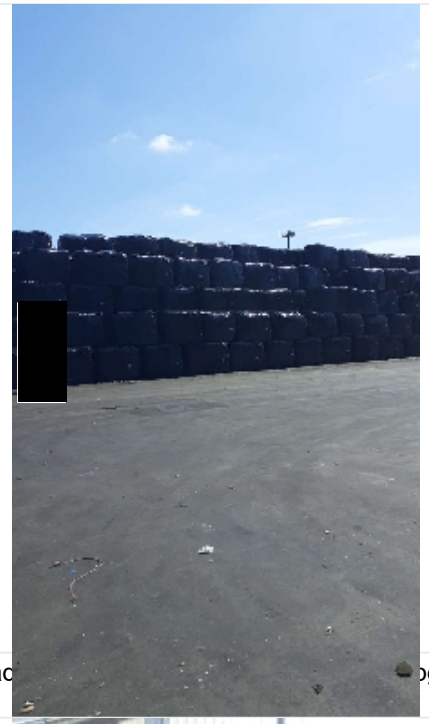
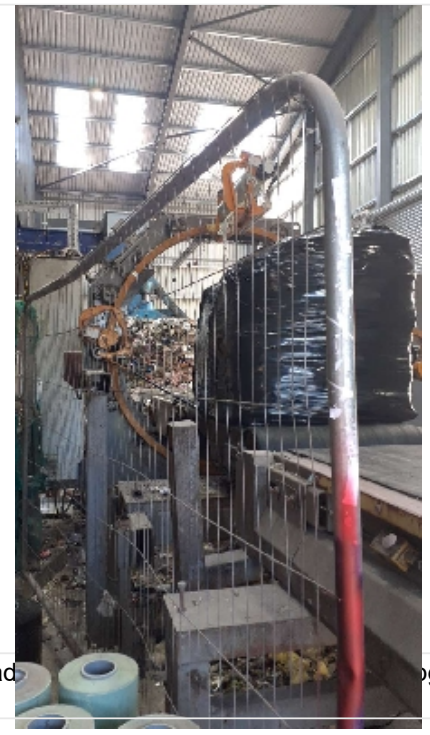
Site in compliance. Points to note-Shreading, baling and processing of waste back in operation (refer to temporary working plan). New baler in operation. Any spillages in shed confined to concrete floor and dealth with acccordingly, no longer drainage channels in building.
6* Some of the pin wells need attention. [redacted] contact B9.
Plume discussed...NIEA to attach copy of recent report received by NIEA to this inspection report.
Outlet of aluminium tins to be confirmed.
Asbestos received onsite 14.5.25. Quarantined in MRF1. Consignment note to follow.
New Cell 11a - Testing clay pad and placing of clay to commence this week. Schedule of works to be sent by [redacted]
Waterway dry at time of inspection. Stones visible on bed of waterway.No discharge from MRF1. Upstream of MRF1 water clean at SW9.
