BLUE SKY RESOURCE RECOVERY LTD.

LISBANE LANDFILL RESTORATION

CQA PLAN

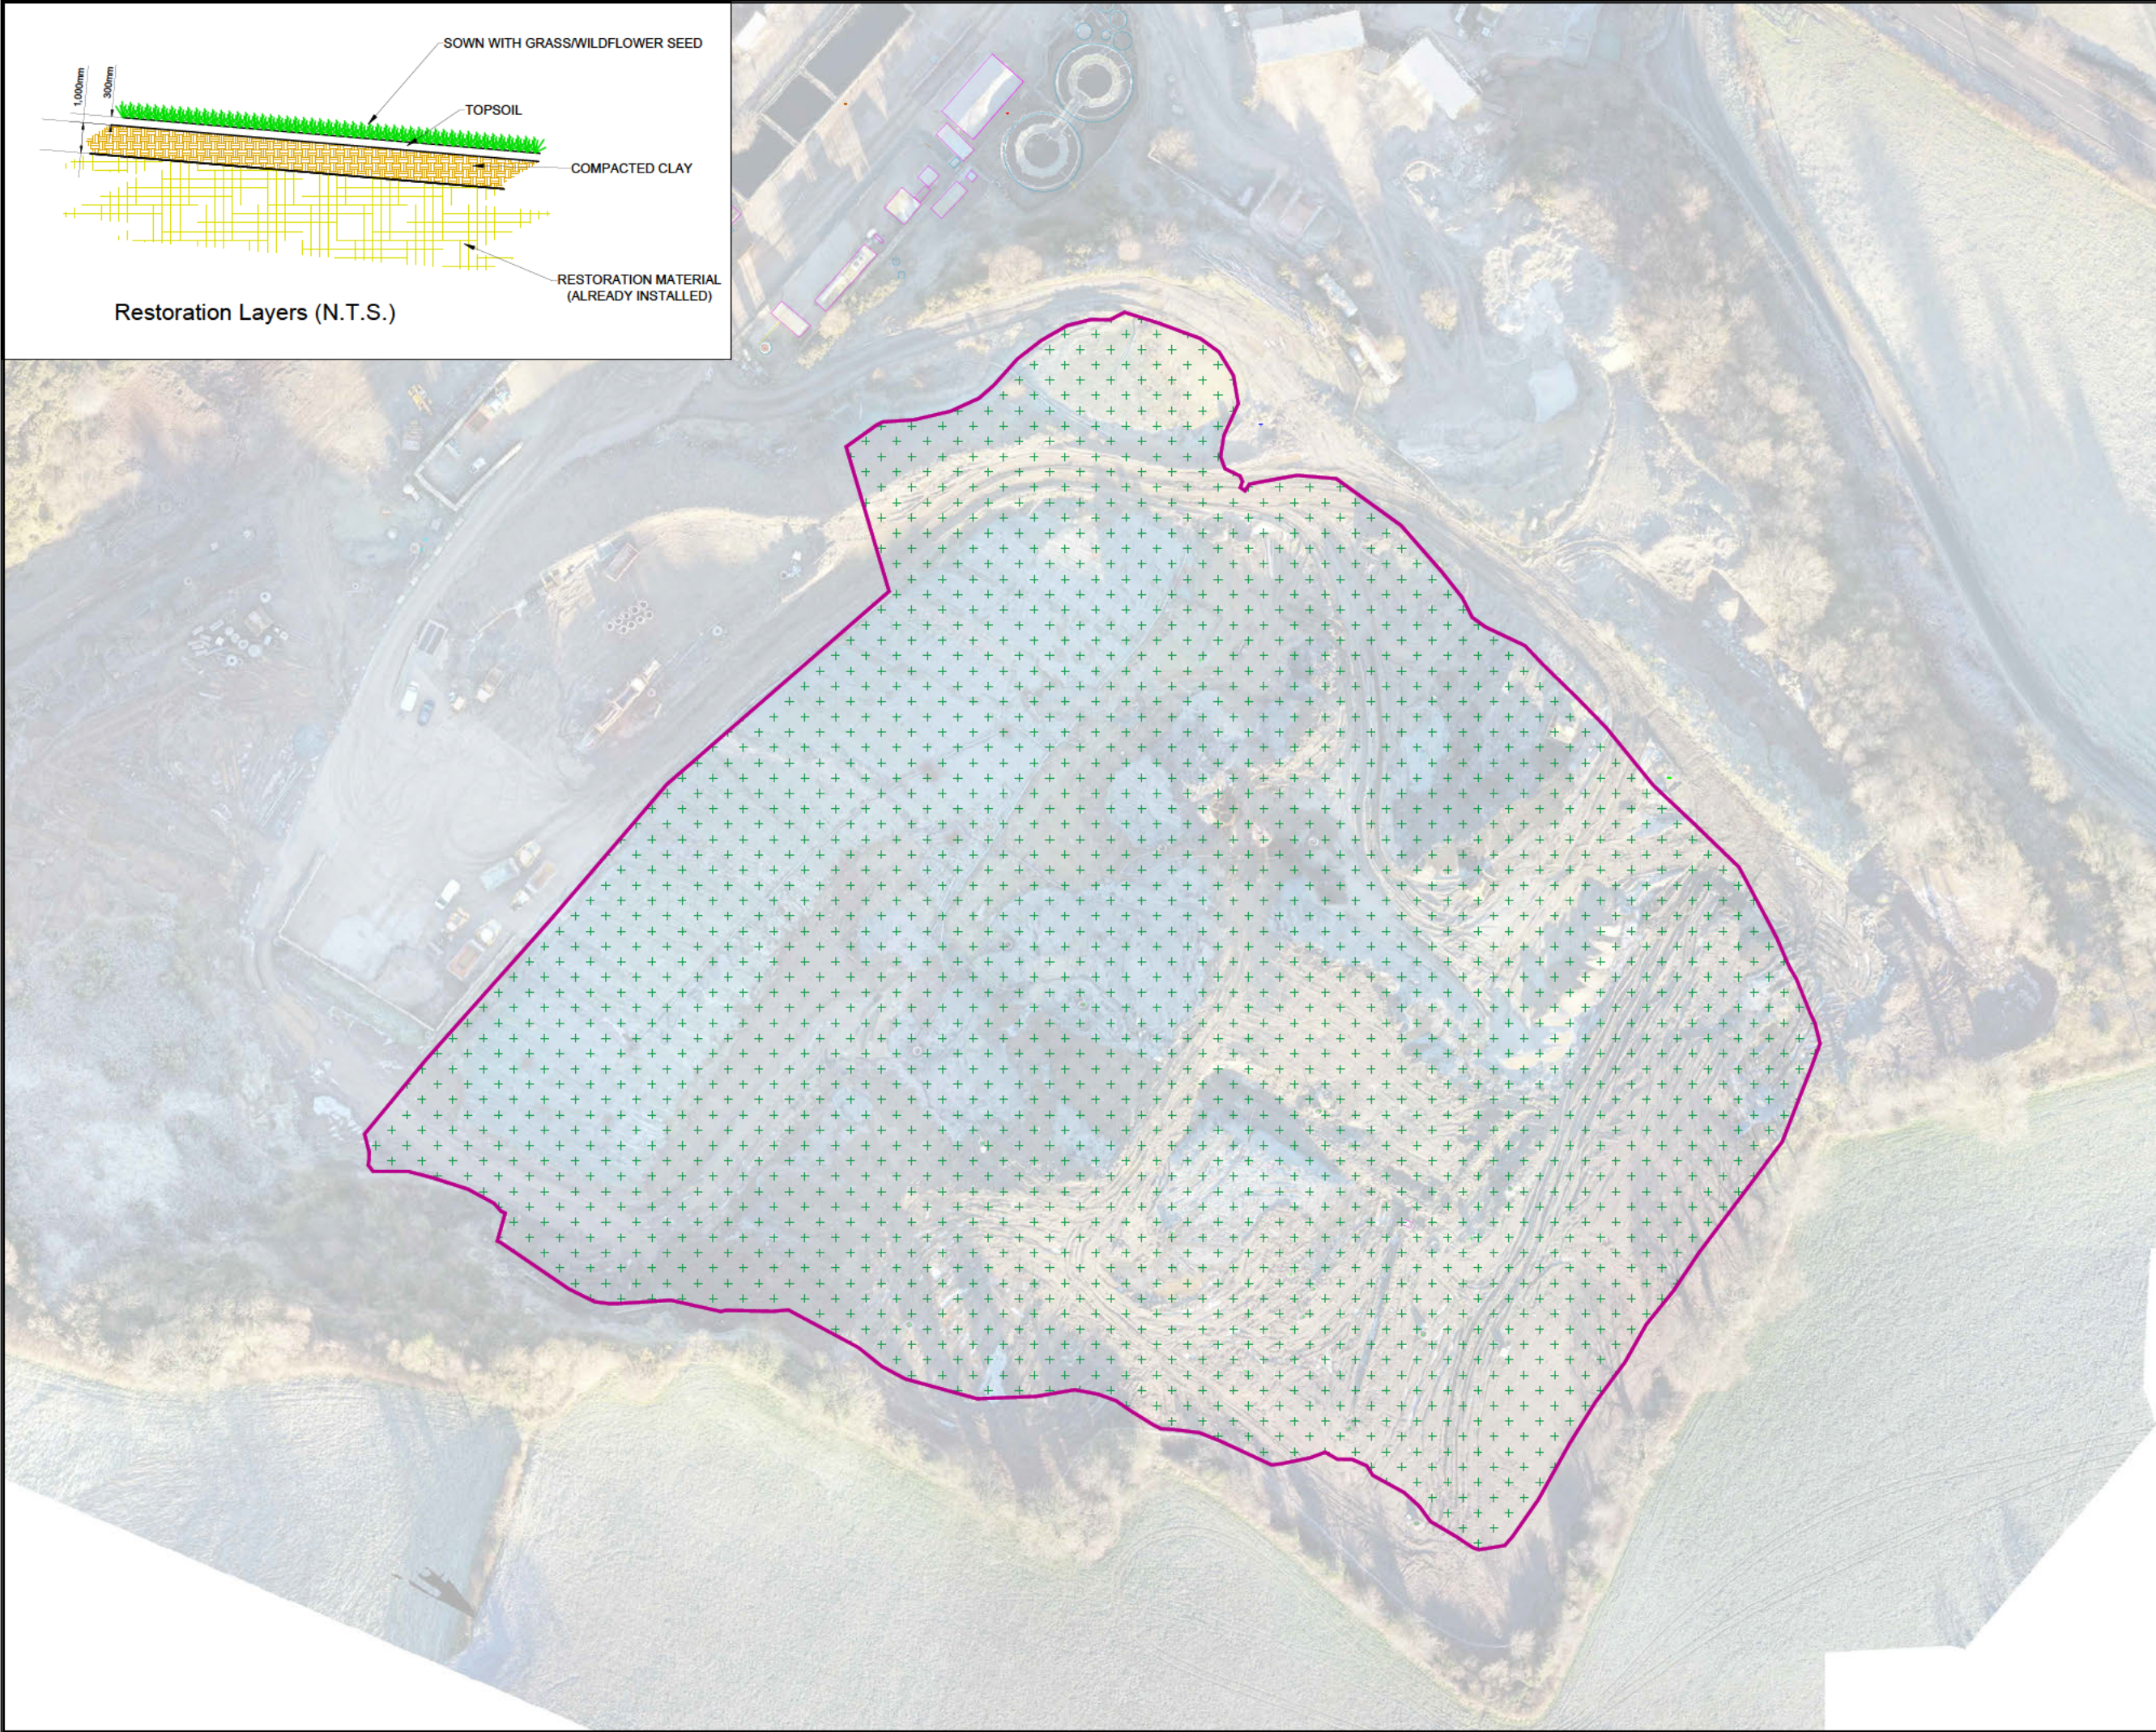
- Restoration Area
- Approx. Restoration Area

Further details of the works and approximate location can be seen on Drawing 15047-201R.
