## Ballygally – Bathing Water Profile

Ballygally beach, County Antrim, Northern Ireland

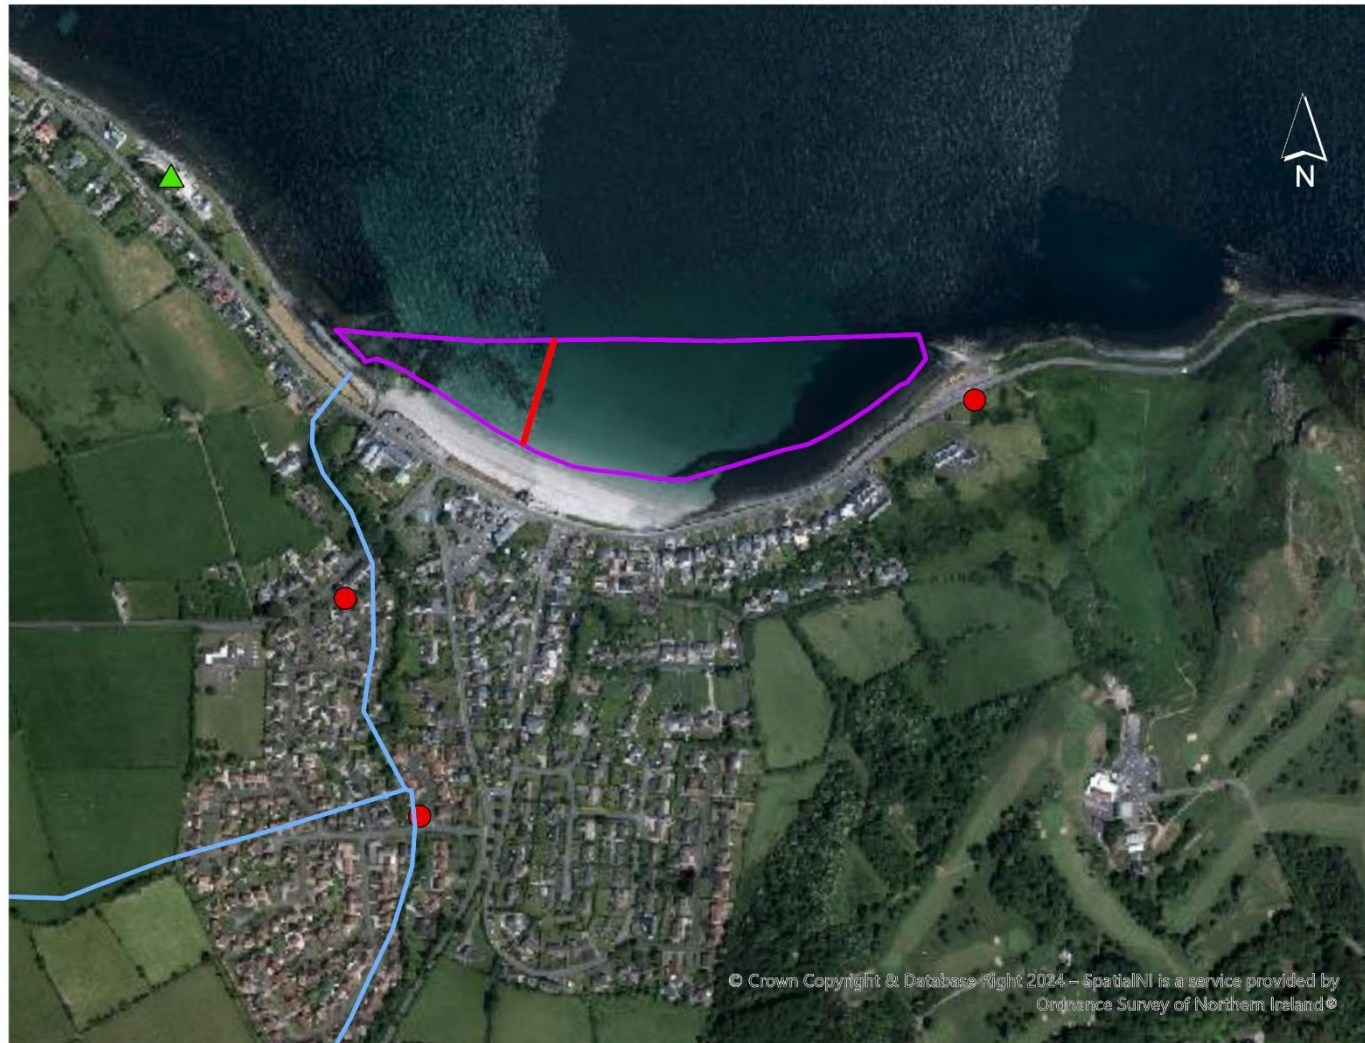
Map 1 Ballygally Bathing Water

The collection and treatment of wastewater has the potential to cause pollution as all combined collection systems are designed to overflow in periods of extreme wet weather or following failure of the system. This prevents overflows into residential properties. Within the Ballygally area there are a number of combined sewer overflows (CSO) and wastewater pumping stations with associated emergency overflows, highlighted on Map 1
