## Ballyhornan – Bathing Water Profile

Ballyhornan Beach, County Down, Northern Ireland

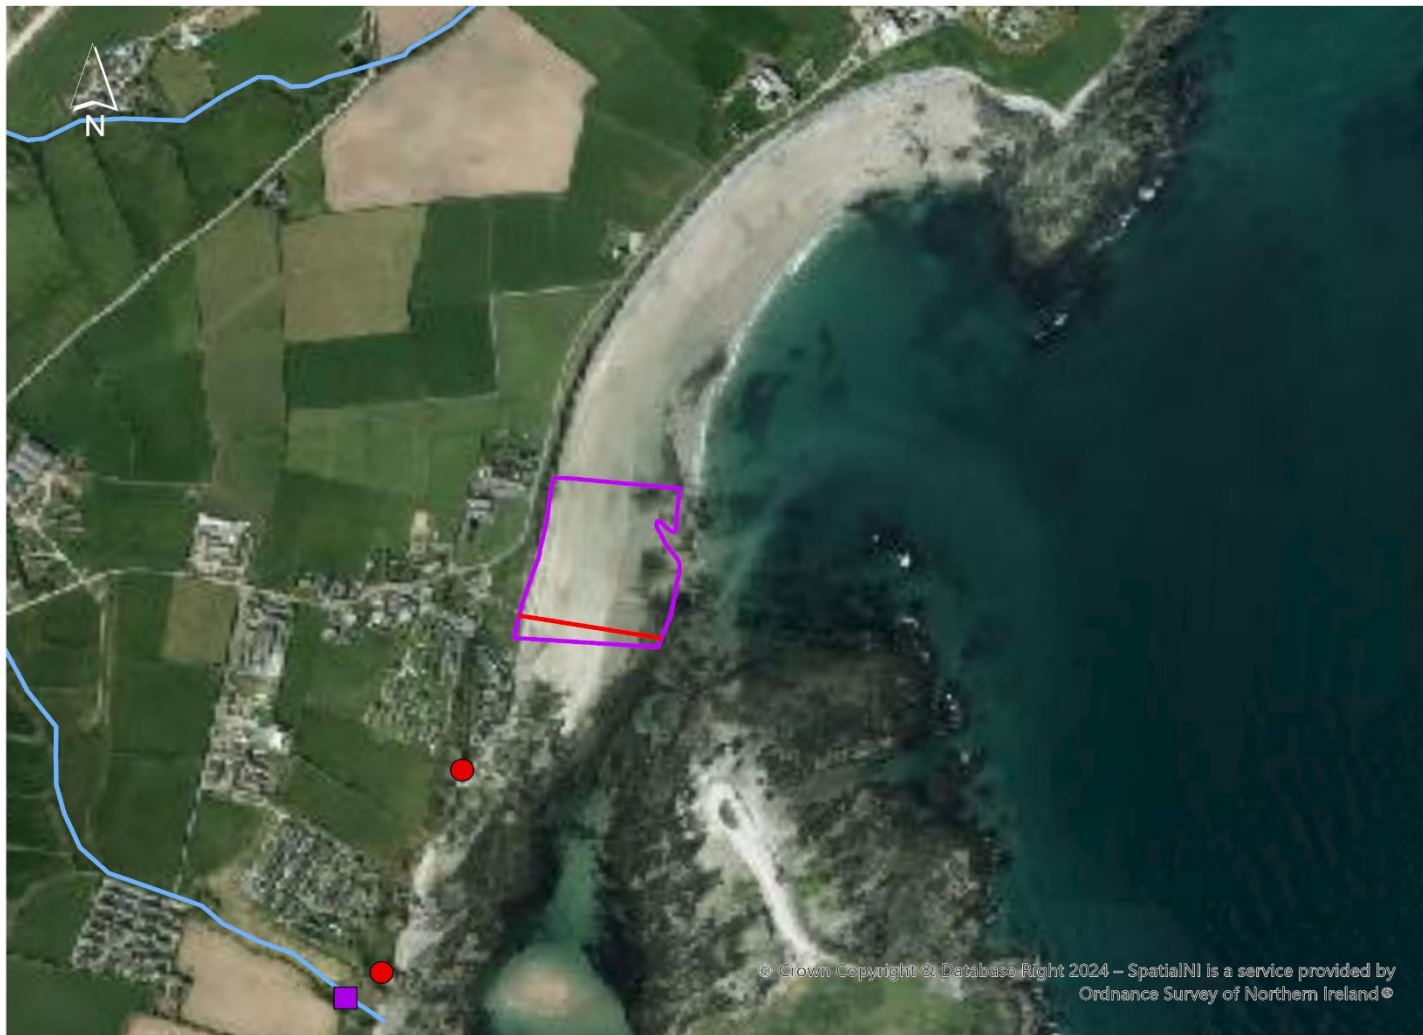
Map 1 Ballyhornan Bathing Water

The collection and treatment of wastewater has the potential to cause pollution as all combined collection systems are designed to overflow in periods of extreme wet weather or following failure of the system. This prevents overflows into residential properties. Within the Ballyhornan area there are a number of wastewater pumping stations and associated emergency overflows, highlighted on Map 1.

There is one wastewater treatment works approximately 0.6km to the south of Ballyhornan bathing water. The wastewater from the Ballyhornan area is pumped to this works for treatment.
