## Magilligan Benone – Bathing Water Profile

Benone beach, County Londonderry, Northern Ireland

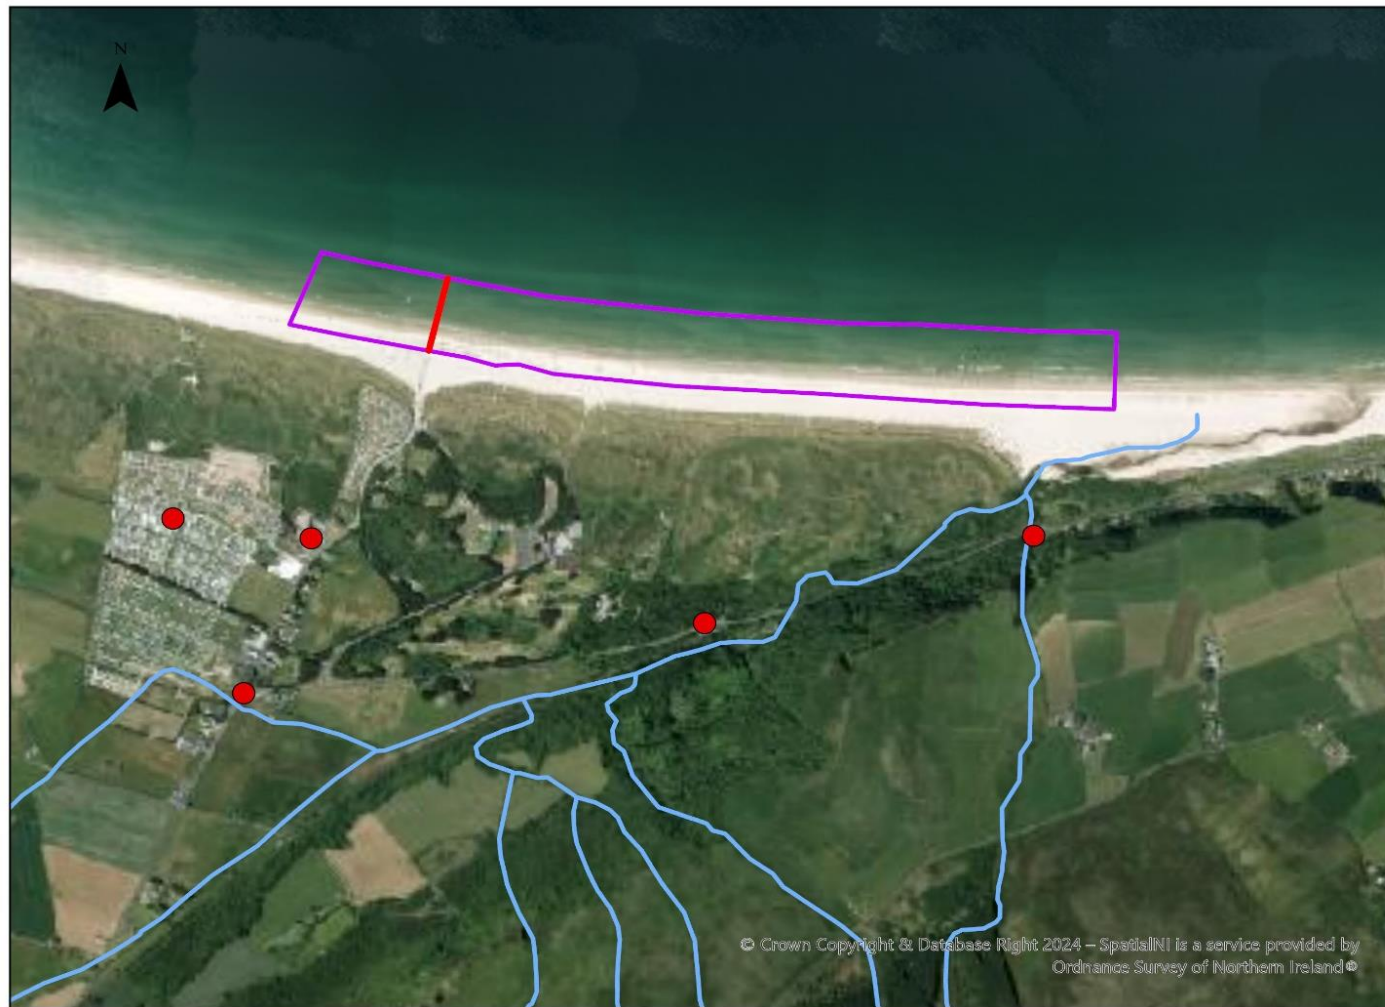
Map 1. Magilligan Benone Bathing Water

The collection and treatment of wastewater has the potential to cause pollution as all combined collection systems are designed to overflow in periods of extreme wet weather or following failure of the system. This prevents overflows into residential properties. Within the Benone area there are a number of wastewater pumping stations and associated emergency overflows, highlighted on Map 1.
