Cushendall – Bathing Water Profile

Cushendall, County Antrim, Northern Ireland

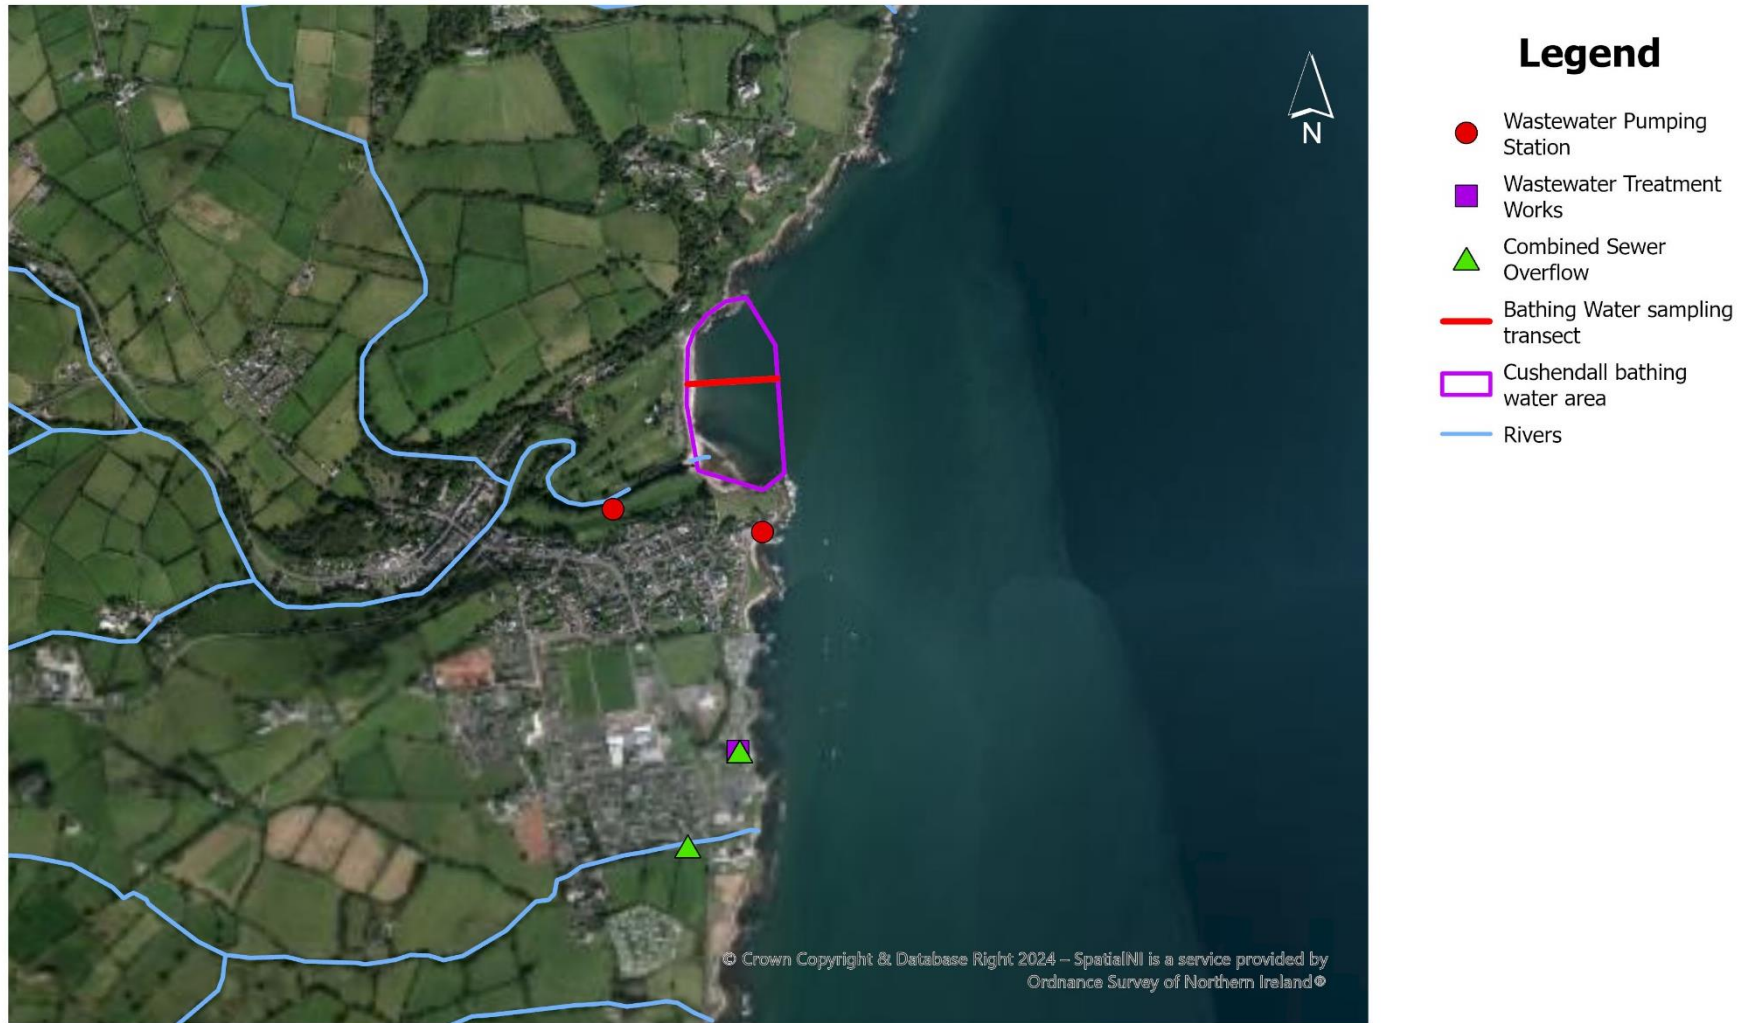
Map 1 Cushendall Bathing Water

The collection and treatment of wastewater has the potential to cause pollution as all combined collection systems are designed to overflow in periods of extreme wet weather or following failure of the system. This prevents overflows into residential properties. Within the Cushendall area there are combined sewer overflows (CSO) and wastewater pumping stations with associated emergency overflows, highlighted on Map 1.
