Portballintrae (Salmon Rock) – Bathing Water Profile

Salmon Rock beach, Portballintrae, County Antrim,
Northern Ireland

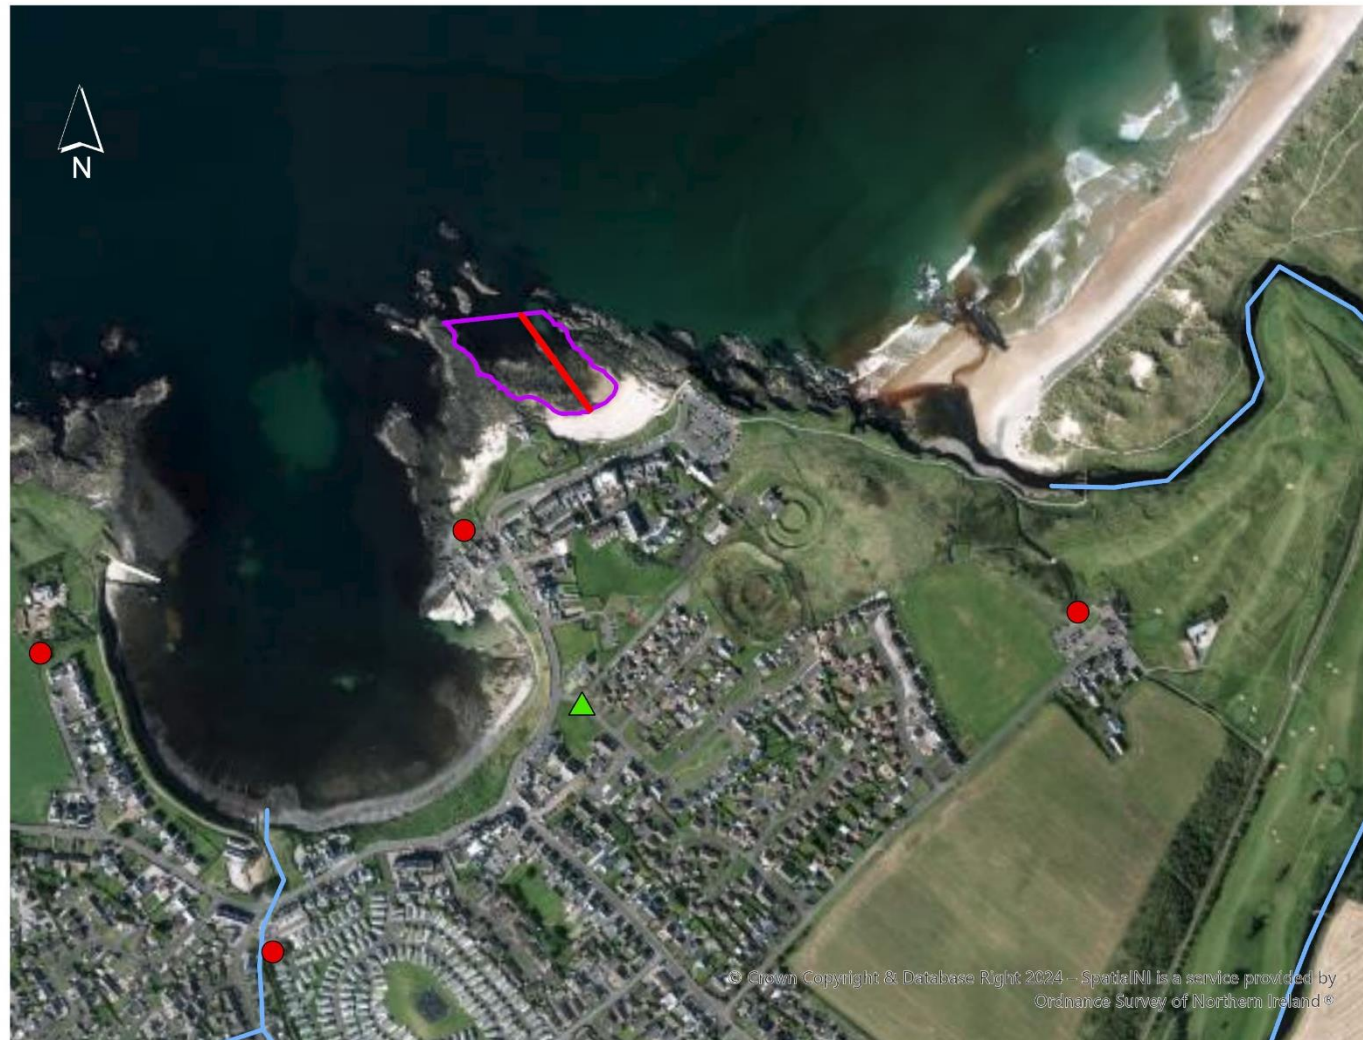
Map 1 Portballintrae (Salmon Rock) Bathing Water

The collection and treatment of wastewater has the potential to cause pollution as all combined collection systems are designed to overflow in periods of extreme wet weather or following failure of the system. This prevents overflows into residential properties. Within the Portballintrae area there are combined sewer overflows (CSO) and wastewater pumping stations with associated emergency overflows, highlighted on Map 1.
