Portrush Curran Bathing Water Profile

Portrush Curran (East Strand), County Antrim, Northern Ireland

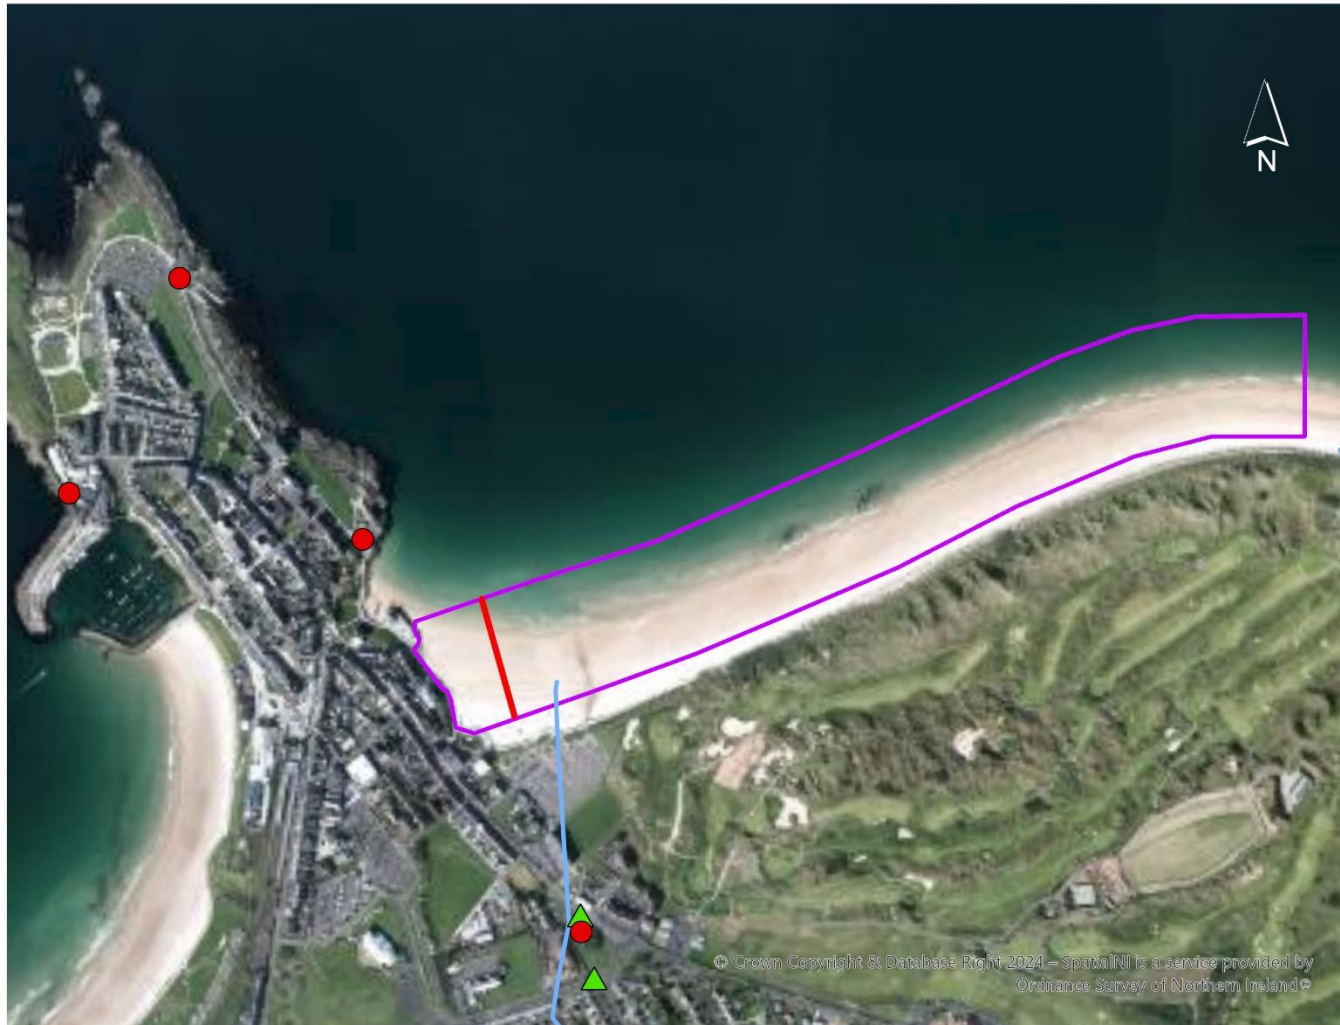
Map 1 Portrush Curran Bathing Water

The collection and treatment of wastewater has the potential to cause pollution as all combined collection systems are designed to overflow in periods of extreme wet weather or following failure of the system. This prevents overflows into residential properties. Within the Portrush area there are combined sewer overflows (CSO), emergency overflows and wastewater pumping stations with associated emergency overflows, highlighted on Map 1.
