# Bathing Water Profile **Downhill**

May 2019

# A Description of Downhill bathing water and the surrounding area

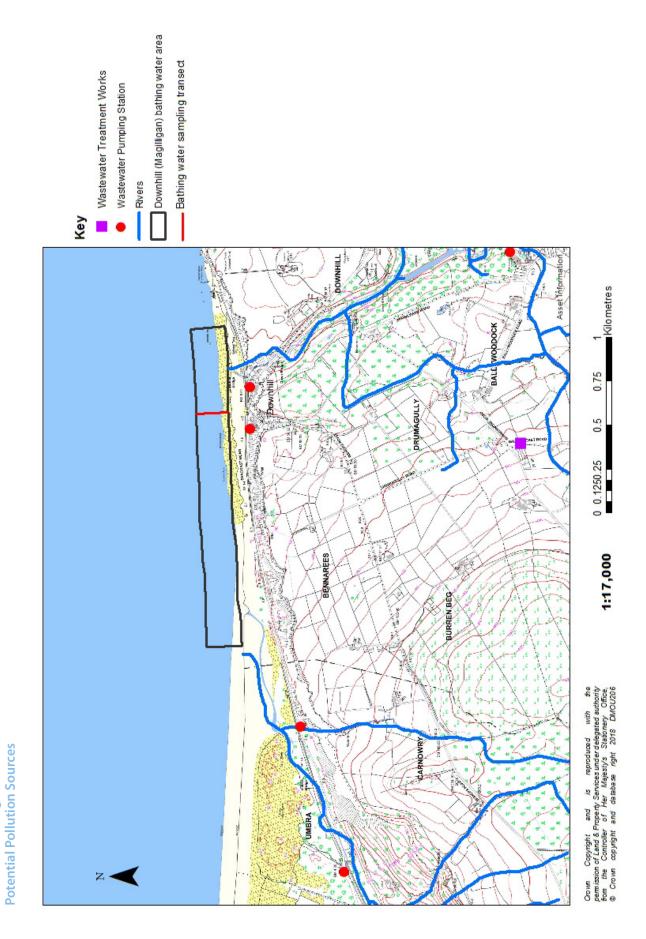
Map 1

The municipal collection and treatment of waste water has the potential to cause pollution because all collection systems must be designed to overflow in periods of extreme wet weather. If systems are not designed in that way, then sewers may overflow into residential areas. Within the Downhill area there are wastewater pumping stations with associated overflows as shown on Map 1.

Downhill Bathing Water -

There is a small waste water treatment works less than 2 km from the bathing water (Map 1).The majority of sewage generated in this area is treated at the new WWTW approximately 10kms west of the bathing water.

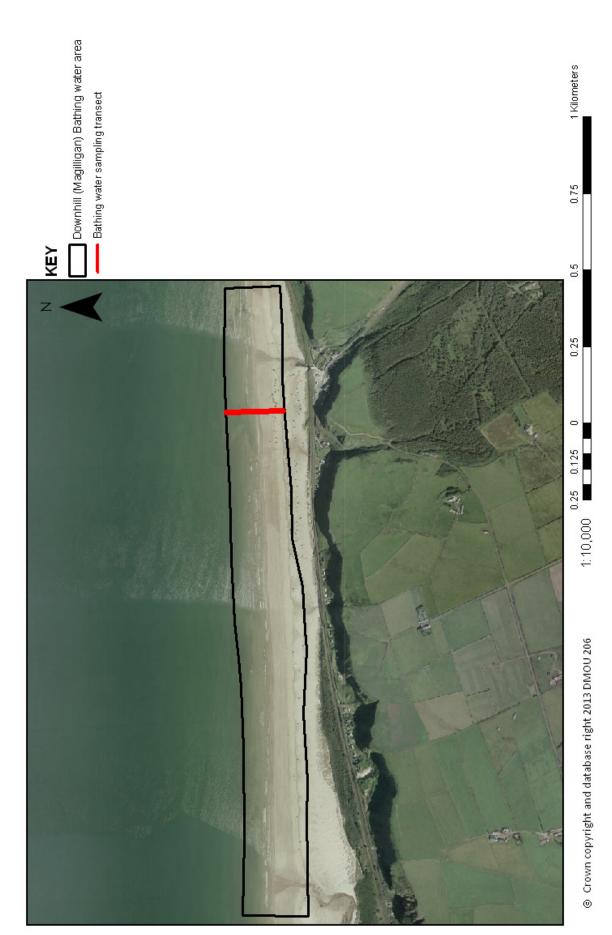
Bathing Water Name	Downhill Bathing Water
EU bathing water ID number	UKNO4_47500
Location	UK/Northern Ireland/County Londonderry/North Coast
Year of identification	2006
Local council area	Causeway Coast and Glens Borough Council
Bathing Water Operator	Causeway Coast and Glens Borough Council
Description of bathing beach	Sand, 4 kilometres in length, contiguous with Benone Bathing Water
Monitoring Point	West of cemented access onto beach, C 7503 3627, (Map 2)
