Bathing Water Profile

Murlough, County Down

May 2020

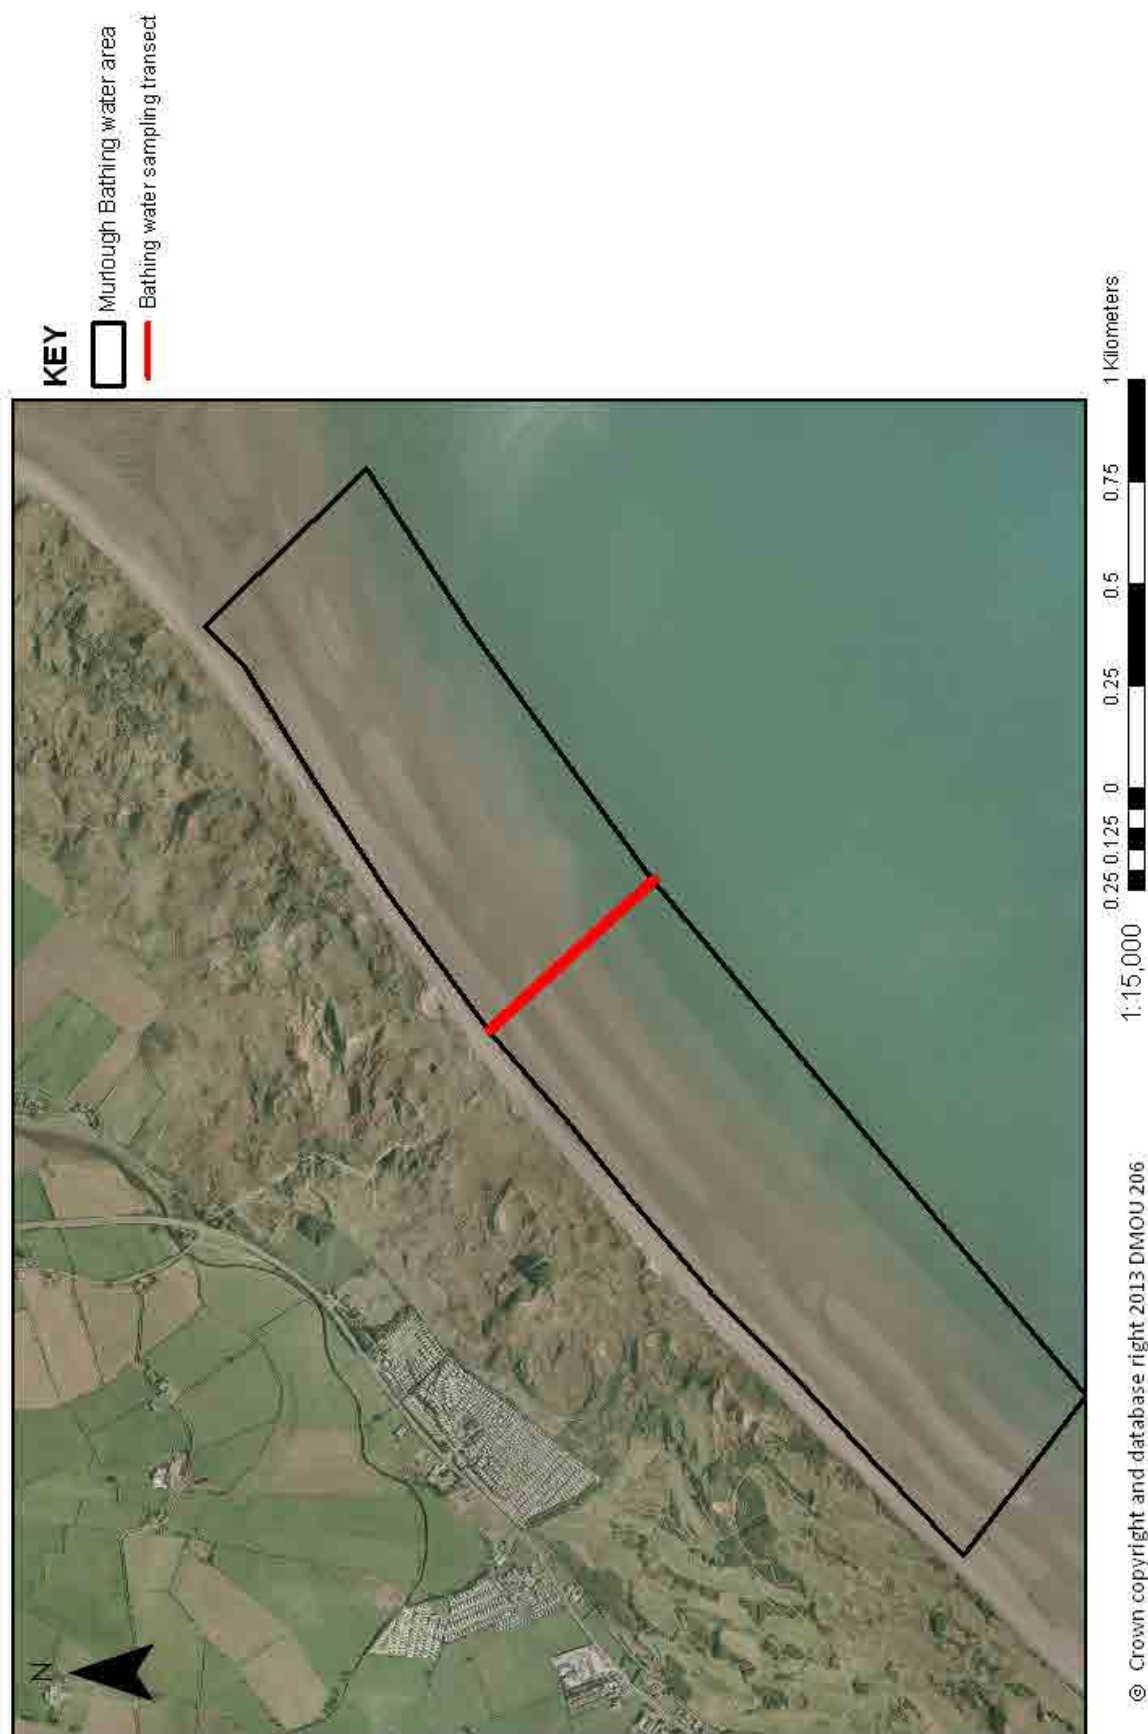
Map 2
Murlough Bathing Water -
EC Bathing Water Sample Location

Bathing Water Name	Murlough Bathing Water
EU bathing water ID number	UKNO3_54100
Location	UK/Northern Ireland/County Down/South Down Coast
Year of identification	2006
Local council area	Newry, Mourne and Down District Council
Bathing Water Operator	Newry, Mourne and Down District Council
Description of bathing beach	Sand, approximately 3 km in length, contiguous with Newcastle Bathing Water
Monitoring Point	Near the middle of the bathing water, J40043344 (Map 2)
